### TNO report

TM-04-D009

## Roadside Infrastructure for Safer European Roads: Road-scene analyses of ten accident sites

This report describes the road scene analyses performed by TNO Human Factors of the ten accidents.

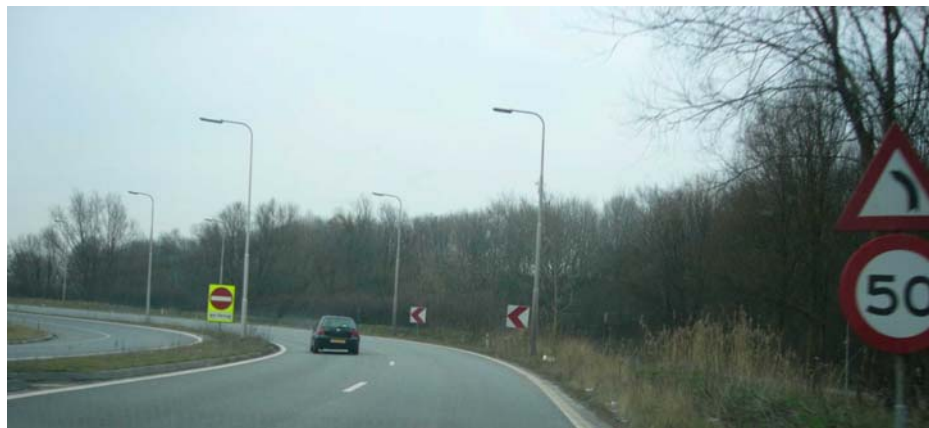
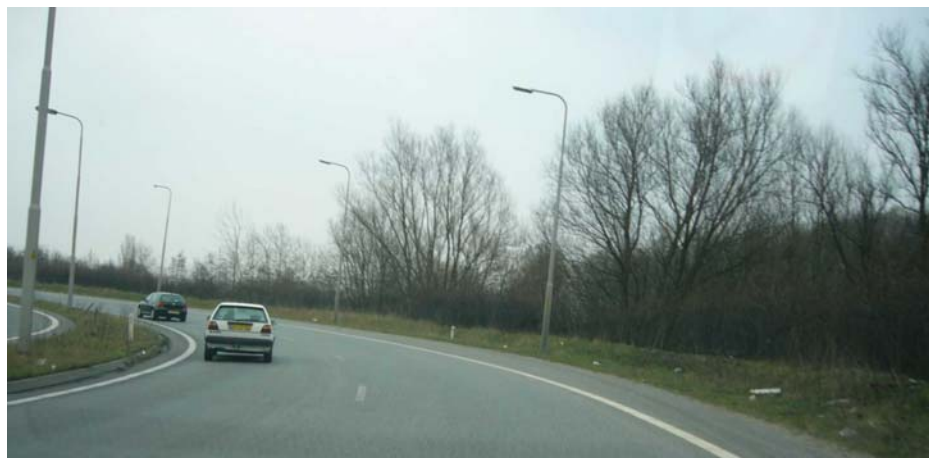
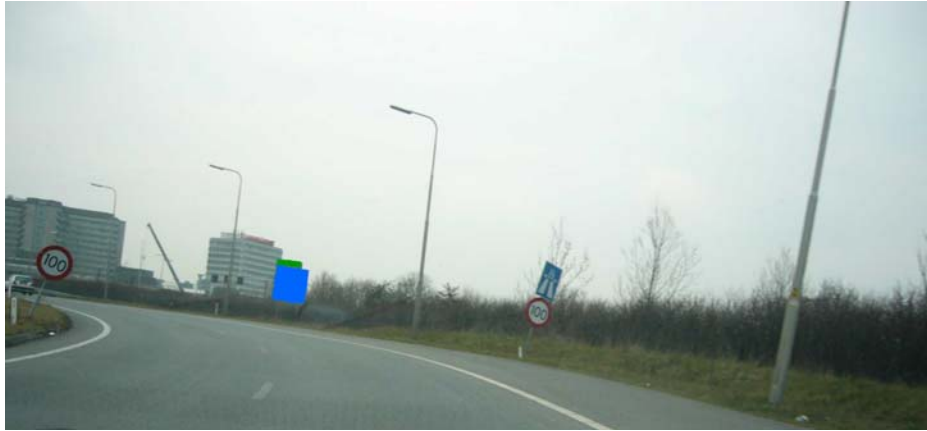
Before getting to the parallel carriageway, the motorist encountered two curves: first a curve to the left with a maximum speed limit of 50 km/h (Figs 1, 2 and 3, show this situation) and secondly a curve to the right (Figs 4 and 5) before entering the main parallel motorway.

Figure 1 – Curve 1 at location 1 at entrance.

Figure 2 – Curve 1 at location 1 continued 1.

Figure 3 – Curve 1 at location 1 continued 2.

A perceptual narrowing of the road due to the curves causes a limited sight distance while the speed limit is changing from 50 to 100 km/h; therefore it is hard to oversee the complete situation beforehand. The advance direction sign as can be seen in Figure 4 indicates that drivers should move to the left while they are negotiating the transition between the curves (entering a right hand curve) to enter the main motorway. The motorist is negotiating a right-hand curve while having to look to the left at the same time; this is counterintuitive.

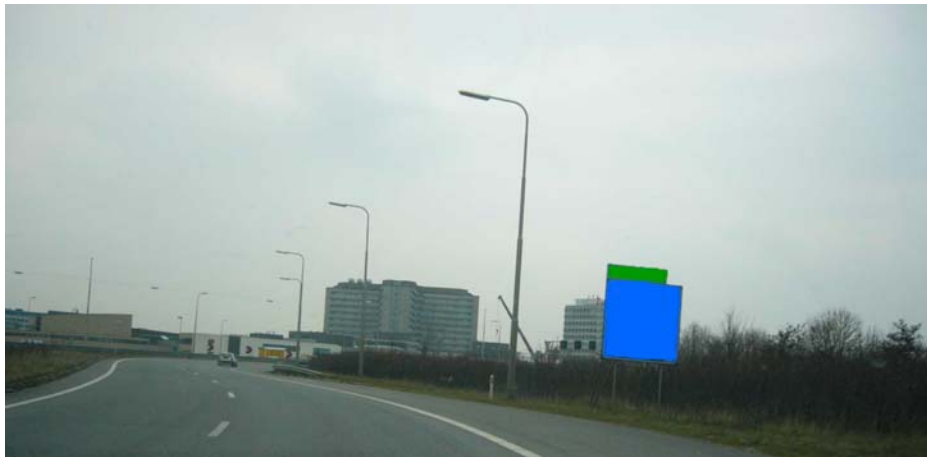
About halfway the first curve the maximum speed limit changes from 50 to 100 in accordance with the fact that at this point the entry officially changes into to a motorway. On the right side a direction sign is positioned (see Figs 3 and 4). After the curve to the left, a transition followed between the left and the right curve (see Fig. 4).

Figure 4 – Transition between the left and the right curve at location 1.

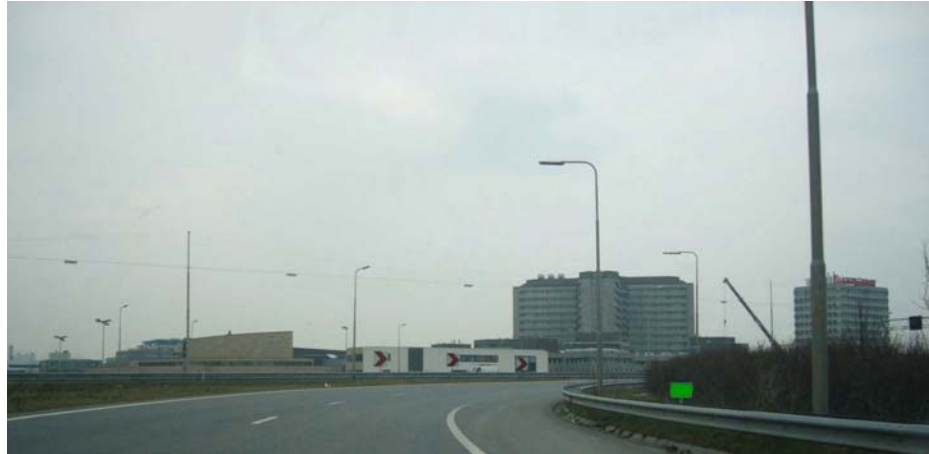
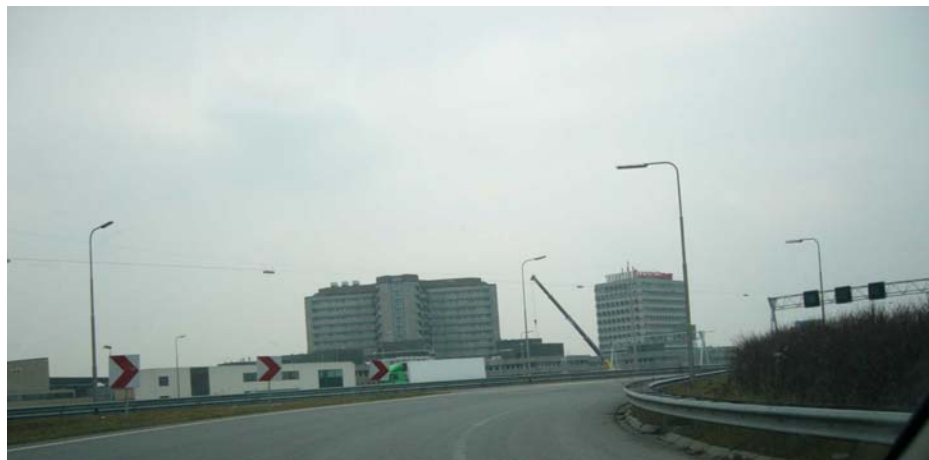
Figure 5 – Curve 2 location 1.

Essentially, while negotiating this second curve the motorist was preparing to enter the main motorway, as can be seen in Figures 5 and 6. In Figure 6, the location of the green and white truck is about the location where the parallel main motorway lane is located that the motorist most probably wanted to enter.

Figure 6 – Curve 2 continued, location 1: preparation position to enter motorway parallel lane.

While the situation may be hard to negotiate for the unfamiliar driver on this stretch of road, the familiar driver might see the design of the road as a challenge when the motorist is receptive for this, because the entry itself has an element of “machismo”: the curves can be seen by a risk-seeking motorist as a perfect race-track. This can be confirmed by the fact that the road markings are very worn down at the typical places where motorists would break out of the curve: the middle marking in the left-hand curve and the right sided marking in the right-hand curve (see Figs 3 and 6).

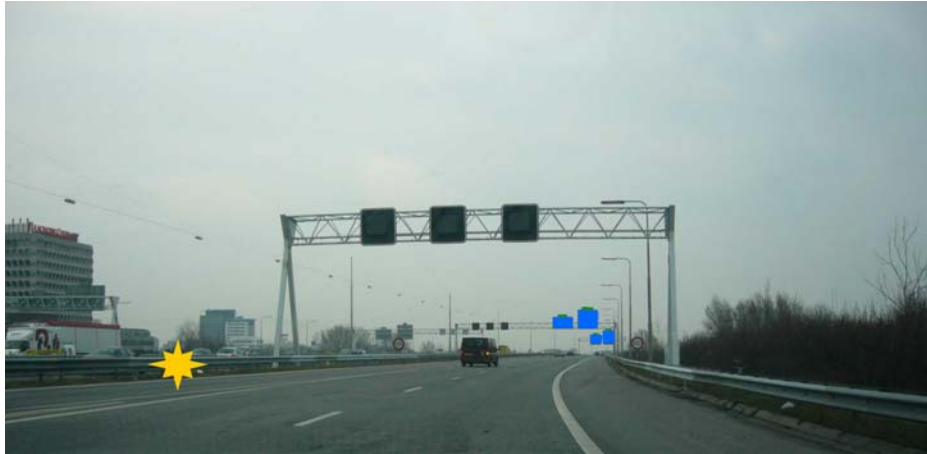
Figure 7 shows the entrance on the main motorway with on the left side the crash location of the motorist with the left side barrier.

Figure 7 – Entrance of motorway with crash location (yellow star), location 1.

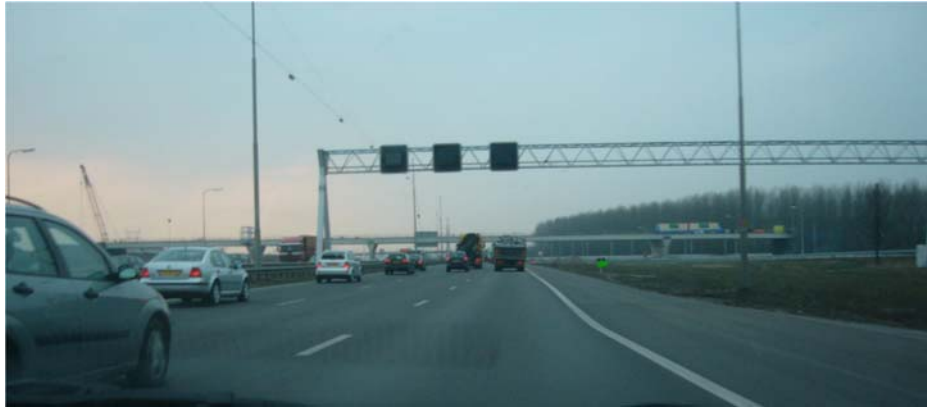
Figure 9 – Three-lane motorway toward location 2: change in horizontal alignment.

Figure 9 shows the lay out of the road just after the entrance lane where the road makes a shift to the right as can be seen: a change in horizontal alignment. Just after this shift the driver gets on the shoulder and eventually off the road.

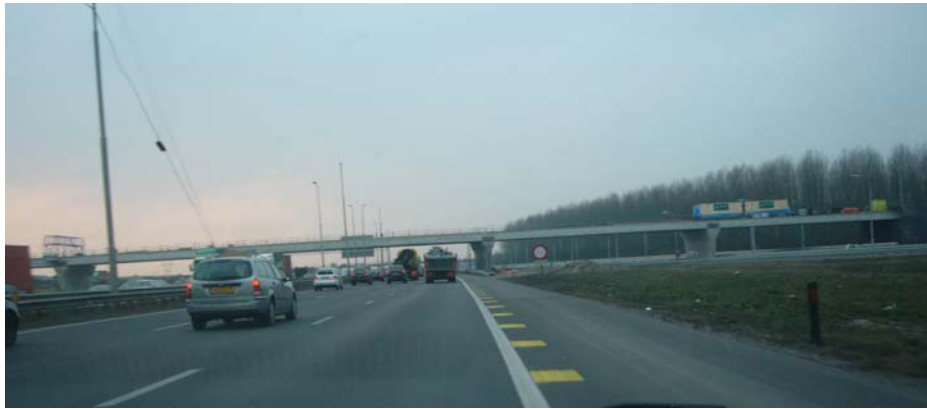
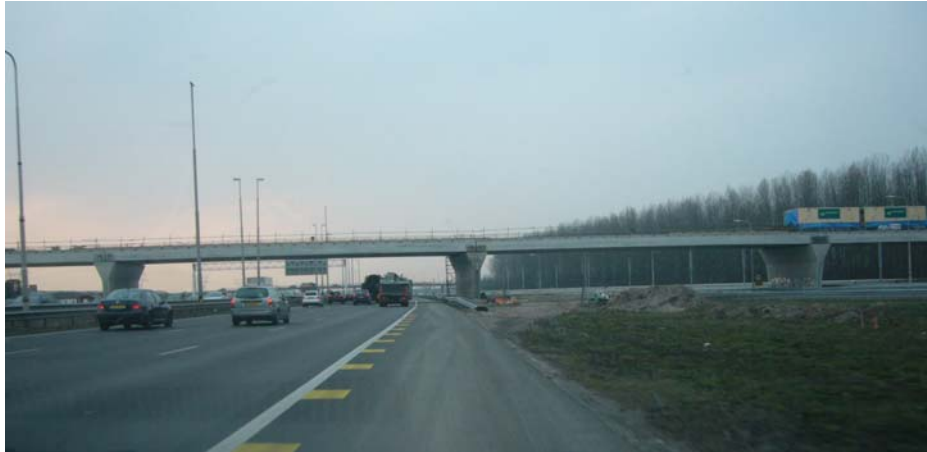
Figure 10 – Temporary exit lane for work-zone traffic indicated with yellow marking, location 2.

Figure 10 shows the lay out of the hard shoulder where the driver has driven before getting off the road. The yellow block markings indicate that there is an exit for work traffic. A yellow traffic sign positioned before that had indicated this already: a mirror image of sign WIU100.1 with an extra arrow added for the third lane (NVV, 2001). Figure 11 shows the exit itself.

Figure 11 – Temporary exit for work-zone traffic on shoulder location 2.

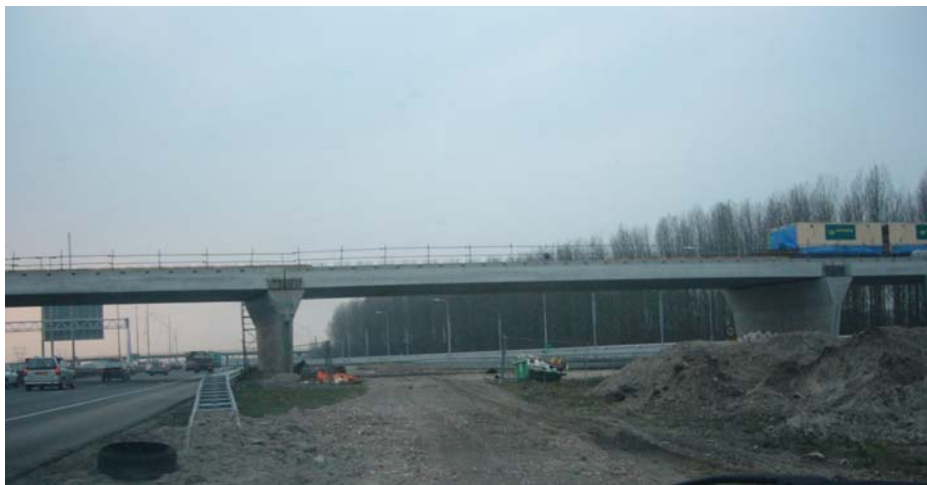
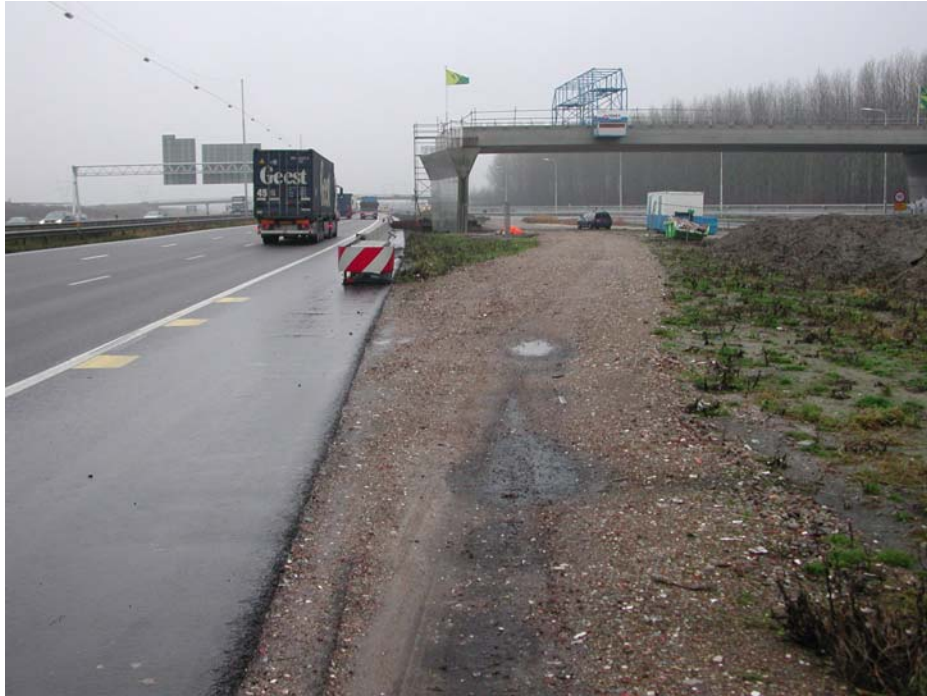
Figure 12 – Accident location 2 with new barrier at time of road-scene analysis.

Figure 13 – Accident location 2 with old barrier at time of accident.

Figures 12 and 13 show a picture of the two different barriers that were located alongside the pillar at two points in time. Figure 12 shows the situation as encountered during the road-scene analysis. Figure 13 shows a picture of the barrier that was located at this position at the time of the accident.

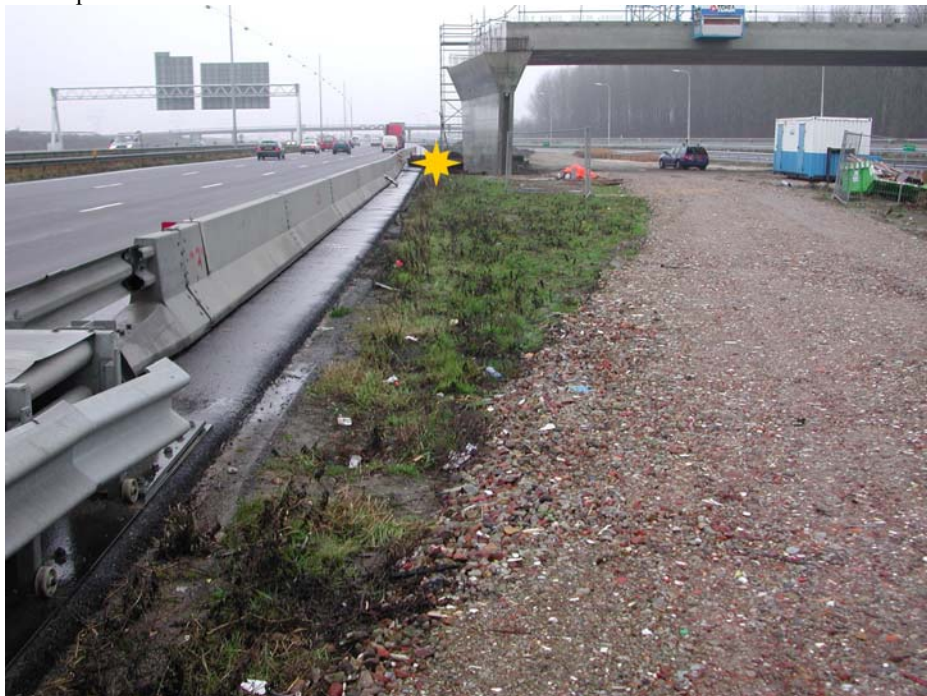
Figure 14 – Accident location 2.

Figure 14 shows a picture of the exact accident location at the time of the accident (with the old barrier). The yellow star indicates the position of the iron wall in between the pillar and the barrier that the driver hit eventually.

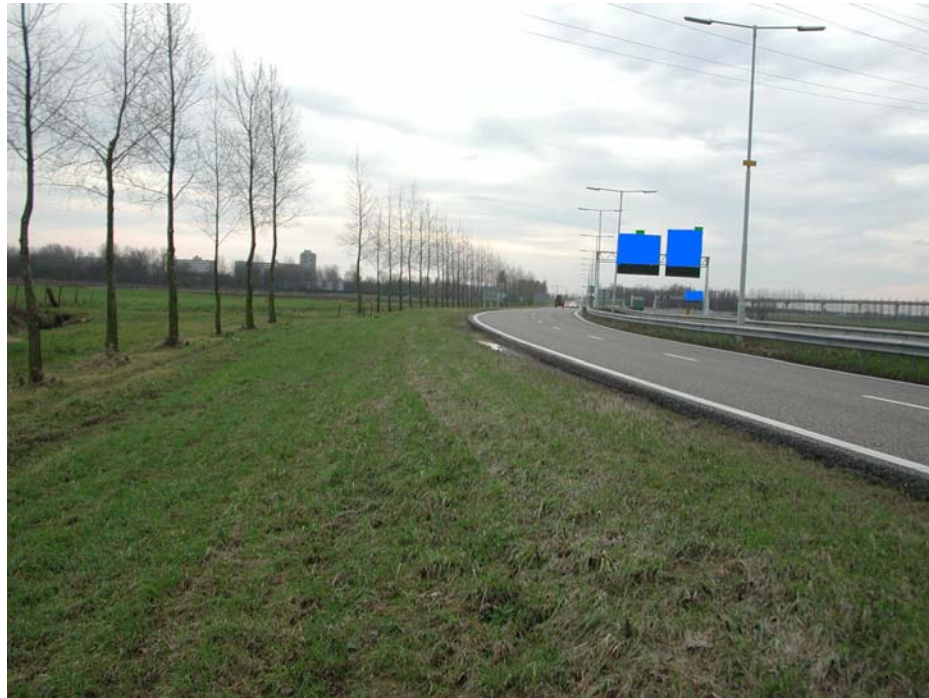
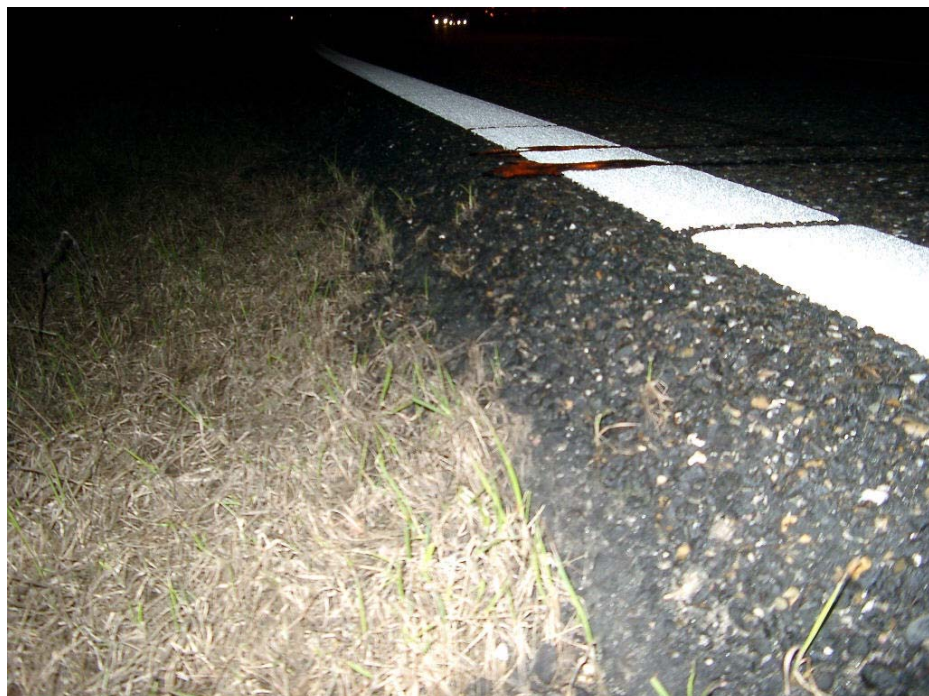
Figure 17 – Location 3 illustration of drop-off of roadside (a) looking back (not according to driver perspective).

Figure 18 – Location 3 illustration of drop-off of roadside (b).

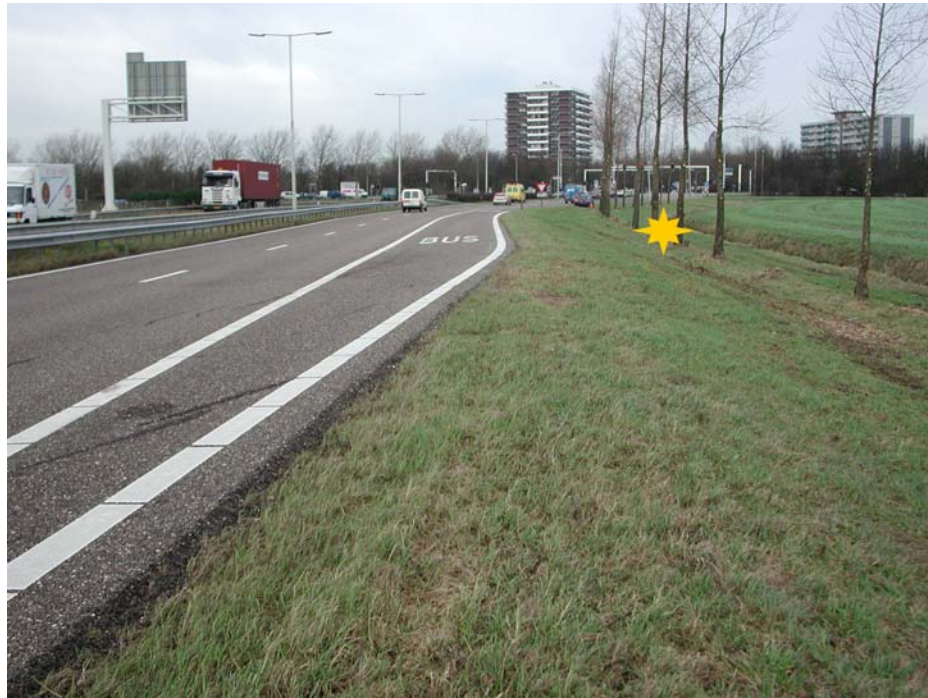
Figure 19 – Collision location with tree, location 3.

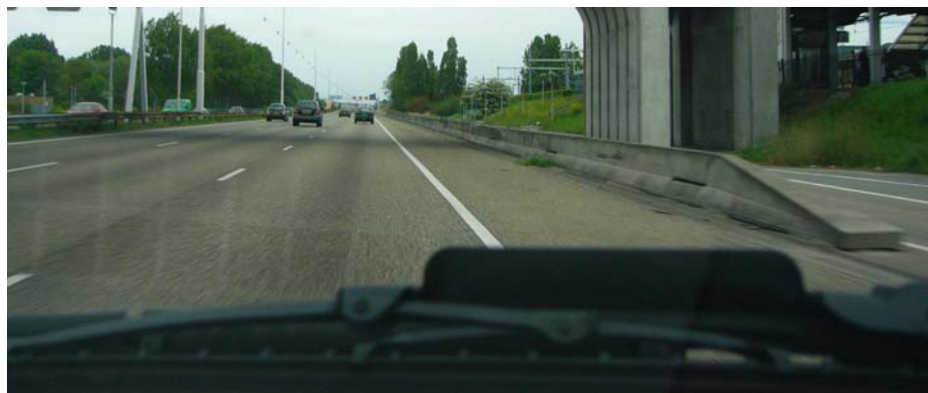
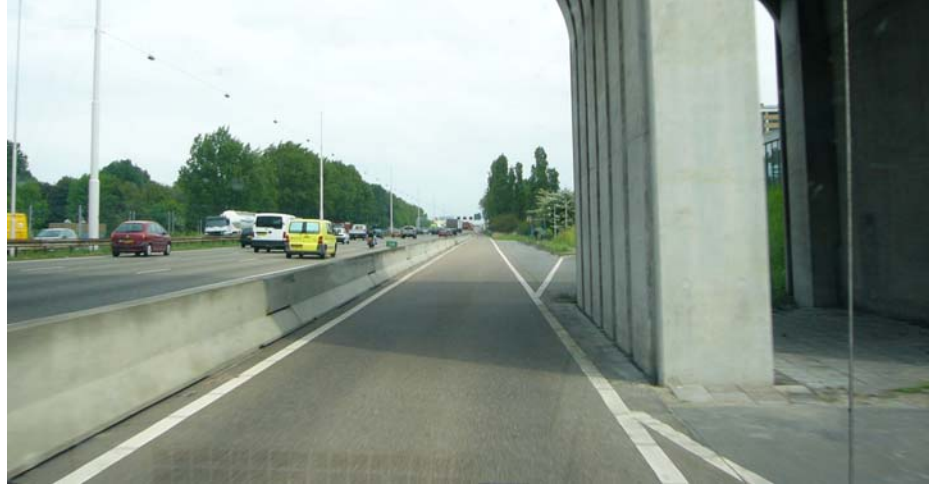
Figure 22 – View from motorway at barrier and pillar, location 4.

After about 10 metres the motorway and the bus lane pass under the cross over. The bus lane is here situated on the left side of two pillars. The barrier for the motorway shields the pillar at this point. (See Fig. 22 for the location of bus lane and motorway.) For the traffic on the bus lane, however, the pillar is not shielded (see Fig. 23).

Figure 23 – Bus lane passing under crossover with unshielded pillar on right side, location 4.

We recommend extending the barrier such that the general traffic can not easily travel onto the bus lane as well as shielding the pillar itself. We can imagine that the emergency/break-down area can be used by busses as a ‘waiting’ area during busy hours. We recommend, however, that the design of the area be then changed into a design that fits this function and does not resemble a break down area with an emergency pole.

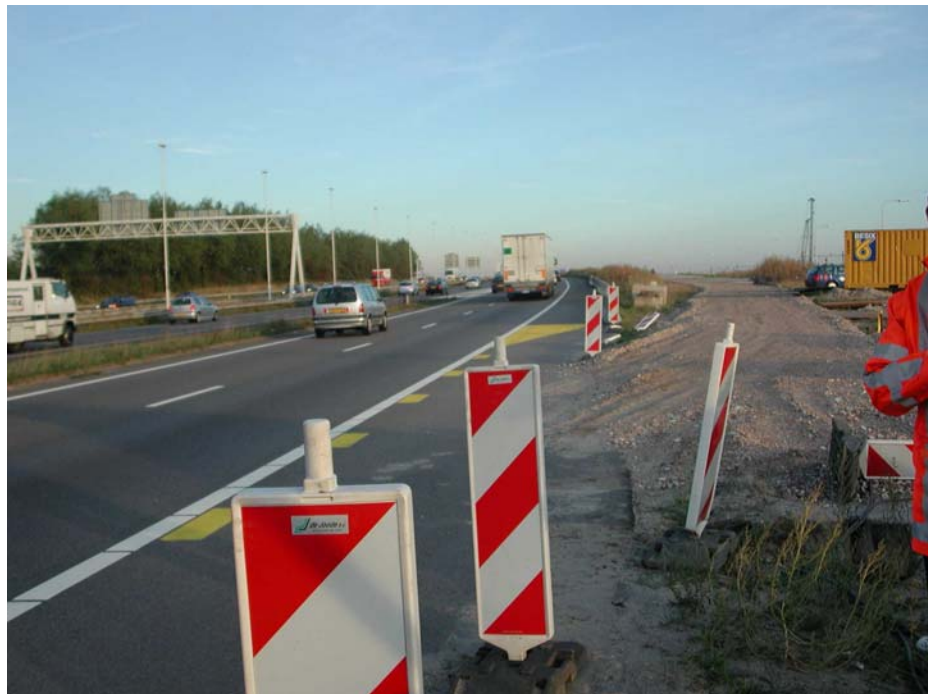
Figure 24 shows the location as it was during the accident. The yellow markings indicate the work zone exit. The exit is made more conspicuous with the red and white poles. A yellow traffic sign positioned before that had announced the exit for the driver already: a mirror image of sign WIU100.1 (NVV, 2001).

Figure 24 – Work traffic exit location 5.

- Work-zone situation that can cause confusion
- Barrier is discontinuous to let work-zone traffic through. This opening is not very visible.

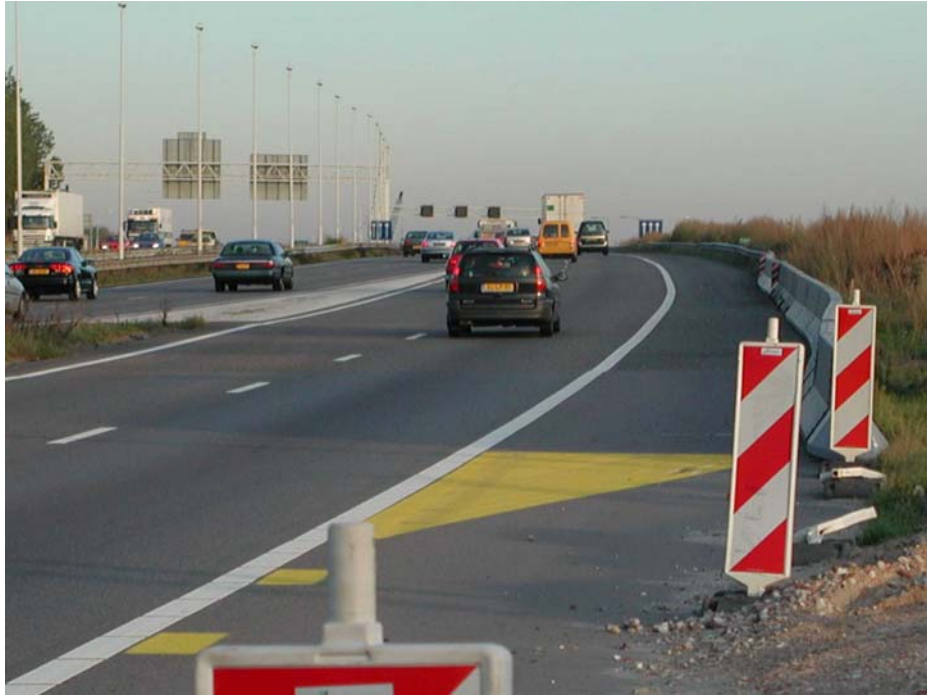
Figure 25 – Work traffic exit and barrier (behind last red/white pole), location 5.

Figure 25 shows the barrier at the end of the yellow marking that the driver encountered eventually. The driver hit the barrier from the right side and was launched back onto the road.

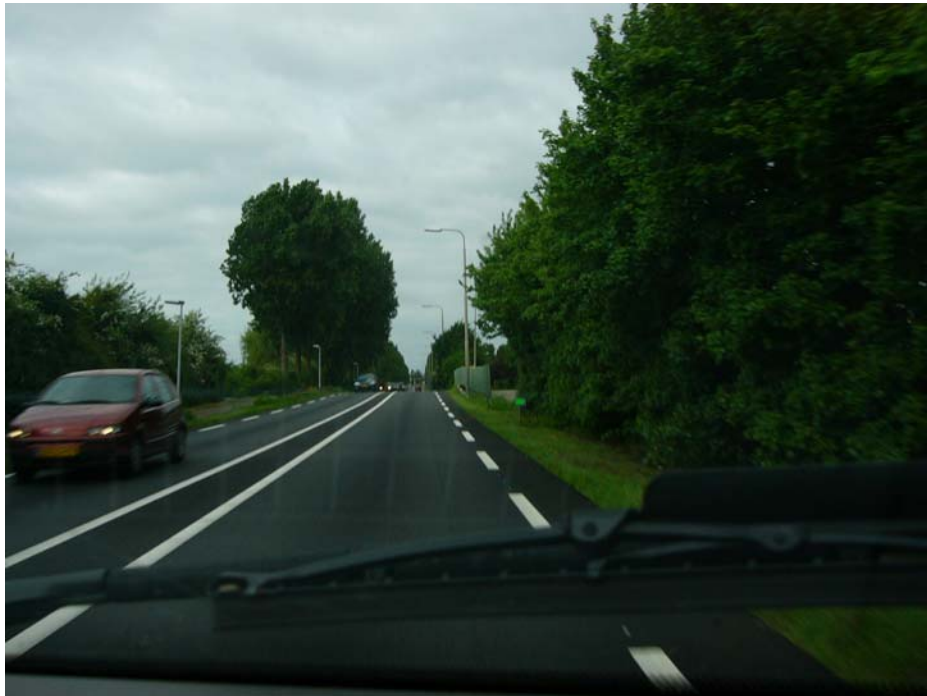
Figure 28 – Location where a vehicle starts swerving off the road to the right (location 6).

There were no discontinuities in alignment other than the fact that after the vehicle got off the road the driver entered the site of the viaduct where the road was slightly elevated. Once off the road on the right side and trying to recover this could have enhanced the difficulties of recovery. No other elements of discontinuity during night or day have been encountered. No other elements in terms of light arrangements, traffic signalling, sight distance or stop distance, misleading elements or any other element have been found. The driver said to have fallen asleep and although we have not driven the complete route the driver drove before falling asleep the conclusion should be that it was not because the road was inducing boredom or inattention as such.

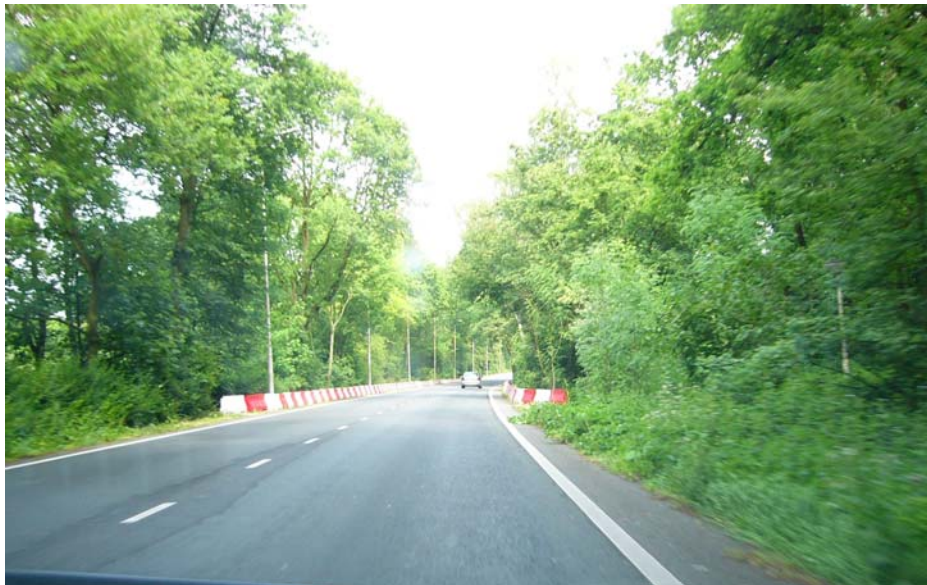
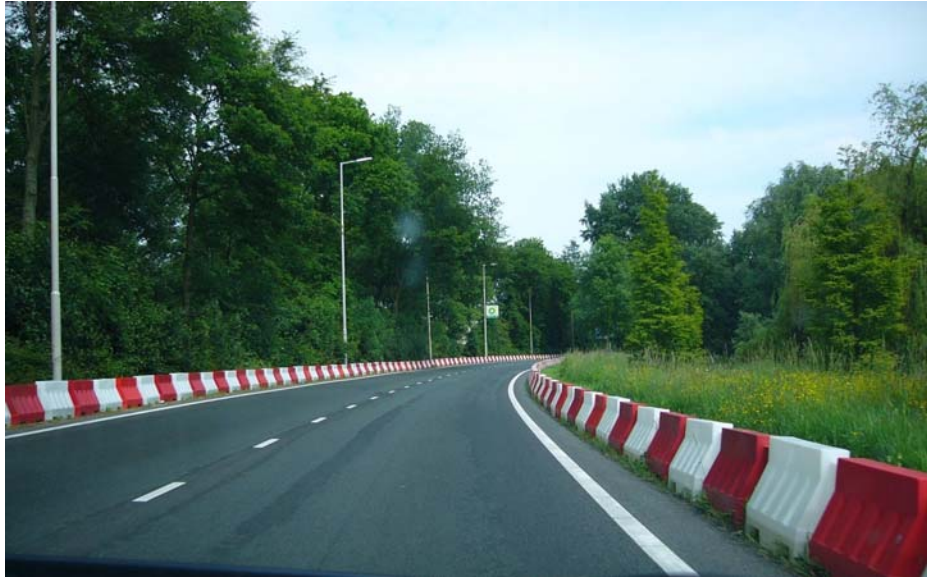
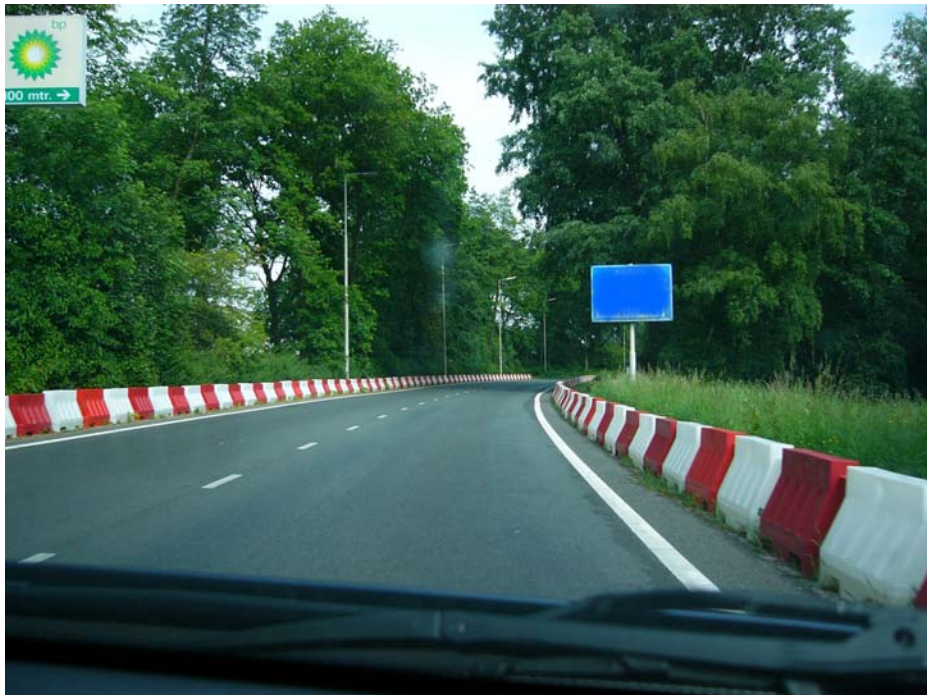
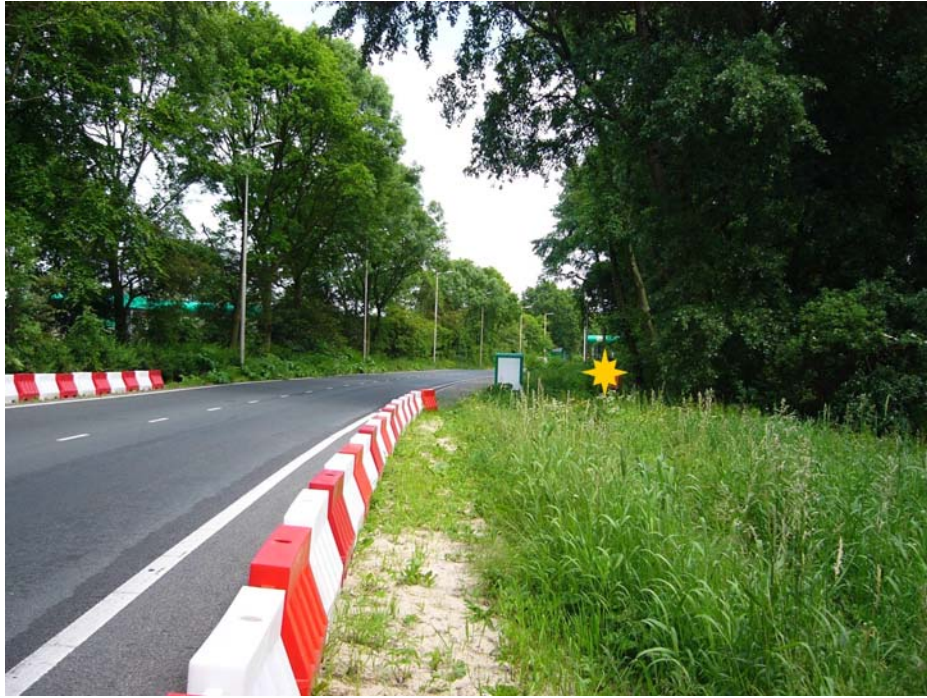
Figure 30 – Start of curve to the right of accident location 7: the red and white low plastic barrier is added after the accident.

Figure 31 – Halfway curve, the accident (location 7) occurred at the end of this trajectory.

Figure 32 – Last part of curve, location 7.

Figure 33 – The accident location at time of road-scene analysis (yellow star indicates end position of vehicle).

Figures 30, 31 32 and 33 show the whole curve where at the end the accident occurred. As can be seen from these pictures, this is not a particular dangerous curve when one keeps the maximum speed limit. It is rather shallow. The red and white barrier that is visible in the pictures is added after the accident had occurred. Apparently the local police had known the location, as a location where frequently people would crash. We assume, however, that this is solely the result of speeding and not because the curve itself is a problem.

The main result of this analysis is that this road invites the driver to drive faster than the 70km/h speed limit, especially for the frequent user. The road has a layout including trees on the side of the road that give enough guidance to speed. The road design of the curves allows a higher speed limit as well. Once a driver has decided to show willingly unsafe behaviour by speeding there are no places where he is forced to lower the speed limit in a safe manner. The curve where the accident occurred has been known to have more accidents and is located at the end of the road connecting a build up area with a motorway system. The barrier that is placed now does induce a lower speed limit and as such will probably be beneficial to prevent high speeds at this location. It is advised that in order to keep the speed down on this road more measures like this should be put in place.

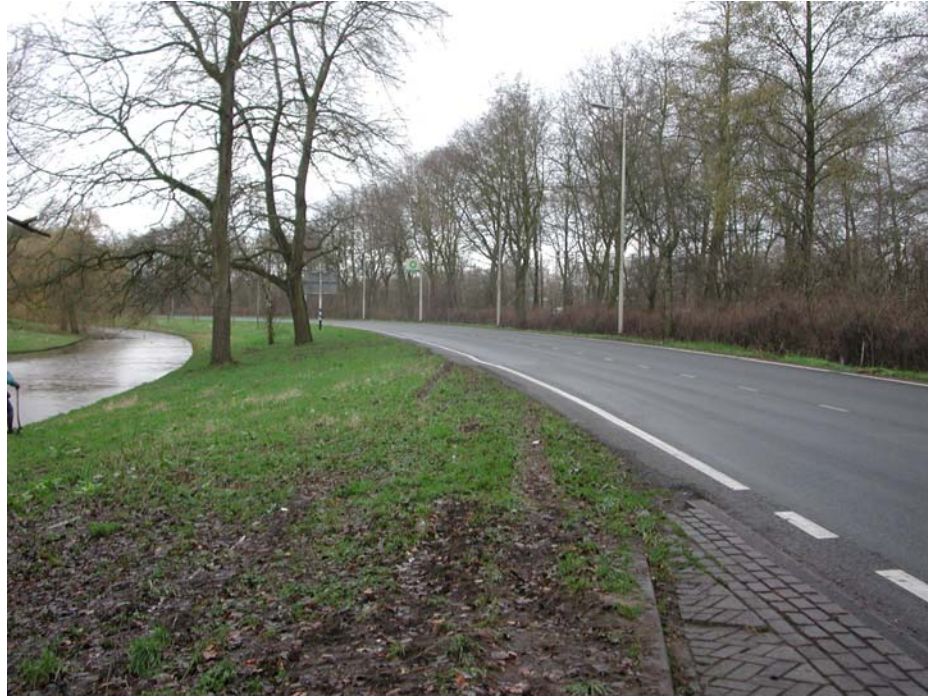
Figure 34 – Looking back from location 7 at tracks of vehicle exiting the road (at day of accident).

Figure 34 shows the tracks of the vehicle leaving the road looking onto the road in the opposite direction the driver was driving. The brick road visible on the right hand corner is the start of an entrance to a gas station just beyond the accident location. We have specifically looked at the influence of the location of this gas station in relation to the accident location.

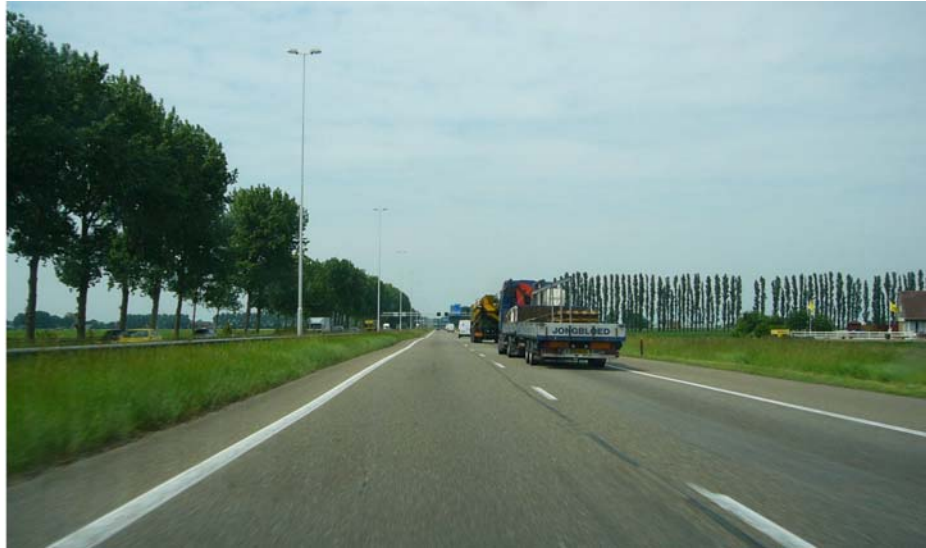
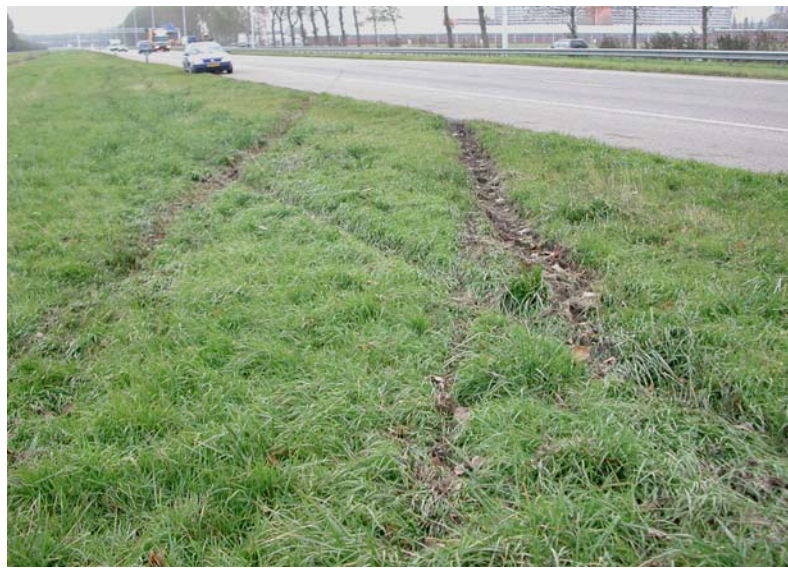
Figure 36 – Location 8: position where vehicle leaves road on left side.

Figure 37 – Tracks of vehicle leaving road on right side, location 8.

Figure 36 shows the approximate location where the vehicle ran off the road on the left side. Eventually the driver could not fully recover and ran off the road on the right side (see Fig. 37).

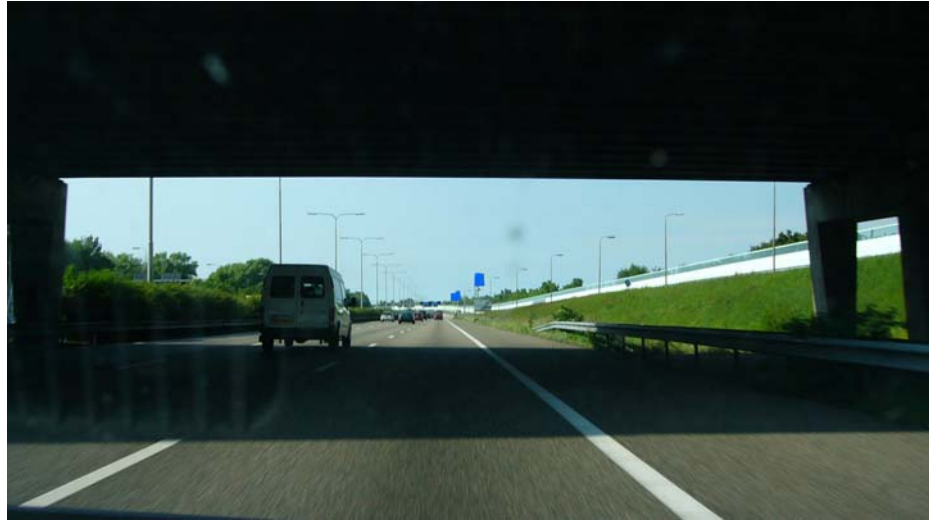
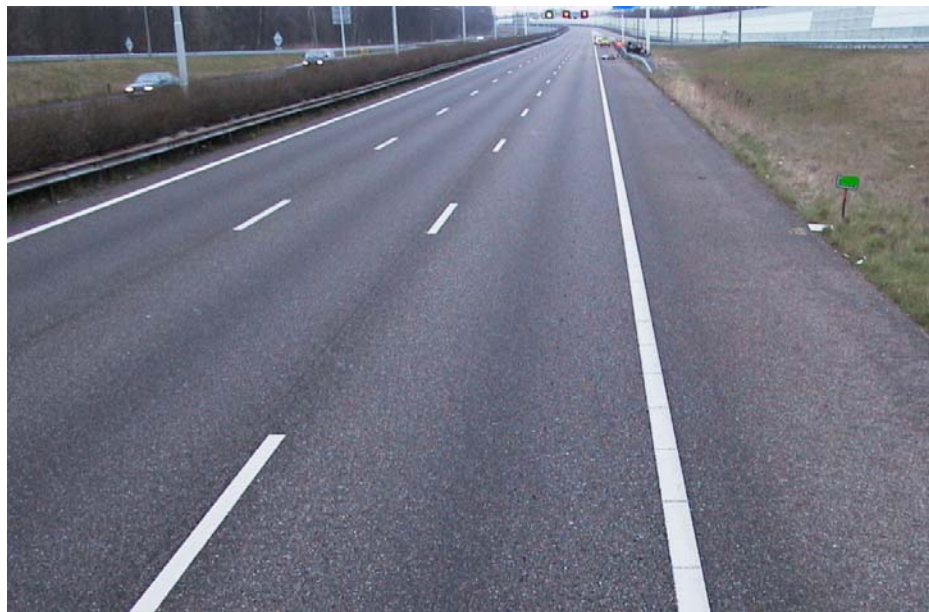
Figure 39 – Approach trajectory, location 9, under second viaduct, pole for route information sign is visible on the right.

Figure 40 – Approach trajectory, location 9, halfway viaduct and end position vehicle.

Figures 39 and 40 show the position where the vehicle ran off the road and ended behind the guardrail against the pole.

- A discontinued guardrail from the viaduct to the route information sign pole.
- A downward slope to the right in the recovery area.
- The downward slope meets an upward slope caused by the elevated entrance lane coming in from the right.
- The two slopes together make a V-shaped ditch in the recovery area.

It is recommended to either position the route information sign at a location where no pole is needed or, to continue the guardrail between the viaduct and the pole.

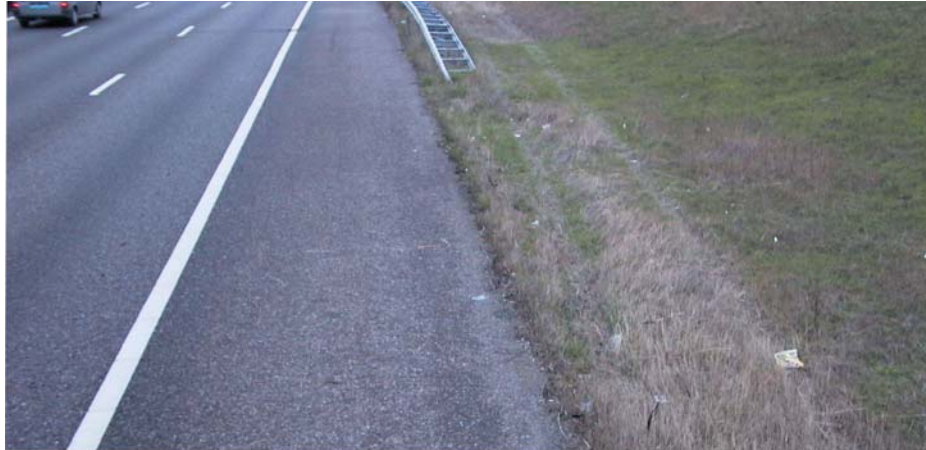
Figure 41 – Location 9, tracks behind guardrail.

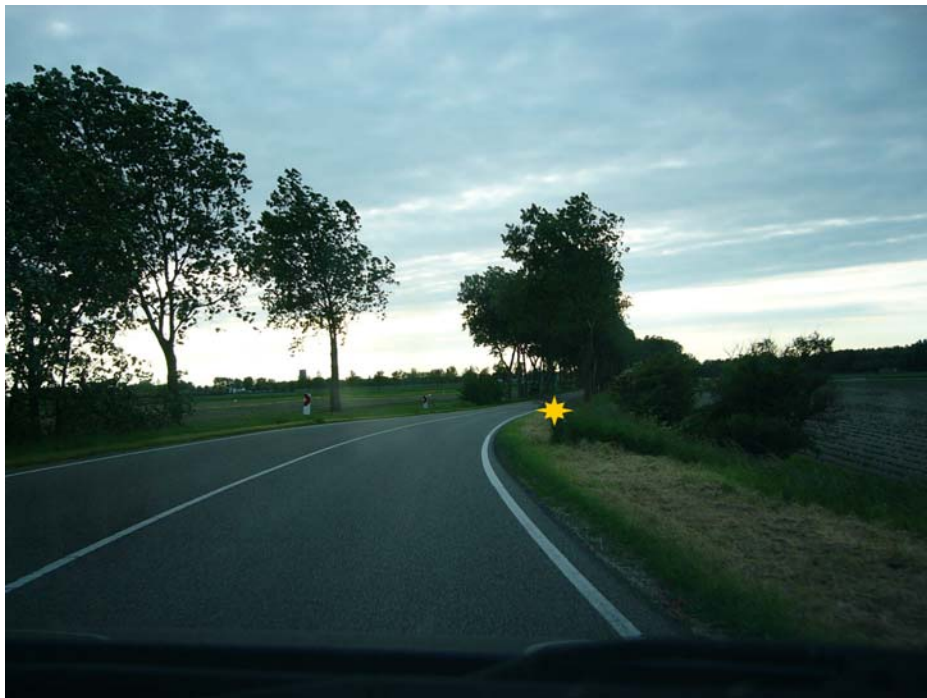
Figure 45 – Accident location 10 at time of road-scene analysis.

Figure 45 shows the location where the driver ran off the road and hit a tree on the right side. The yellow star shows the location of impact.

Although the road was slippery on the morning of the accident which likely has caused the vehicle to leave the road, the main element of importance in respect of the human factors involved in this case, is that the road described has a speed limit of 60 km/h that is only endorsed by a speed limit sign at the entrance of the zone about 2–3 kilometres ahead from the accident location. The layout of the road is not different from any traditional 80 km/h road in that the driver is not reminded throughout the journey by road design elements that the speed limit is 60 km/h.
