Monitoring alkali-silica reaction in structures

H. Borsje and W.H.A. Peelen

TNO Building and Construction Research, Department of Civil Infrastructure, Delft,
The Netherlands

Key words: alkali-silica reaction, monitoring, structures

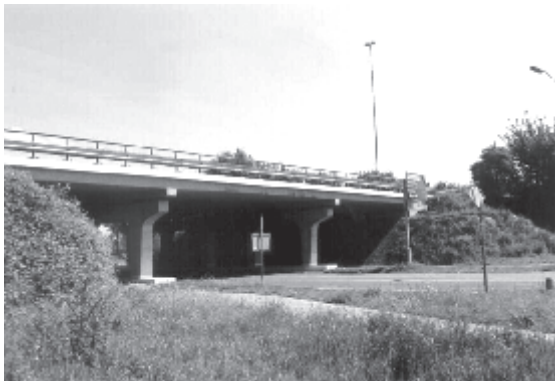
Fig. 1. Overview of viaduct Wolput.

Below the northern driving lanes, the bottom of the bridgedeck displays major cracking, especially below the left driving lane. This part of the bridgedeck has been strengthened by vertical anchors through the deck. Since onset of the project, part of the cracks were carrying water, especially in the thicker parts of the deck located above the supporting plates on the abutments. On measuring locality, minor efflorescence was observed once (March 30, 2001).

Measuring sites B and D are situated in the most intense cracked part of the northern driving lanes; site C is situated north of this area; site A is situated below the southern driving lanes, in an area with minor cracking only.

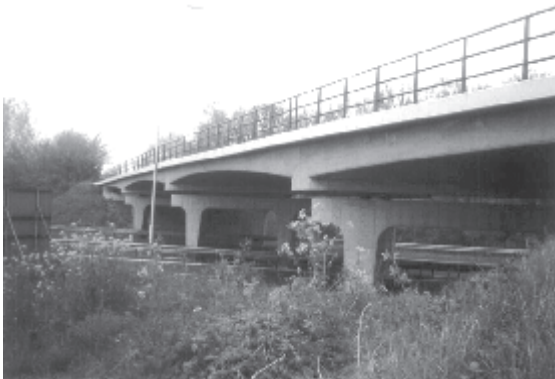
Fig. 2. Overview of viaduct Vlijmen-Oost.

The bridgedeck shows cracking over almost its entire bottom. At onset of the project, cracks were dry. Cracks remained dry after stripping of the coating in October, 1999.

All measuring sites were situated in cracked areas, A and B on the southern section, C and D on the northern section.

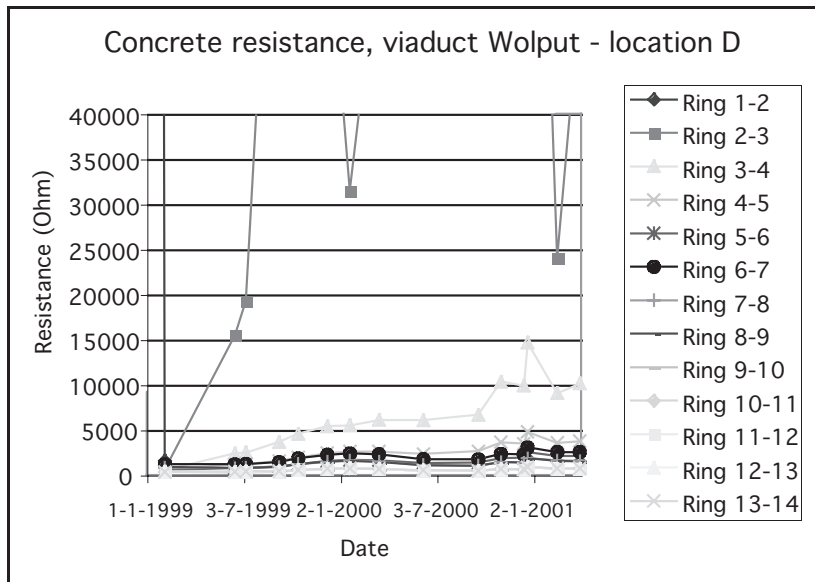
Fig. 5. Concrete resistance at site D, viaduct Wolput.

Concrete resistance measurements (for examples, see figs. 5 and 6) show that:

- The lower rings of the multiple ring sensors indicate an increase in concrete resistance with

time at most sites. This is probably due to drying of the injection grout surrounding the sensors, possibly combined with detachment of the grout from the surrounding concrete due to shrinkage.

- For the rings yielding realistic values in viaduct Wolput, those at sites B and D are lowest. Concrete resistances measured at site C are slightly higher, those at A are highest. A lower resistance for concrete of similar composition indicates higher moisture contents, viz. for sites B and D. This is in agreement with field observations.

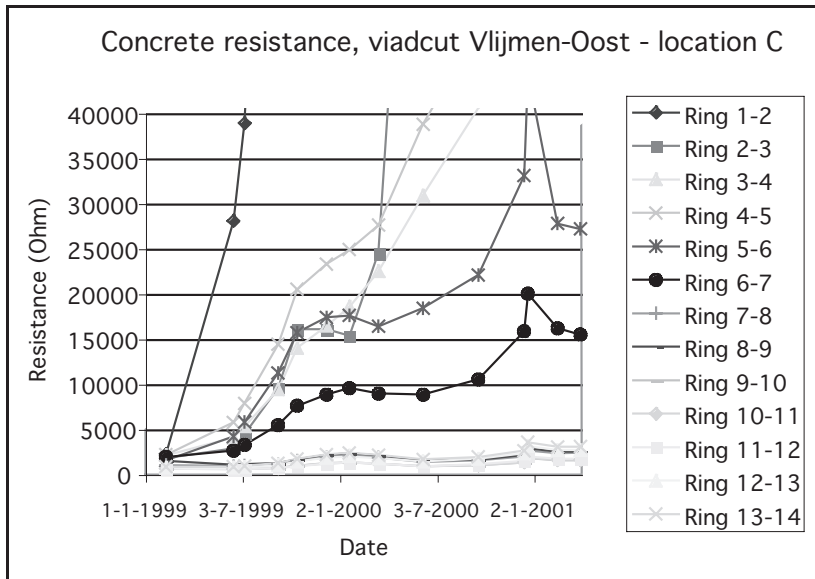
Fig. 6. Concrete resistance at site C, viaduct Vlijmen-Oost.

Rings yielding realistic values in viaduct Vlijmen-Oost show comparable values for concrete resistance at all sites. Resistances are comparable with those at site C in viaduct Wolput. Rings yielding realistic values in both viaducts show an increase in concrete resistance with time in the bottom part of the bridgedecks. This might be explained by some extent of dessication, which is, however, considered unlikely. For most of the timespan during which measurements were performed, both structures had not yet been rehabilitated. Nevertheless, a systematic increase of concrete resistance is measured. The question arises whether this increase should be explained by other processes than dessication.

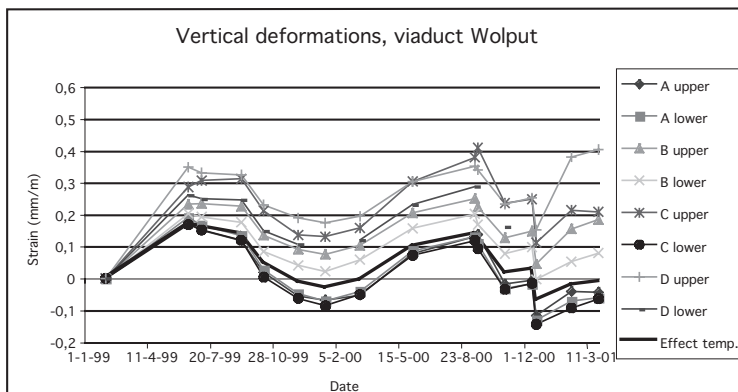
Fig. 7. Vertical deformations in viaduct Wolput, as determined using vibrating wire strain gages. Letters indicate measuring sites, 'lower' and 'upper' indicate the lower and upper sensors at each site, respectively.

Deformations perpendicular to the bridgedecks were measured on two depths for each site. Results for viaducts Wolput and Vlijmen-Oost are given in figures 7 and 8, respectively. The figures also show displacements with time as result of temperature relative to the first measurement (Effect Temp. curves in figs. 7 and 8), using a thermal expansion coefficient of $12 \times 10^{-6} \text{ m m}^{-1} \text{ }^\circ\text{C}^{-1}$.

It appears that results for all sites in viaduct Vlijmen-Oost and sites A and the lower part of site C in viaduct Wolput agree reasonably well with deformations resulting from variations in temperature. On sites B and the upper part of site C in viaduct Wolput, vertical deformation (expansion) is considerably larger than the temperature effect. This indicates, possible, that expansion due to ASR continues.

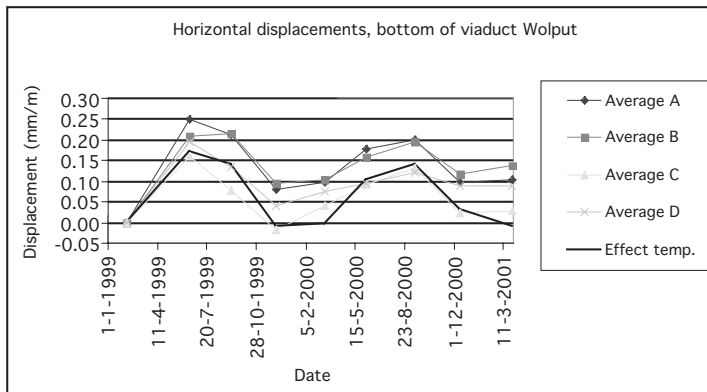
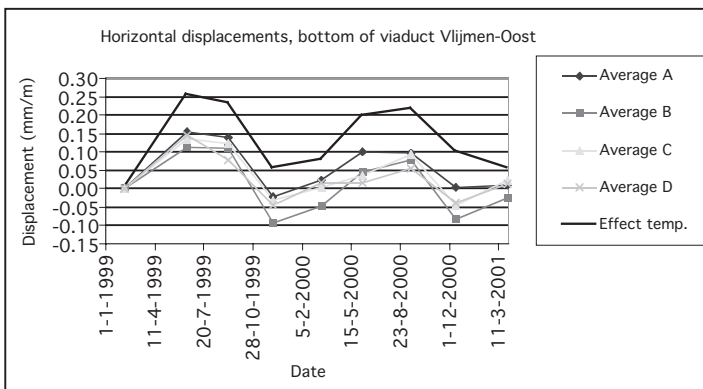
tion due to ASR. Figures 9 and 10 show the average displacements for each direction at each site, as well as the calculated temperature effect.

For all sites, it appear that horizontal displacements agree reasonably well with those expected from measured variations in temperature. No significant differences between different sites have been observed. There are no indications for continuing deformation due to ASR.

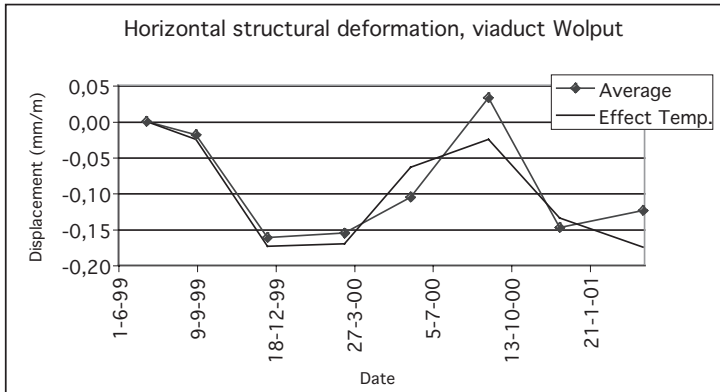
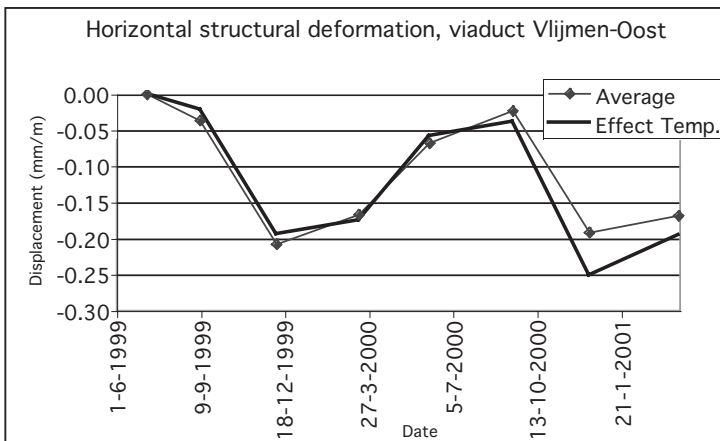
Structural deformations have been measured by determining displacement between successive reference studs on the top of the bridgedecks. Results and the temperature effect are given in figures 11 and 12. The average displacements at all sites correspond with those expected with those calcu-

lated from measured variations in temperature. There are no indications of continuing horizontal structural deformation due to ASR.
