**TNO report**

**TNO2021\_R12776 | Final report**

**Effects of former coal mining: upward drillings  
and sinkhole formation**

| Date | 21 juni 2021 |

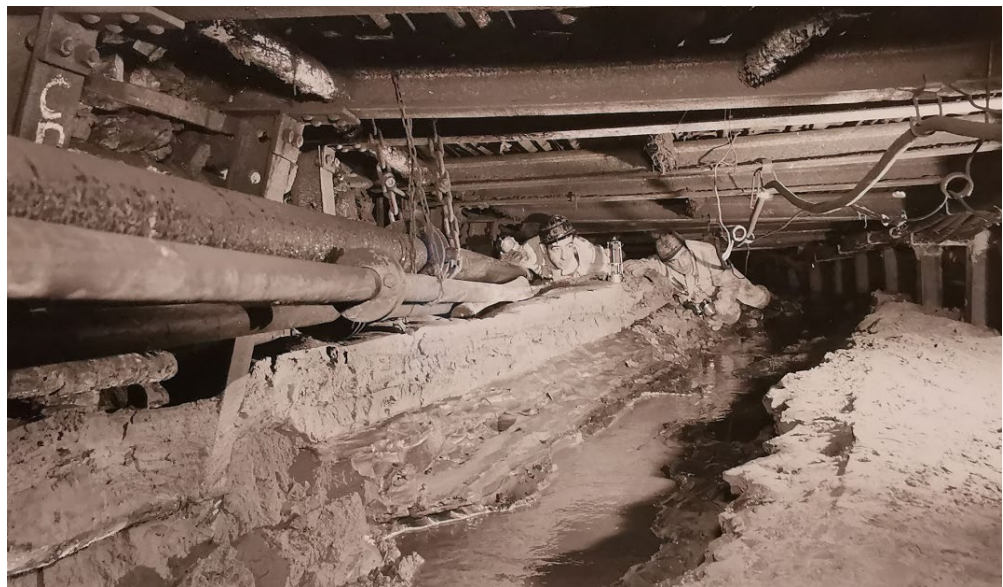
Figure 2: Two mineworkers inspect a mining gallery that was filled by an uncontrolled influx of quicksand and water. UD's were used to prevent this by allowing a manageable influx of quicksand. Mining gallery heights are in the order of >2 m, through which the 2 mineworkers are only able to crawl now.

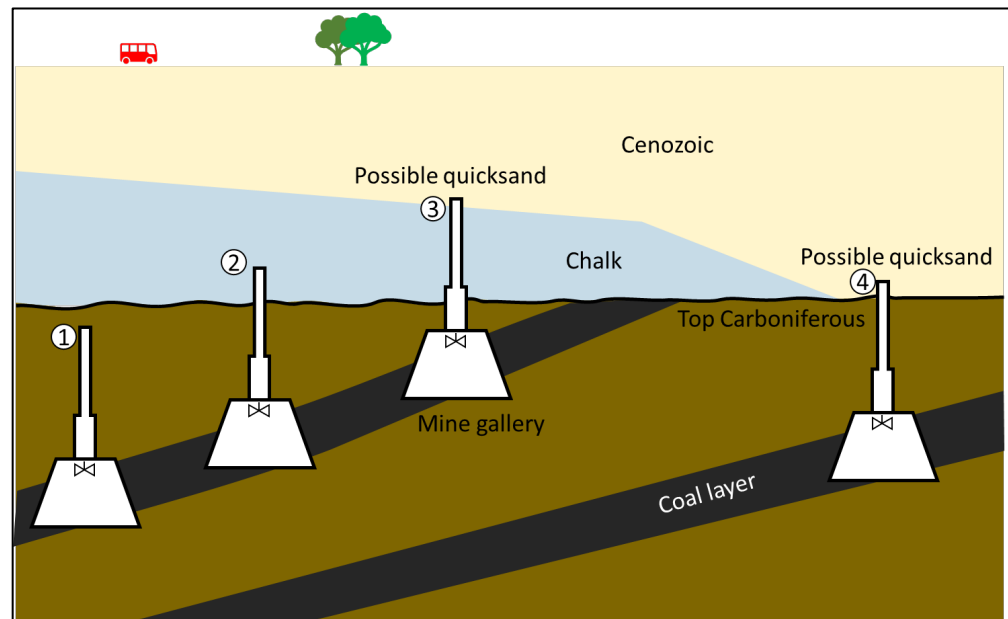
Figure 4: Upward drillings can end in the Carboniferous (1), Chalk (2) or Cenozoic (3 and 4). When upward drillings end in the Cenozoic, they might be a pathway for sediment transport. The upward drilling reaching the Cenozoic is most likely when the Chalk is absent and/or the Carboniferous roof is thin.

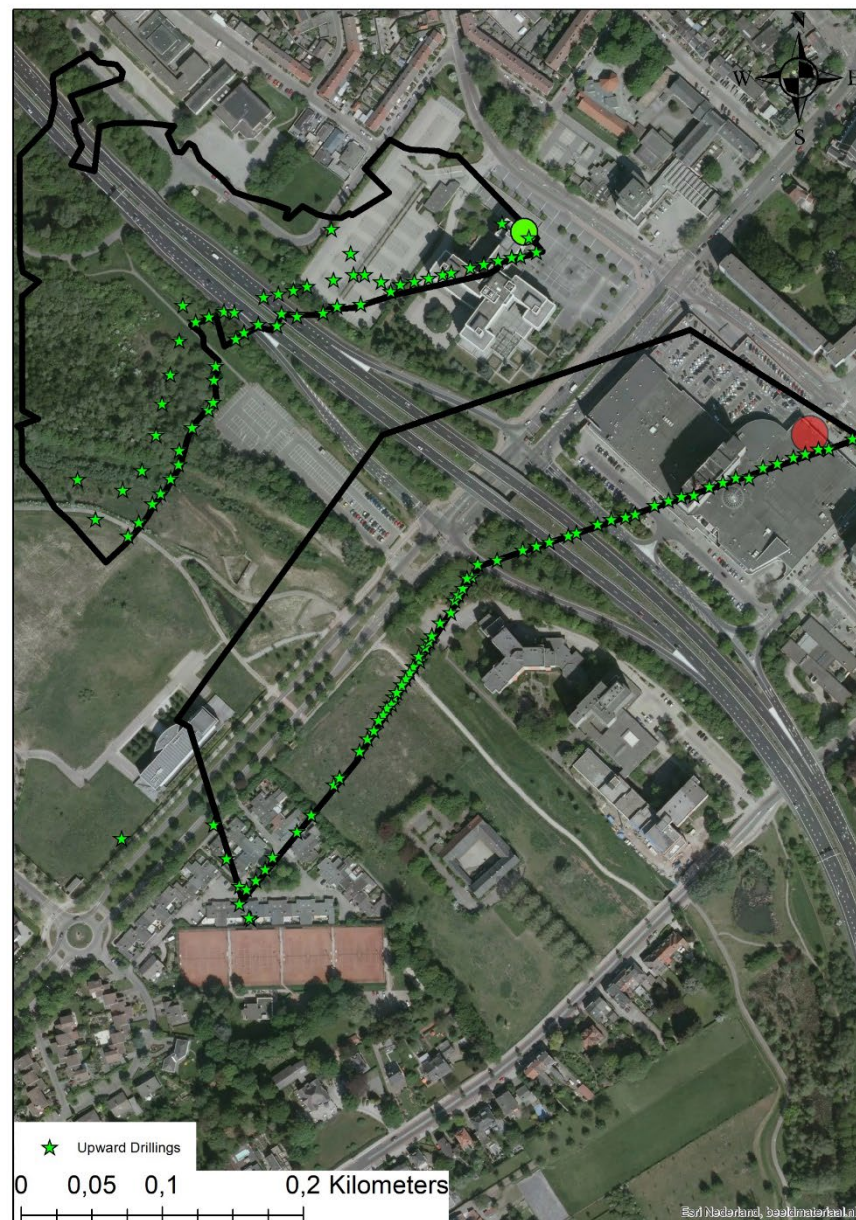
We studied two recent sinkholes at 't Loon and DSM (Figure 5) and found that the UD's ended in solid rock (Chalk) at both sinkhole locations. Therefore, it is unlikely that the UD's at these locations were the pathways for unconsolidated sediment (Cenozoic) transport: i.e. there must be another pathway for sediment transport.

Figure 5: Location of UD's in respect to the recent sinkholes at 't Loon (red circle) and DSM (green circle). Black line is the outline of the mining panel (within which the coal is mined). Green asterisks are upward drillings.
