Investigation of the Aalma el-Chaab incident

TNO 2023 R12286 – 26 January 2024

Author(s)	Not disclosed
Classification report	TNO Public
Report text	TNO Public
Number of pages	70 (excl. front and back cover)
Sponsor	Reuters News & Media Limited
Project name	Reuters investigation

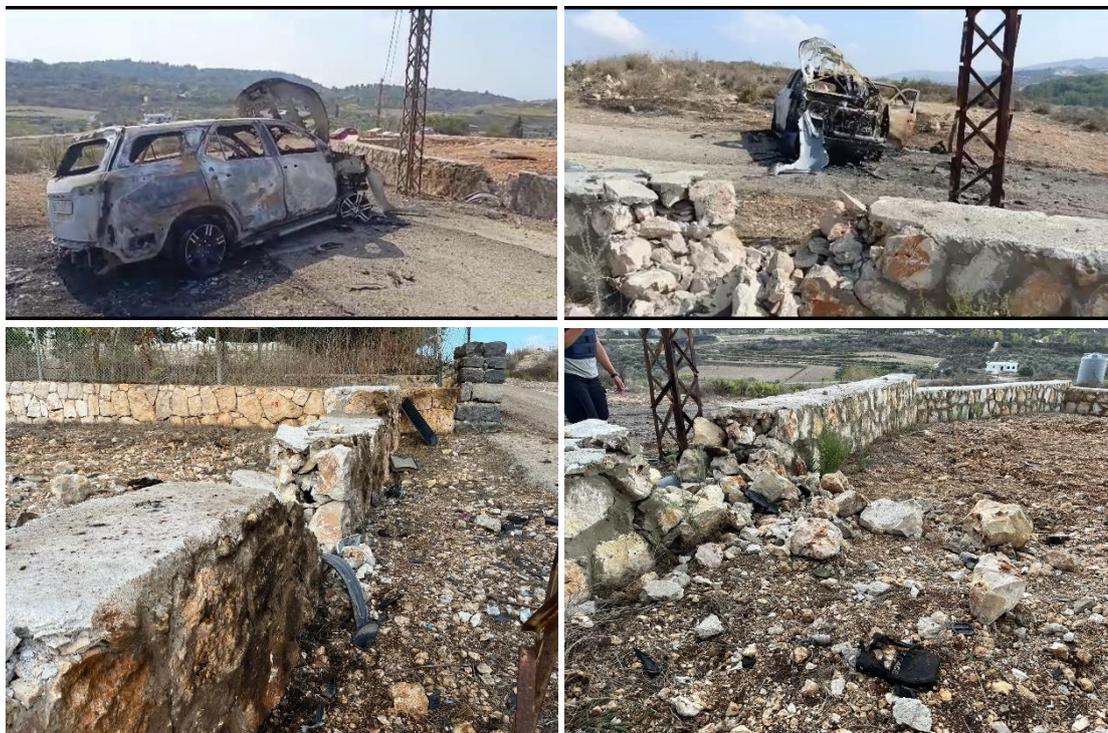
The first strike hit the stone wall just north of the utility pole, leaving a substantial hole in the wall, see Figure 14. From Figure 1 it is evident that this hole was not present prior to the strike.

Figure 14 Hole in the stone wall. Clockwise: still from [Fixer - Walkthrough 1.mp4], still from [Fixer - Walkthrough 2.mp4], [IMG-20231015-WA0063.jpg] and [IMG-20231015-WA0072.jpg].

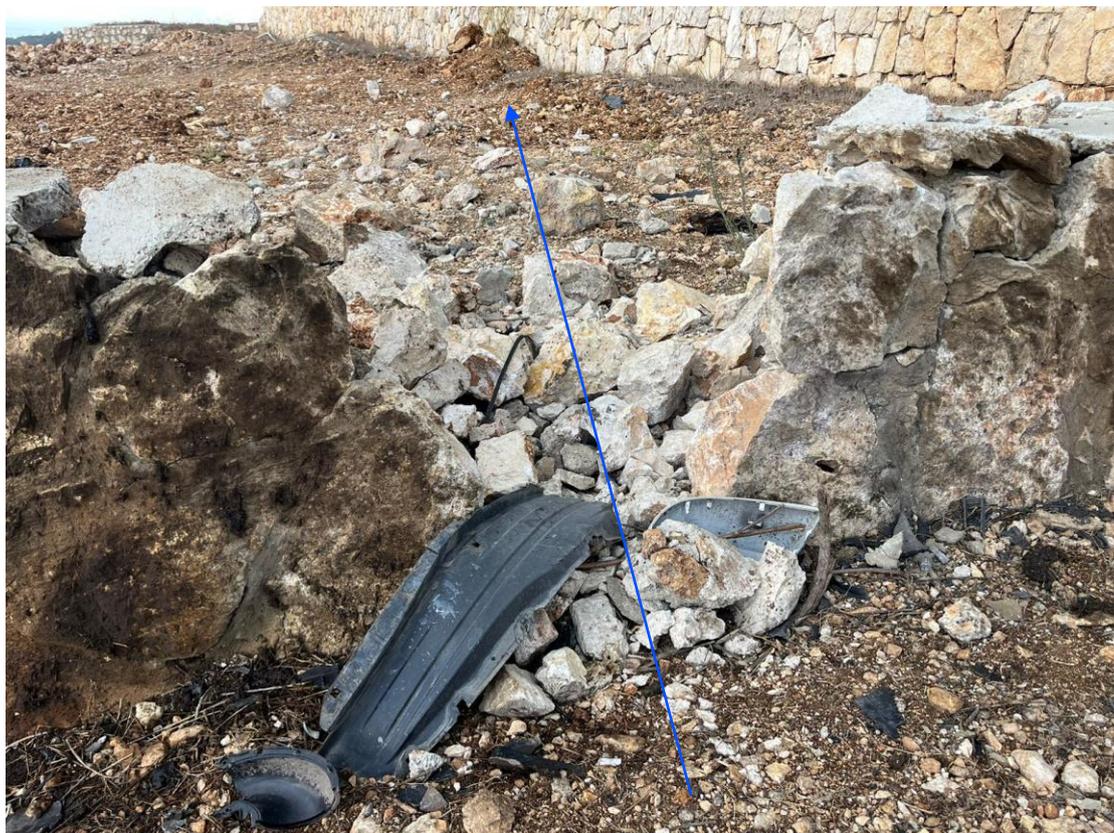
The direction of fire can be roughly aligned with the debris pattern behind the wall, which is shown in Figure 15. The debris is spread out predominantly towards the stone wall in the back of Figure 15. It is noted that the debris pattern only provides a rough indication of the direction of fire as the round may have grazed and deflected off the front of the vehicle on the other side of the road or may have impacted the wall at an angle. Grazing, deflection and a non-head on impact may result in a spread of debris not fully aligned with the trajectory of the ammunition article. An error margin of plus minus ten degrees is therefore maintained for the estimated direction of fire to account for this inaccuracy.

Figure 15 Debris field behind the wall [IMG-20231015-WA0066.jpg]. Its estimated direction is indicated.

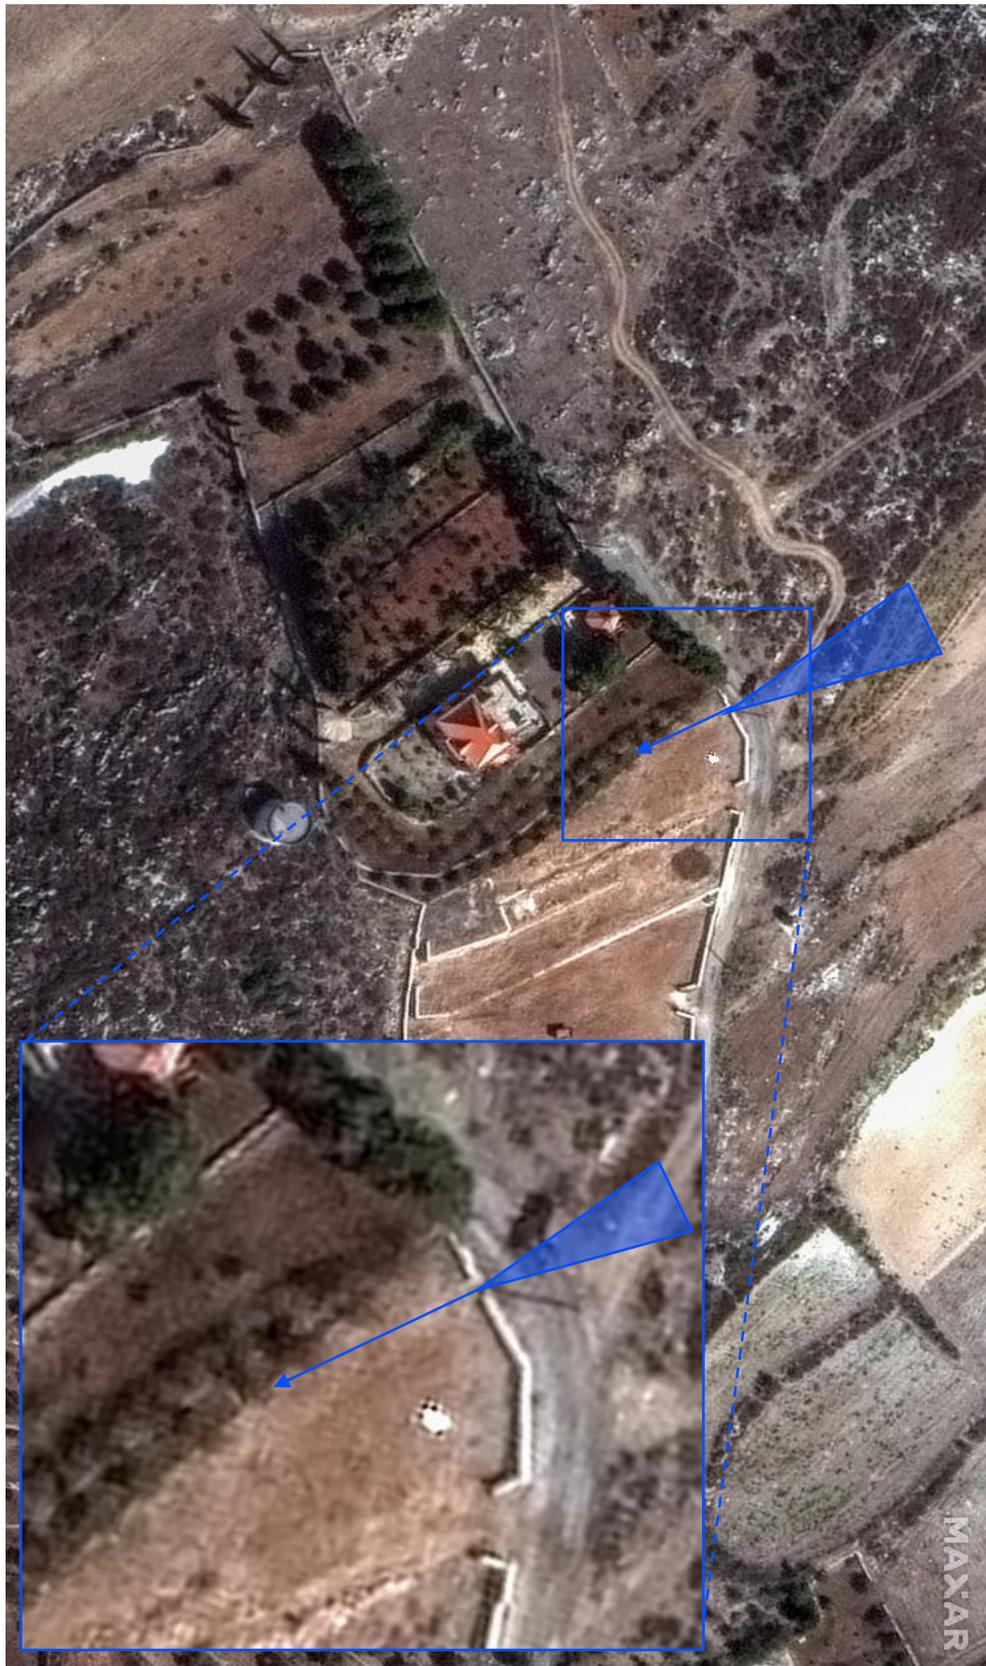
The debris pattern is also observed on a MAXAR satellite image from 26 October 2023, see Figure 16. The image shows the hole in the wall, just north of the utility pole and the burnt wreckage of the vehicle. The white spot represents the hood of the car. The estimated direction of fire based on the debris pattern, including a ten-degree error margin, is indicated. This direction and error margin are then transferred to a Google maps image to illustrate the direction of fire plotted over a wider area. It is clear that the ammunition article that hit the stone wall was fired from the east - southeast.

Figure 16 MAXAR satellite image from 26 October 2023. The arrow represents the estimated direction of fire, with a plus minus ten-degree error margin. The white spot represents the hood of the car.

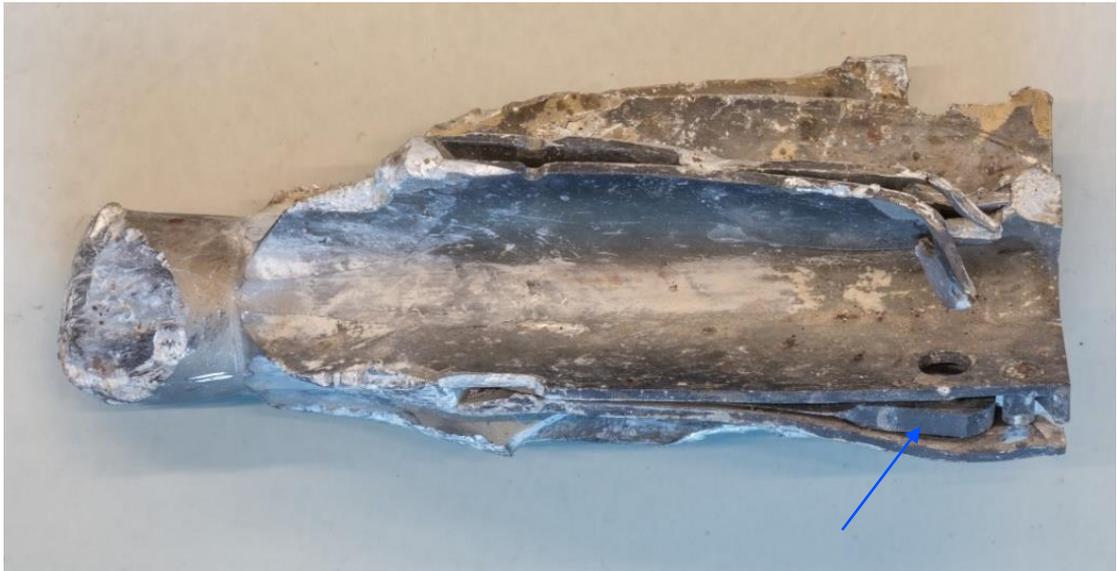
Examination shows that it involves a heavily damaged aluminum tail fin assembly of an ammunition. The assembly has six fixed fins, each incorporating a deployable (pop-out) fin. One of these deployable fins is still present as shown in Figure 33. Using basic workshop tools the deployable fin was dislodged from the fixed fin.

Figure 33 Aluminum tail fin assembly. One of the deployable fins is still present as indicated by a blue arrow.

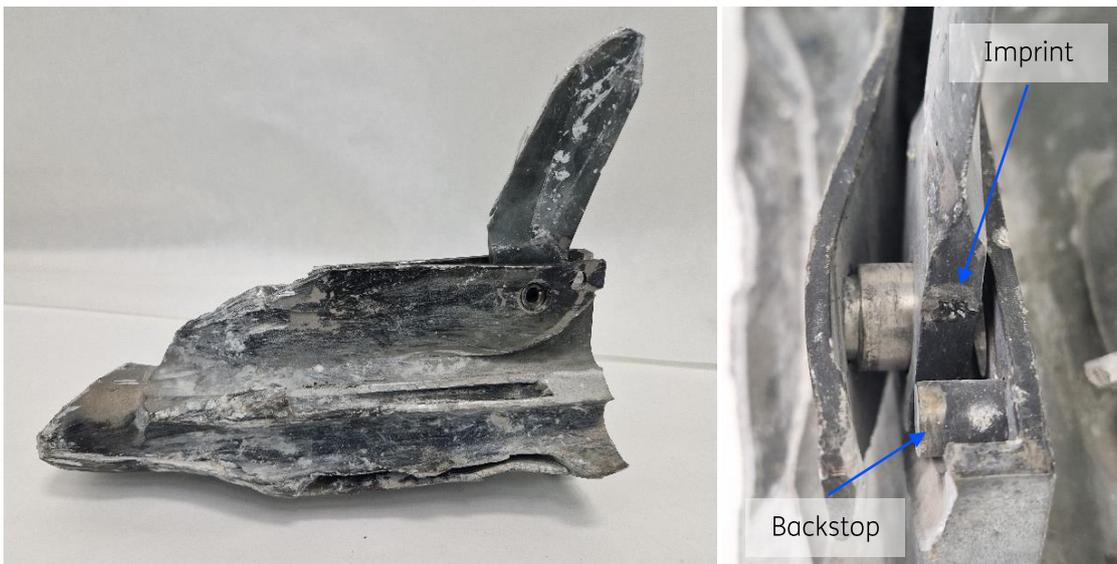
Figure 34 Tail fin assembly with dislodged fin (left). An imprint is visible on the base of the deployable fin, which matches the position of the backstop near the base of the fixed fin (right).

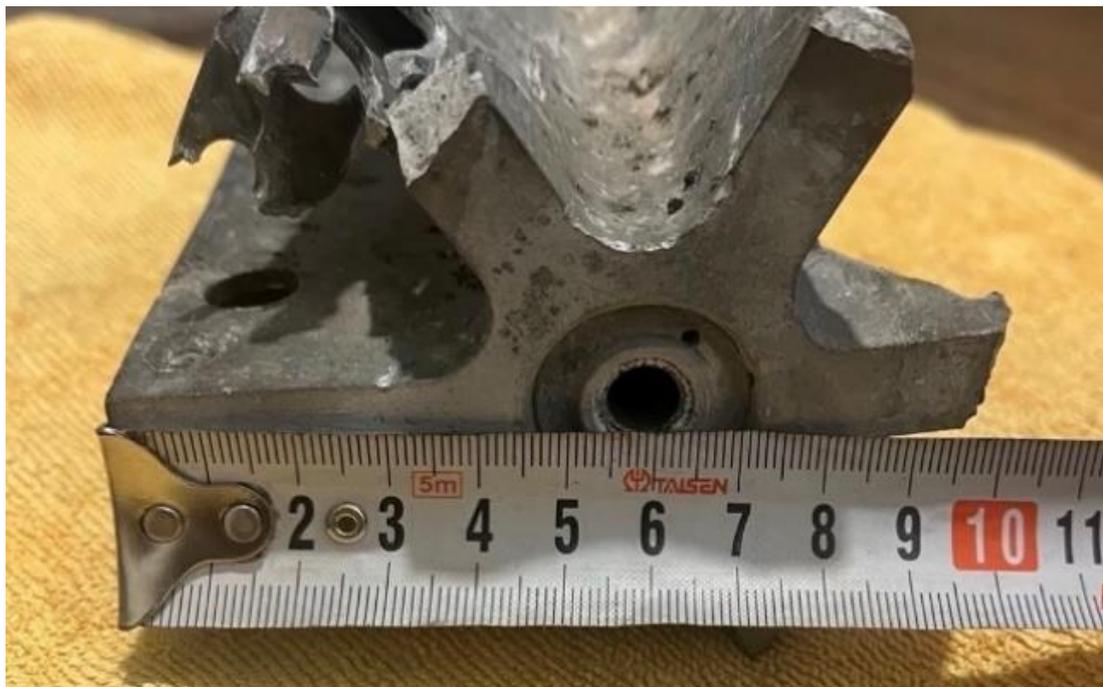
The tail fin assembly has a base cavity with a depth of approximately three centimeters, that originally held a pyrotechnic charge, also known as a tracer, which burns during flight to enable visual tracing of the round's trajectory. The use of an ammunition round with a tracer is confirmed for the second strike by the RAI footage (see top right image in Figure 23). Lab analysis by means of energy dispersive X-ray (EDX) using a scanning electron microscope (SEM), revealed strontium and magnesium in this pocket which are typical compounds of a tracer composition. The distance between the center of the pocket and the tip of an intact fixed fin measures approximately 60 mm, as demonstrated in Figure 35. The diameter of the fin assembly accordingly approximates 120 mm, matching the inside diameter of a 120 mm cartridge.

Figure 35 The distance between the center of the pocket and the tip of an intact fixed fin measures 60 mm. Comparable tail fins are used in mortar bombs, but these are attached to a relatively small diameter hollow shaft, or flame tube, which holds a primary ignition cartridge and external propellant charge increments that are ignited through small holes in the shaft. Since the retrieved tail fin assembly has no flame tube it is not related to a mortar bomb. Therefore, the possibility of a mortar bomb strike is ruled out.

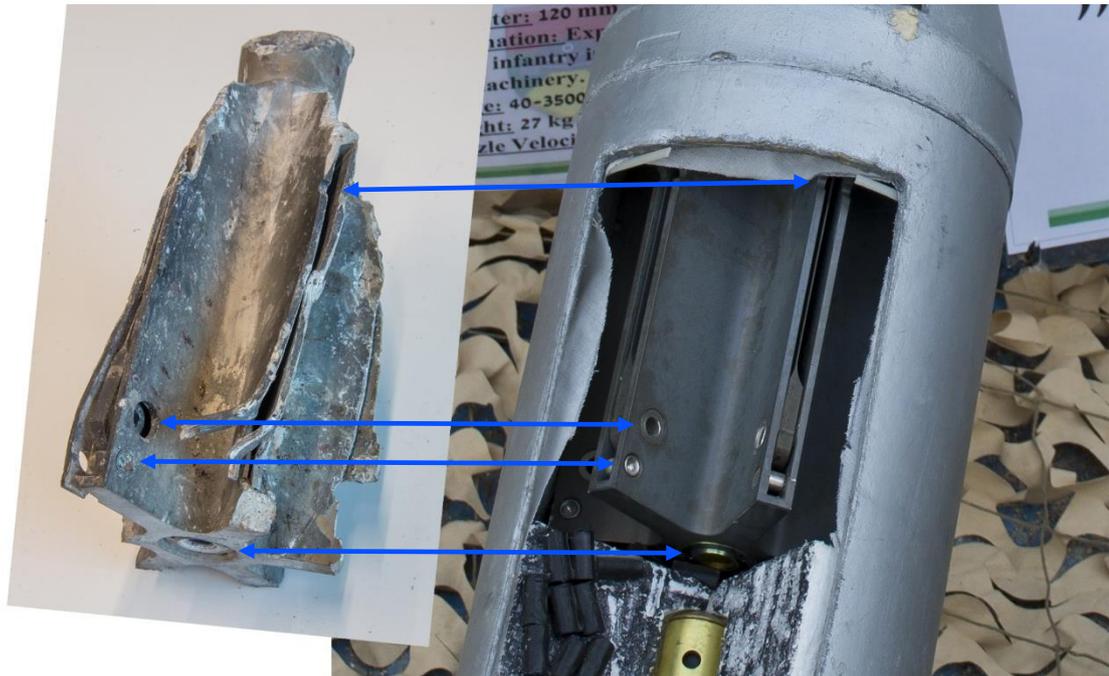
Figure 39 Side-by-side comparison of the tail fin retrieved from the incident scene (left) and the tail fin of the 120 mm Hatzav round (right). Similar distinct features are indicated by blue arrows.

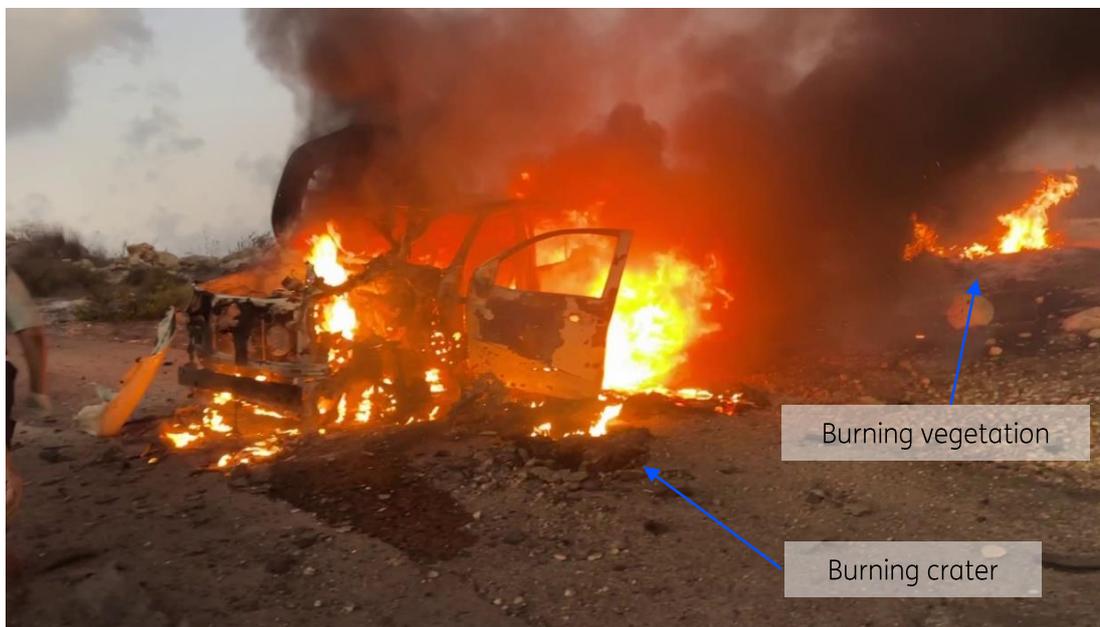
Figure 49 Still from [IMG_9833.MOV]; burning car, crater and vegetation due to the second strike.

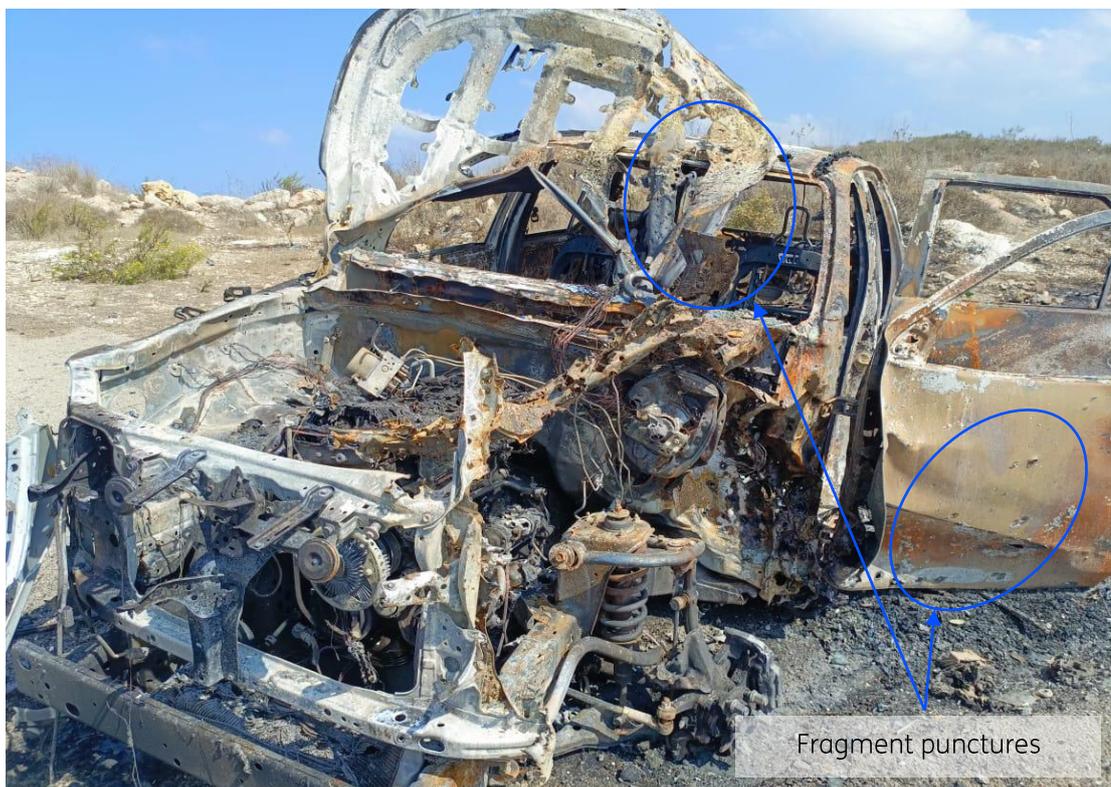
1. Vehicle severely burned after the strike;
2. Left rear wheel seems to be melted by the heat as melted aluminum is seen on the ground surface;
3. Lot of debris around vehicle, mostly plastic parts.

- Structural deformations are seen of firewall (bulkhead), bonnet stiffeners, stiffener top part of left front fender, left front door;
- Bonnet cover plate launched over the wall;
- Left fender launched, probably near wall;
- Left front wheel launched, probably completely broken as four wheel bolts are still in hub;
- Left front wheel brake disc broken, part seen at short distance from vehicle;
- Damages to parts around the engine, exhaust manifold and brake booster destroyed;
- Left chassis beam and wheel suspension intact, but damaged;
- Left doors probably opened by the blast and resulting motion of the vehicle.

Figure 50 Deformation and fragment punctures of the metal car body [Fixer - Car Hood 3.jpg].

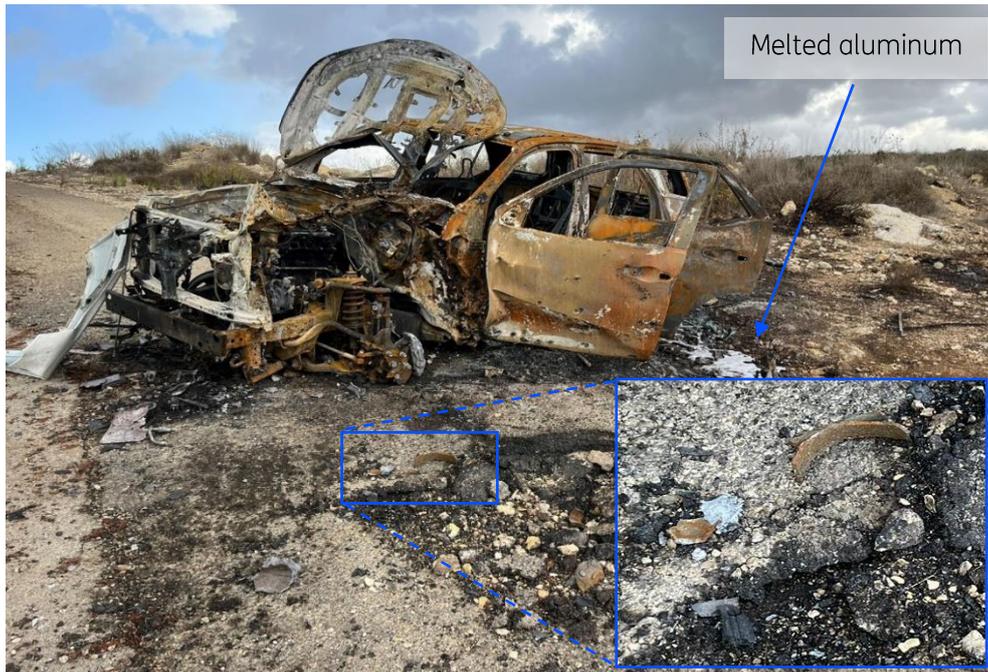
The above listed observations are typical consequences of a detonating high explosive fragmenting ammunition round. Near the edge of the crater a metal fragment and a deployable fin from a tail fin assembly are observed, see Figure 51.

Figure 51 Near the edge of the crater a metal fragment and a deployable fin are observed [IMG-20231015-WA0074.jpg], [IMG-20231015-WA0079.jpg (cropped)]. The left rear wheel seems to be melted.

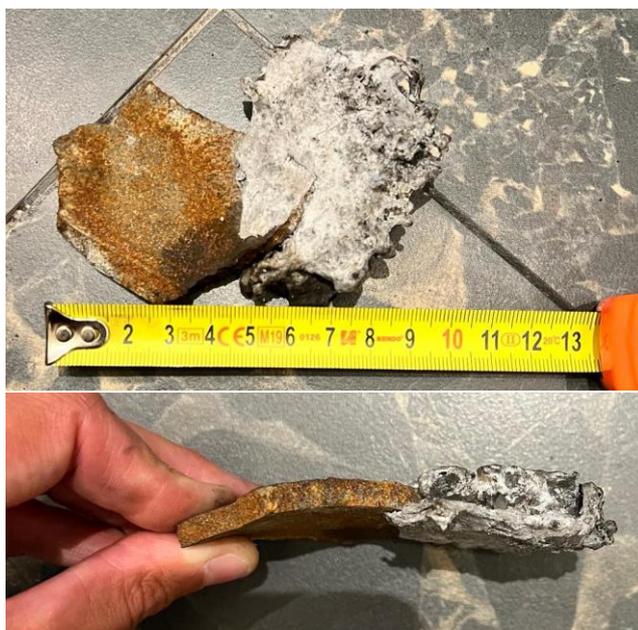
The metal fragment, shown in Figure 52, is a typical fragment from a thick cased ammunition round. Given its location, it is thought to relate to the second strike. The thickness of the fragment flat surface measures 4.5 mm. At the raised edge, seen in the top image of Figure 52, the thickness equals 5.0 mm. Using SEM-EDX, it was determined that the fragment is made of silicon steel¹⁴ with an aluminium piece attached to it. The latter may have flown on top of it coming from a car rim that was melting when the vehicle was burning after the strike.

Figure 52 Fragment from thick cased ammunition round with molten aluminum attached [M5.jpg], [M1.jpg].

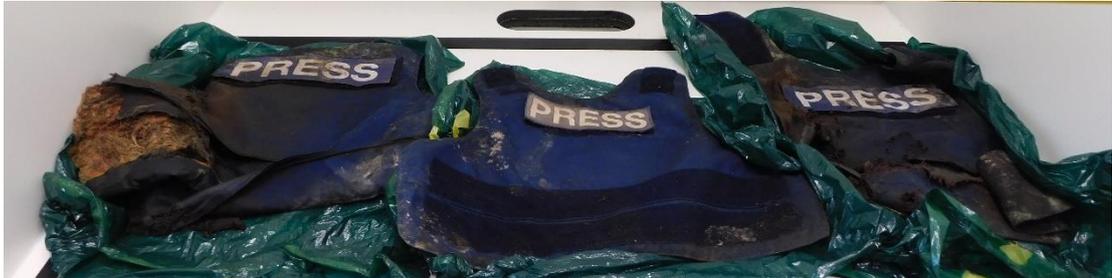
The front outside and backside of the flak vest of Issam Abdallah sustained major damage. Three parts of this vest are shown in Figure 59. The individual parts with corresponding X-rays are displayed in Figure 82 and Figure 83.

Several perforations are observed in the back and front outside of the vest. Part of the Kevlar (or Aramid) has been ripped from the body armour back plate and is still present in the backside of the vest. Whether the armour plates were perforated themselves could not be determined as these plates were not obtained by TNO. No metal fragments were found.

Figure 59 Flak vest of Issam Abdallah; backside, front inside and front outside (from left to right).

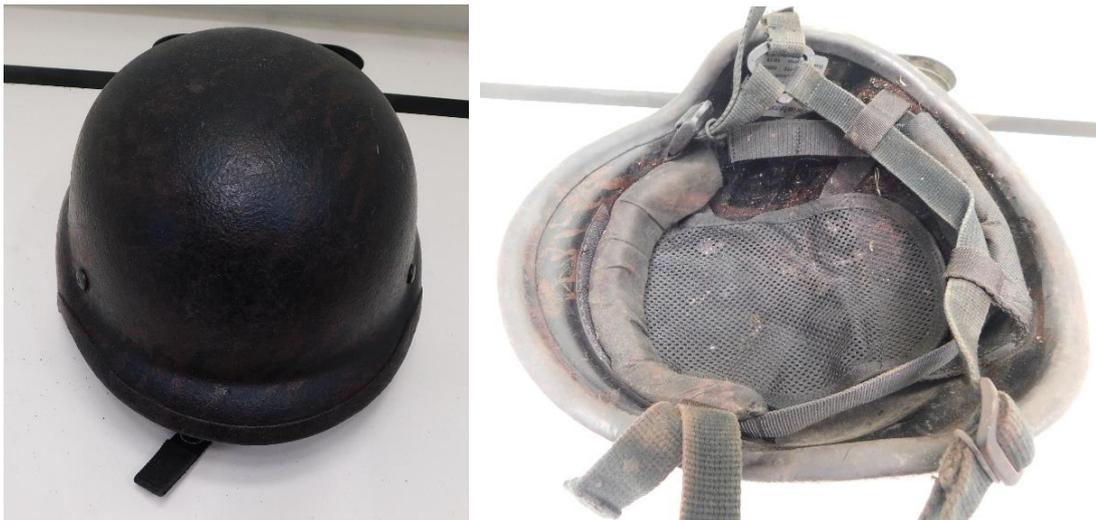
The helmet of Dylan Collins was visually inspected. This helmet has the following protection level: *IIIA*. No damage to the helmet was observed, see Figure 60.

Figure 60 Helmet of Dylan Collins; exterior (left) and interior (right).

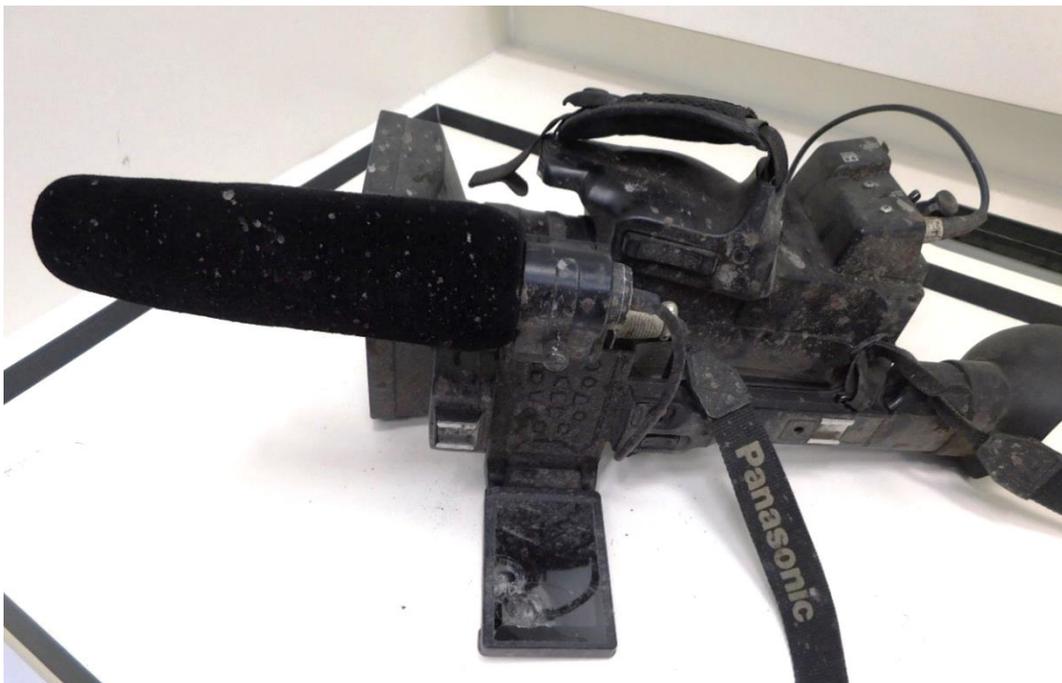
The Reuters camera, tripod and LiveU are displayed in Figure 62, Figure 63 and Figure 64. All three sustained damage. The camera was hit on its video display. The tripod suffered three perforations. As the LiveU pack was perforated at the top side, the pack was X-rayed. No metal fragments were found in all three items.

Figure 62 Reuters camera.

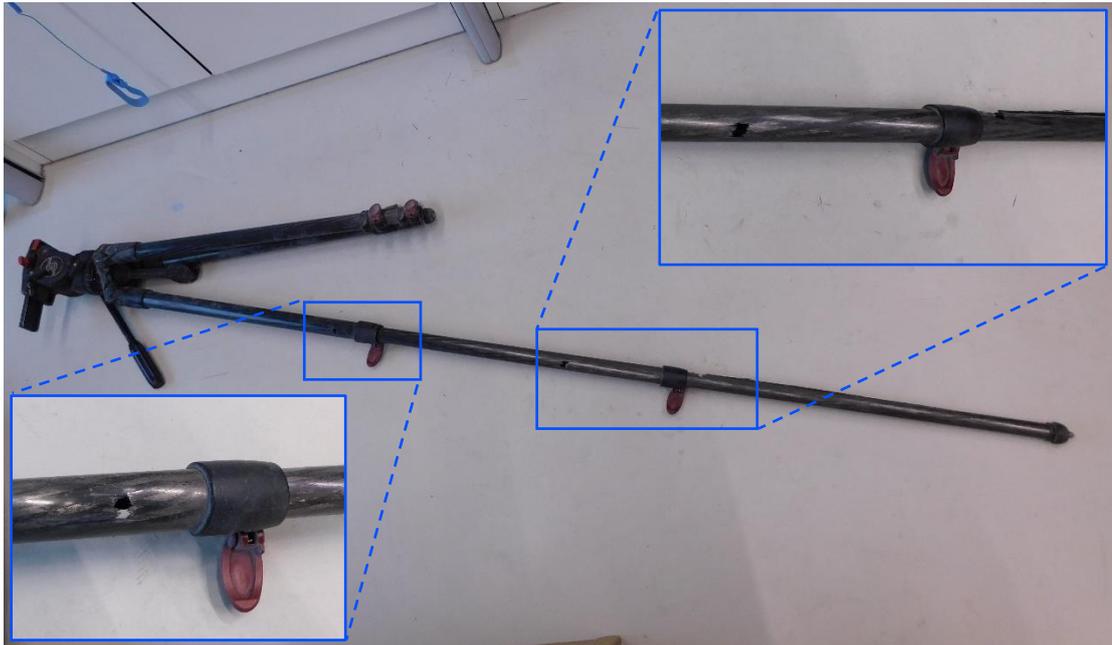
Figure 63 Reuters tripod.

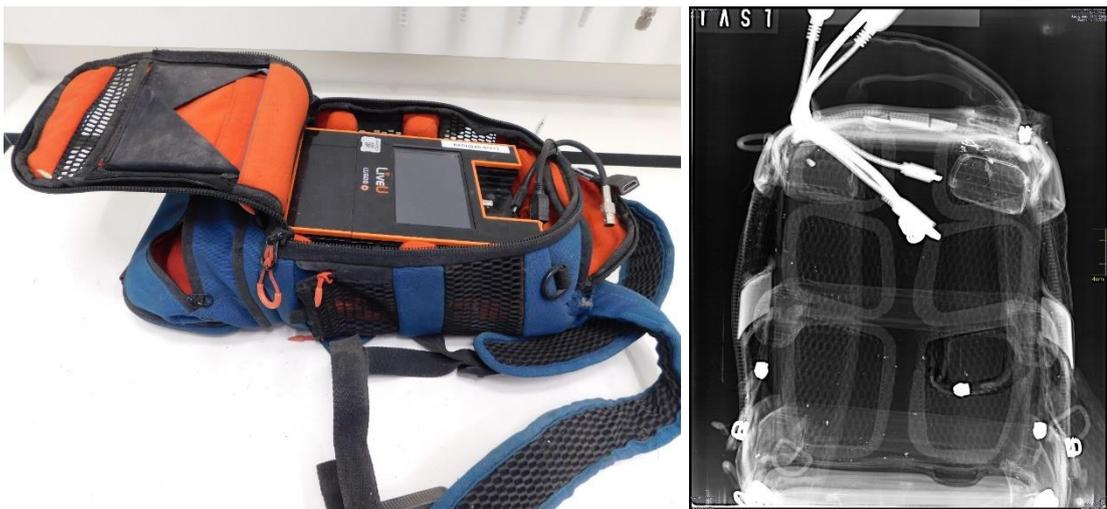
Figure 64 Packed Reuters LiveU (left), and X-ray of pack (right). The pack was perforated at the top (near the clip).

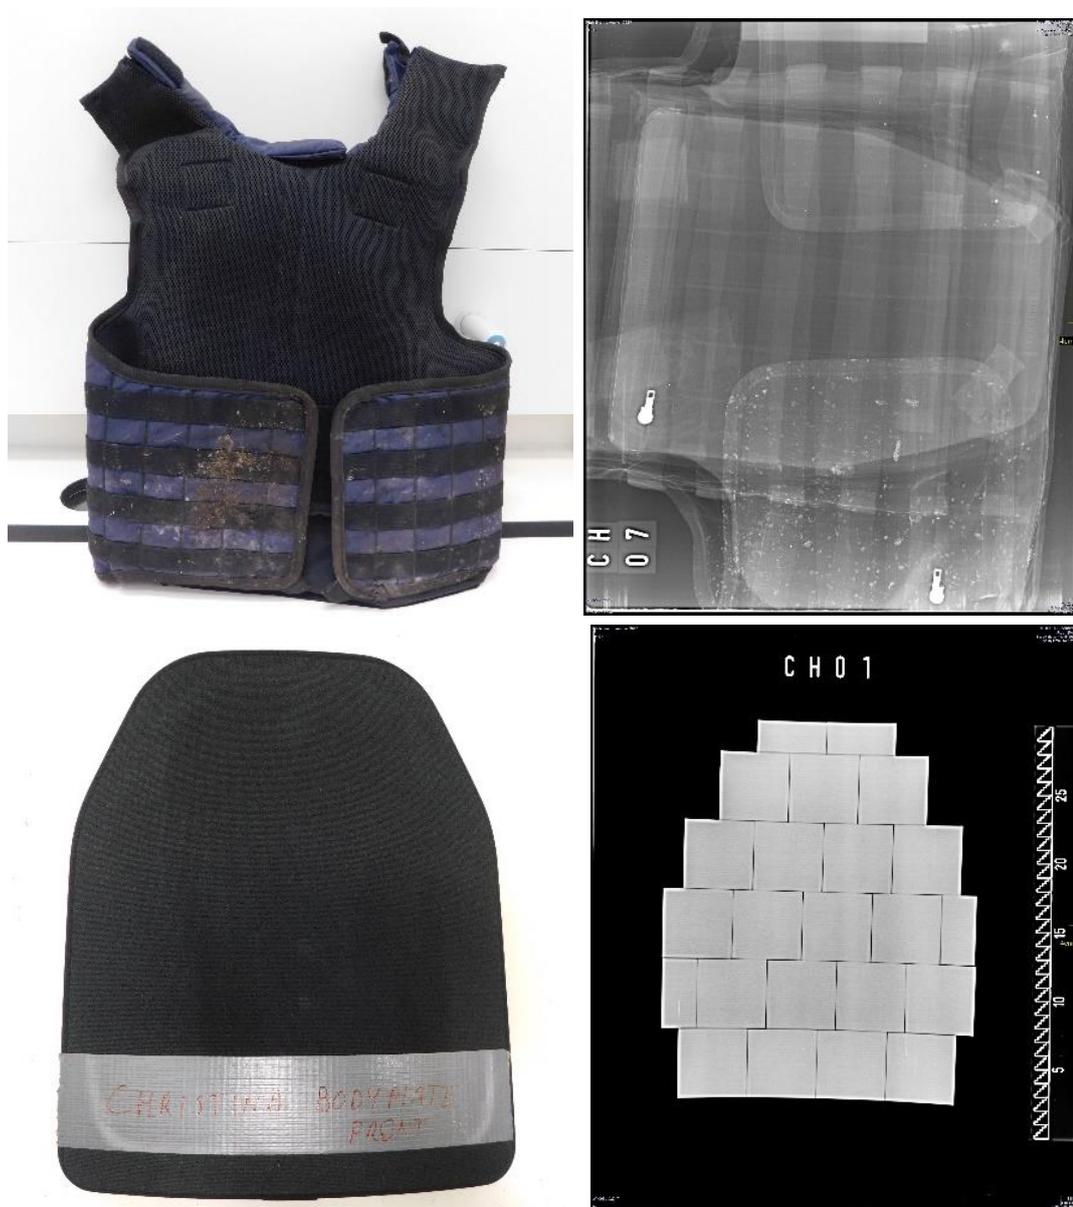
The flak vest of Christina Assi sustained one impact on the lower right front side without damage to the armour plate, and several impacts on the backside with minor damage to the armour plate, see Figure 78 and Figure 79. No metal fragments were found.

Figure 78 Frontside of body vest and armour plate of Christina Assi, with corresponding X-ray images.

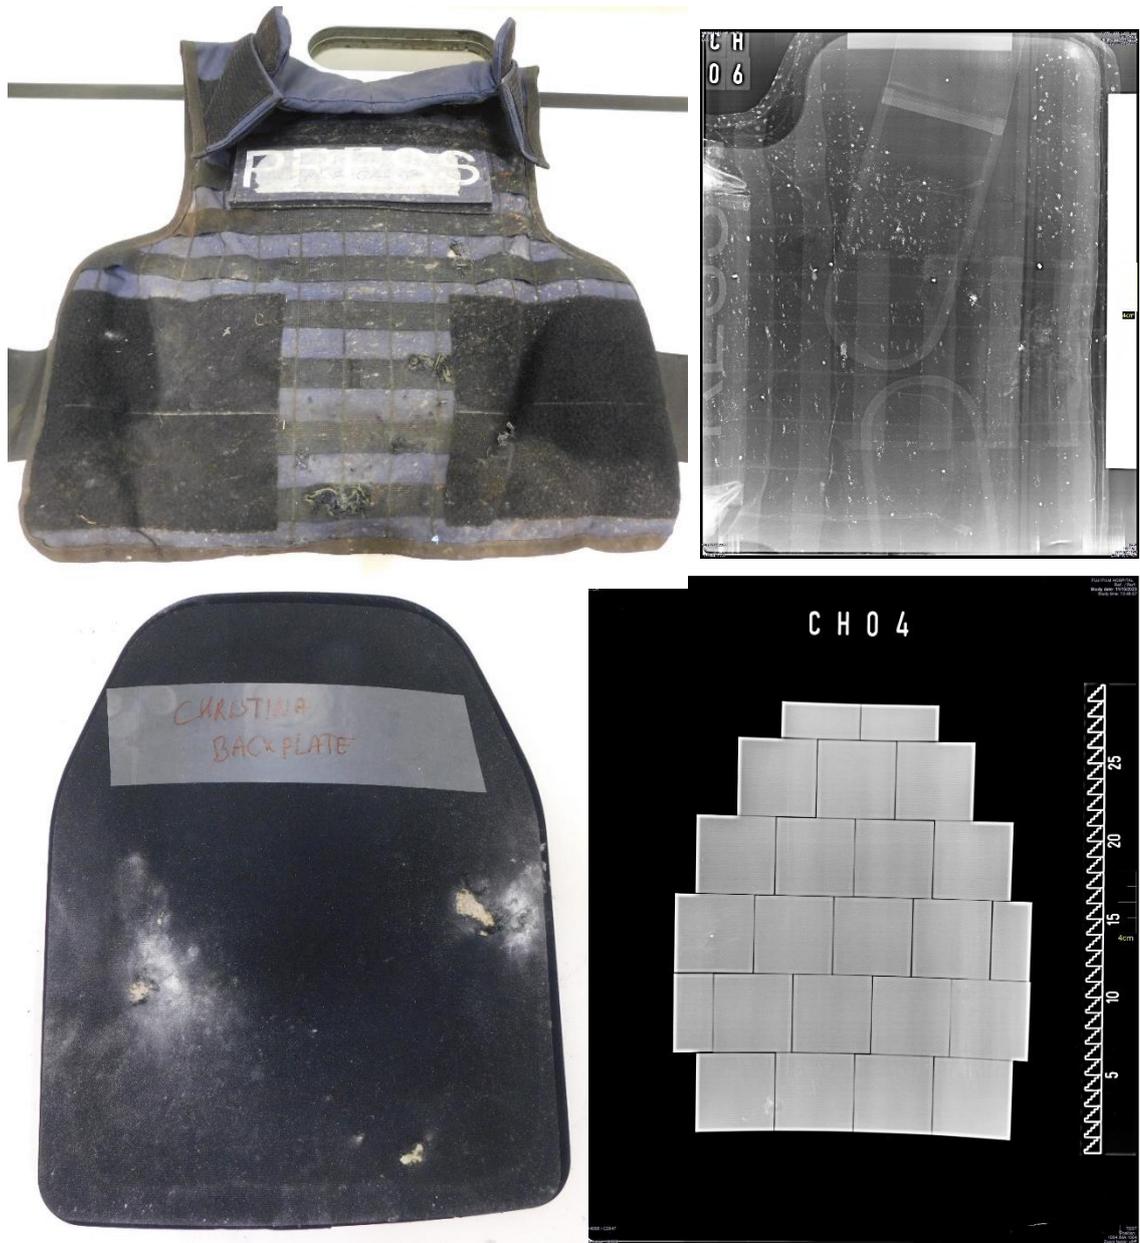
Figure 79 Backside of body vest and armour plate of Christina Assi, with corresponding X-ray images.

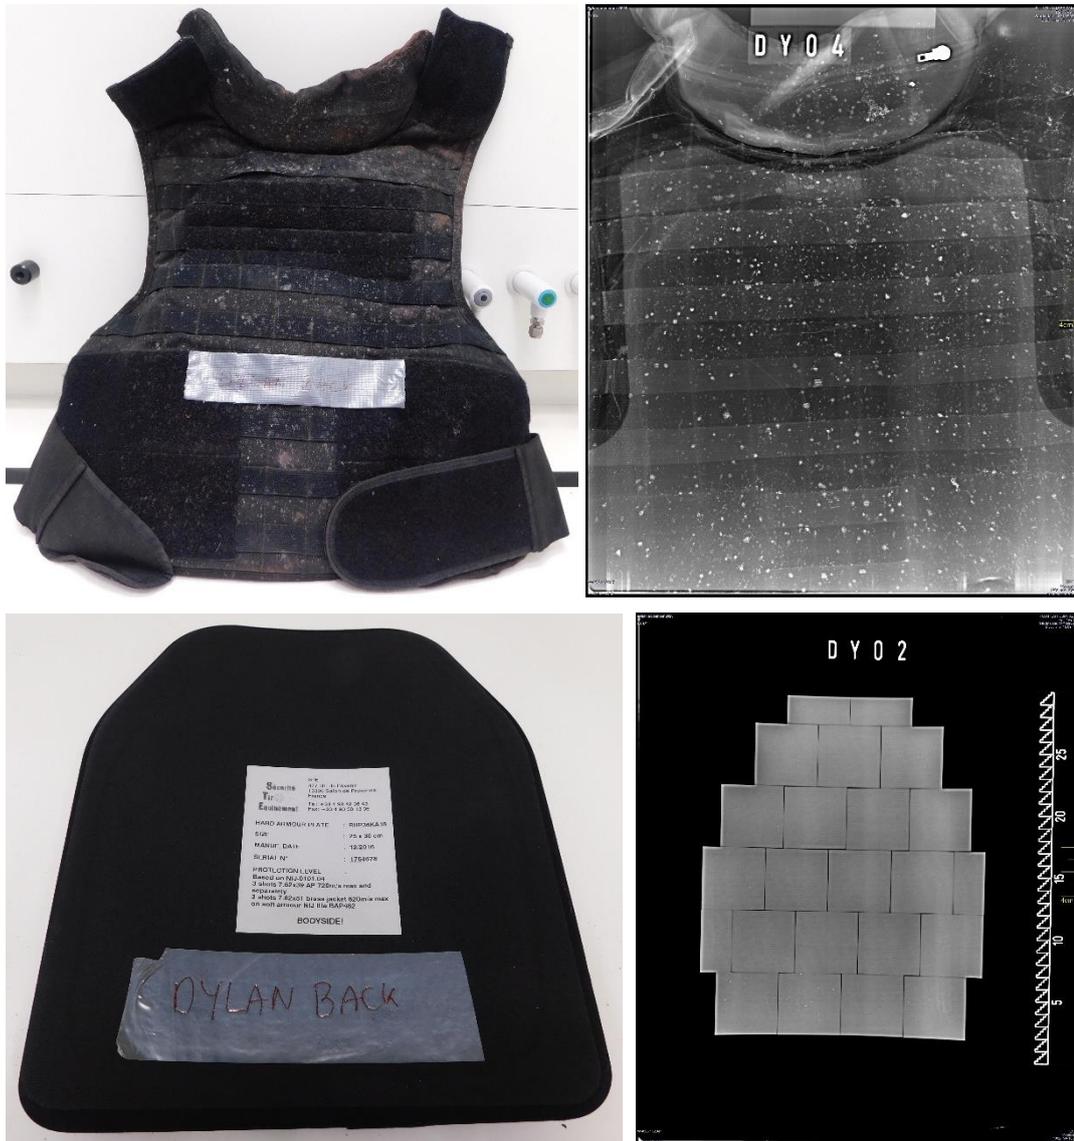
The flak vest of Dylan Collins sustained two impacts on the front right side without damage to the armour plate, and no impacts on the backside, see Figure 80 and Figure 81. No metal fragments were found.

Figure 81 Backside of body vest and armour plate of Dylan Collins, with corresponding X-ray images.

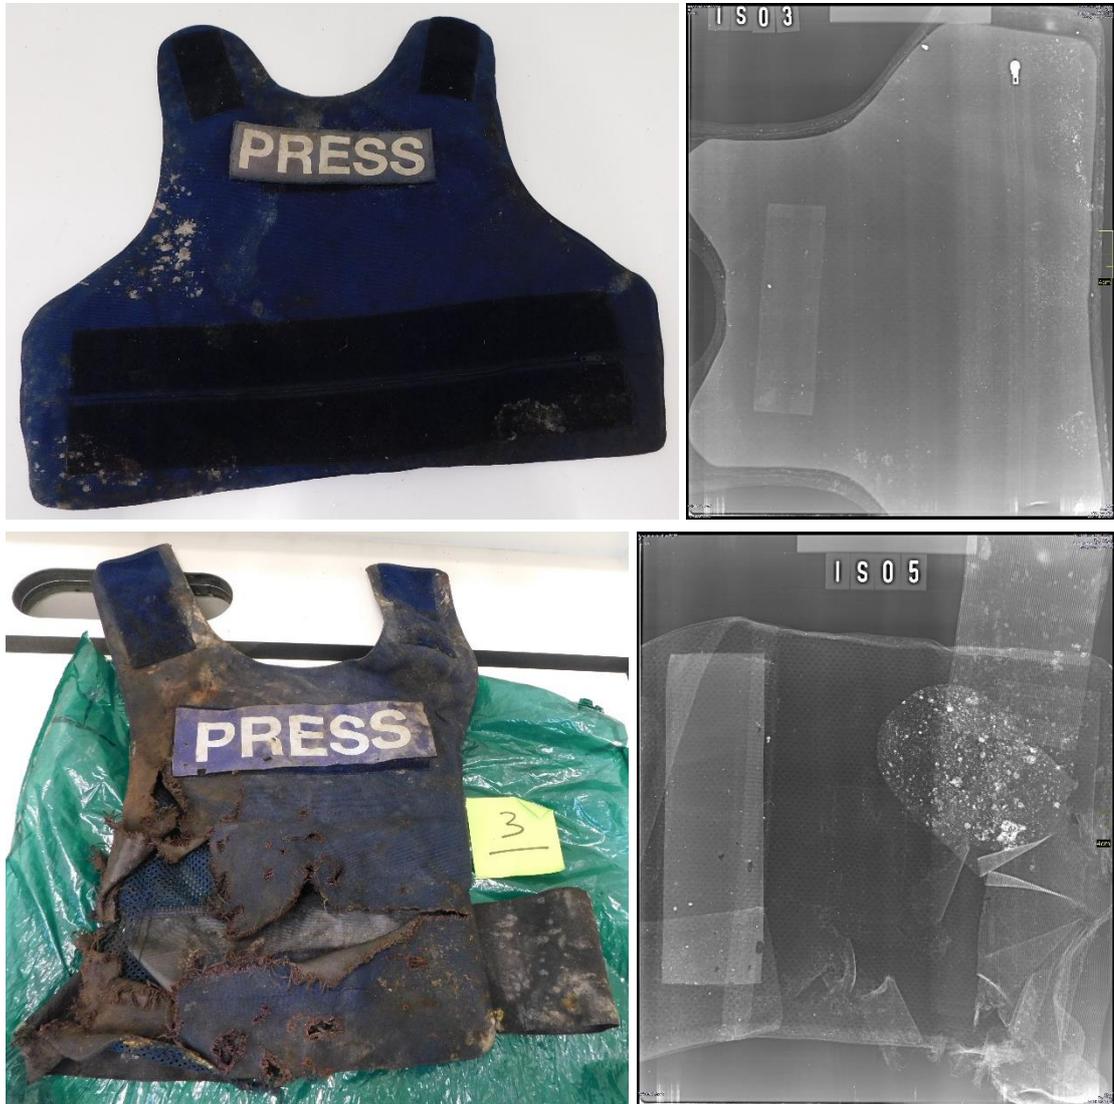
Figure 82 Front inside and outside of the vest of Issam Abdallah, with corresponding X-ray images.

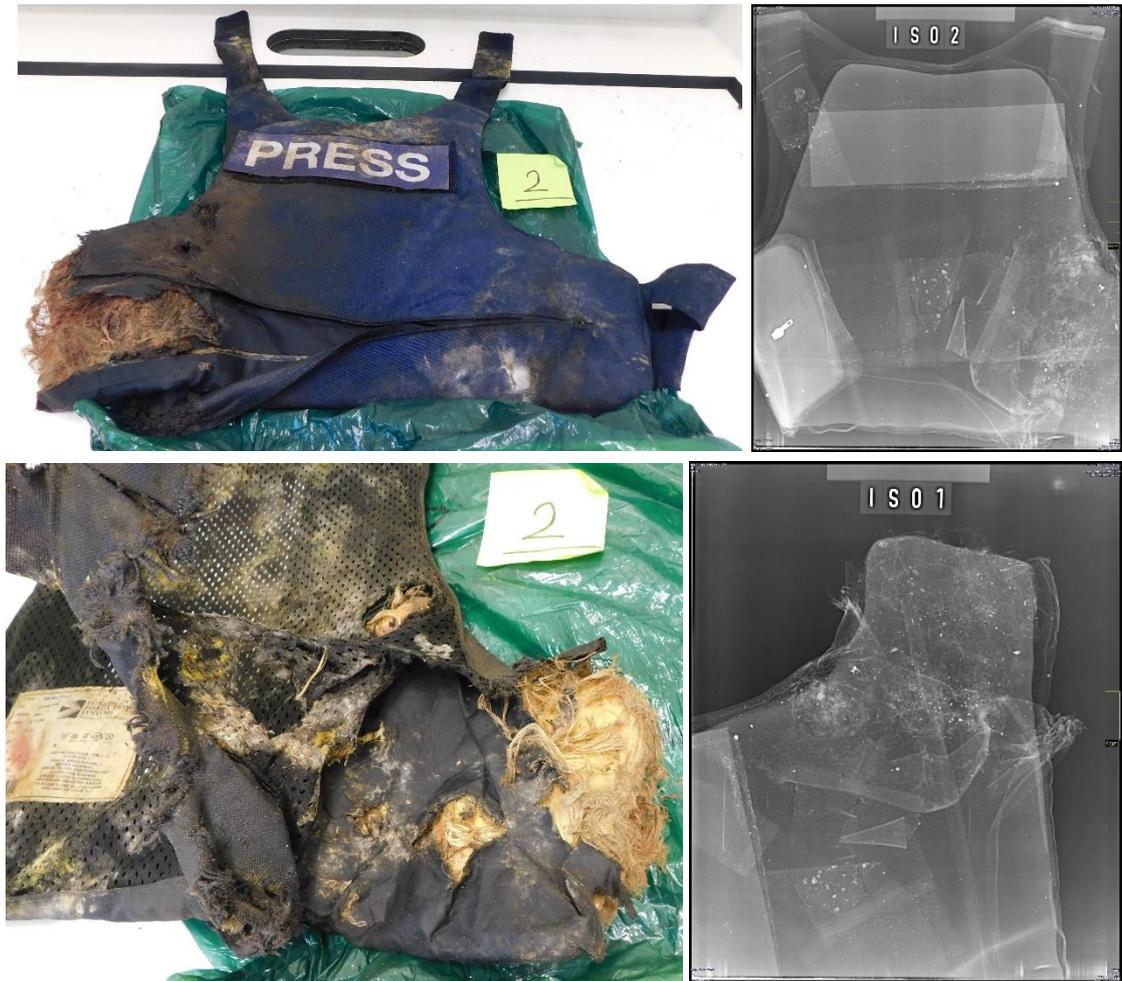
Figure 83 Backside of the vest of Issam Abdallah, with corresponding X-ray images.
