Proceeding Paper

Post-Corrosion Repair Thickness Measurements Using Lamb-Wave Technology: An Aviation MRO Case Study [†]

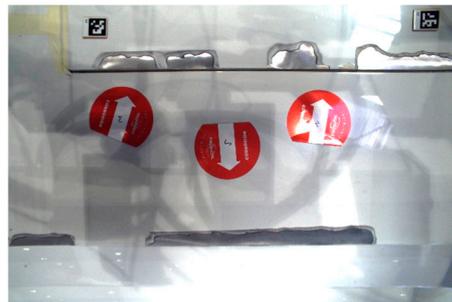
The second round of field trials involved thickness measurements of blended corrosion spots on top of the wing and specifically near and at the edge of the air brake. The repaired spots can be observed in Figure 2. The actuators were placed at every panel located within the inspected area, and no parameters were varied during scanning.

Figure 2. Blended corrosion spots located at the trailing edge of the wing and on the air brake. The red stickers placed by the corrosion repair crew indicate corrosion spots that require removal. ArUco markers are placed only at the top corners of the panel, since the scanning region is at the edge of the wing, to enable co-registration of results.

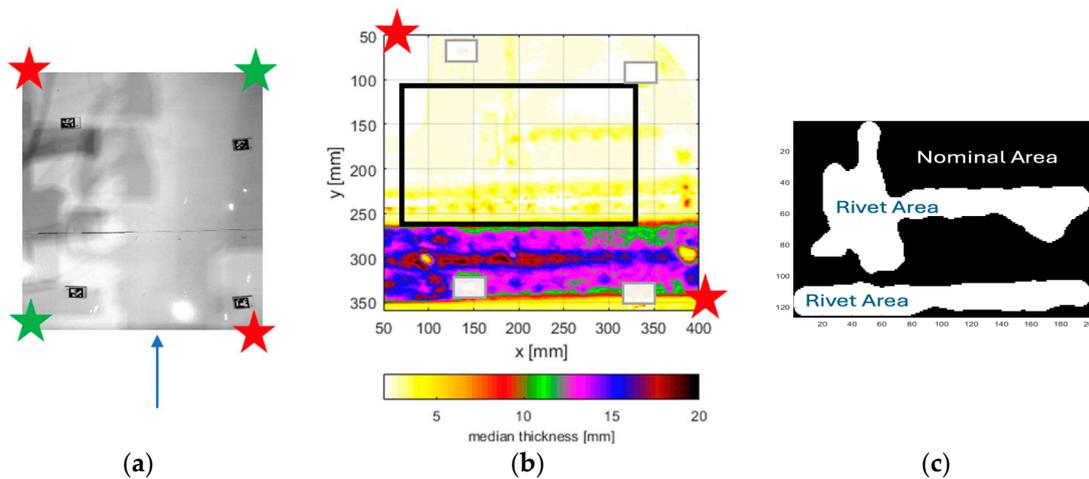
Figure 4. The pristine area of the wing comprises two panels under inspection during vibrations and actuator placement tests. (a) Digital photo of the area with ArUco markers used in co-registration. The ceiling of the hangar is reflected by the wing. The blue arrow indicates the tapping position during vibration tests. The actuator placement in the vibration and actuator-position tests is indicated by the red and green stars, respectively. (b) Resulting thickness map from acoustical data obtained during a first (control) test. Encircled in black is the subset region that was further investigated during these tests. (c) Rivet and nominal areas within the encircled region of (b).

It is evident from Figure 4b that the MEMS sensor, apart from the skin, also detects the underlying structures that are connected to the skin. This is particularly apparent in the area in Figure 4b with thicknesses above 10 mm, which is far beyond regular skin thicknesses. To avoid the influence of these components, a subset of the area, where the acoustic response of the underlying structures is less significant, was chosen to further investigate actuator placement and vibration effects. In this subset, although not as severe, there are still discontinuities in areas of the panels due to rivets, seen in Figure 4c.

Thick underlying structures that are acoustically coupled to the wing skin, for example, through a combination of rivets and adhesives, reduce measurement accuracy, as absolute accuracy decreases with increasing thickness [7]. This reduction in accuracy is critical for

corrosion inspections in these regions, as the 10% thickness reduction criterion applies only to the nominal thickness of the wing skin. Further research is required to enable reliable corrosion assessment in such structurally complex regions. For other applications, such as the detection of stringer debonds, these measurements may still be of interest; however, such applications are beyond the scope of this paper.

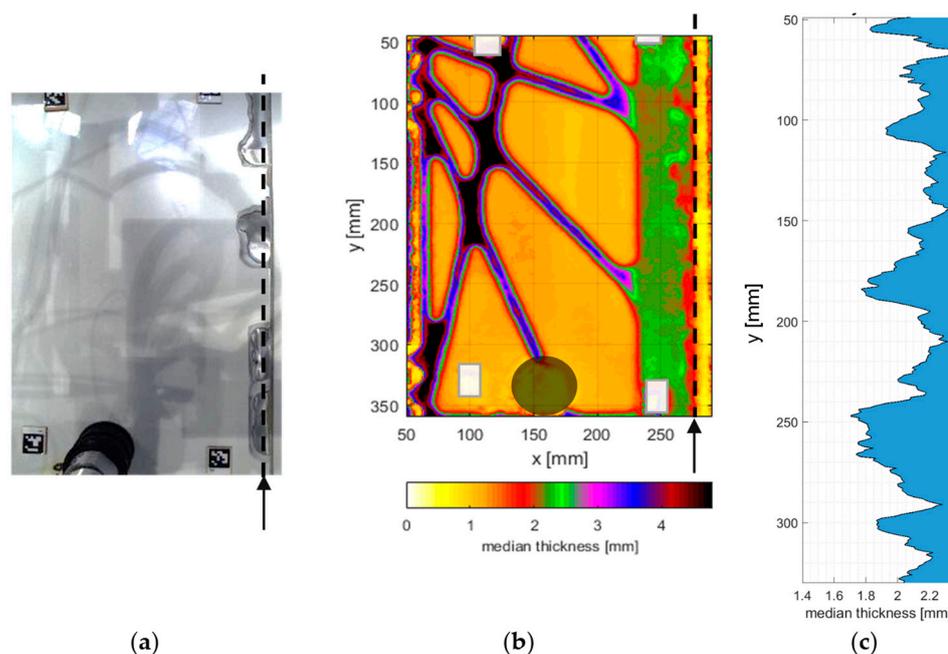
Figure 6 presents the results from the inspection of several blended corrosion spots located on the top surface of the air brake on the aircraft’s wing. The camera image acquired prior to the scan is used in order to associate the blended corrosion spots with their actual locations in the thickness map.

Figure 6. Post-repair (blended) corrosion spots located at the edges of the air brake and the resulting thickness map. (a) Camera image of the inspected area. (b) Thickness map of the area, the white squares indicate the location of the ARUCO markers and the circle map indicates the location of the actuator. (c) Cross-section of the thickness map. The arrows in (a,b) indicate the cross-section of the thickness map shown in (c).

Thickness readings from acoustical data on blended corrosion spots range between 1.8 and 2.2 mm (Figure 6c). Thicker areas (>2.2 mm) in Figure 6 likely correspond to underlying structures acoustically coupled to the wing skin. In these regions, assessing skin thickness—as required during corrosion repairs—is challenging. Several strategies to address these complexities are under development. Moreover, visibility of underlying structures may have broader applications, such as investigating stringer debonding. These results are promising, indicating thinner skin at corrosion spots. However, pulse-echo mea-

surements with manually drawn contours did not enable a reliable quantitative comparison. Future work will establish such a comparison.
