Harald van der Mijle Meijer  
TNO Science and Industry, Corrosion and Fouling, The Netherlands

## Aspects of interest with offshore wind farms

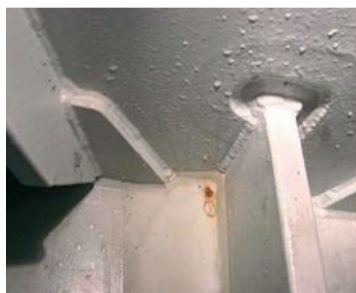
Fig 2. Example coating damage

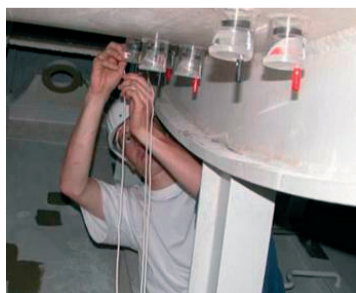
Fig 4. On site EIS

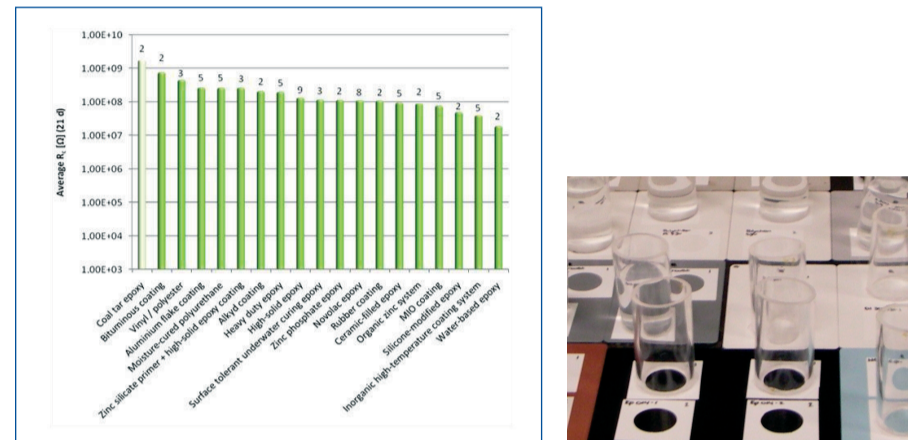
An overview of the obtained Rc values is shown in figure 6. Generally, a good barrier coating has a high Rc value.

Fig 6. Average Rc-values for each coating type after 21 days of immersion.

TNO determined the barrier properties of over 100 commercial coating systems using EIS and created a database of the initial performance of protective coatings.

One of the values that can be derived from EIS is the coating resistance (Rc). The Rc value represents the resistance that charge carriers (ions) encounter as they migrate through the coating.
