TNO report**TNO 2015 R10307v2****Roadworthiness Test Investigations of Diesel
Particulate Filters on vehicles****Urbanisation**Van Mourik Broekmanweg 6
2628 XE Delft
P.O. Box 49
2600 AA Delft
The Netherlands

Date	19 June 2015
Author(s)	Gerrit Kadijk Jordy Spreen
Copy no	2015-TL-RAP-0100283232
Number of pages	23 (incl. appendices)
Sponsor	Mr. H.L. Baarbé Ministry of Infrastructure and the Environment Directorate-General for Environment and International Coordination PO Box 20901 2500 EX THE HAGUE The Netherlands
Project name	IenM LD Steekproef 2015
Project number	060.14432

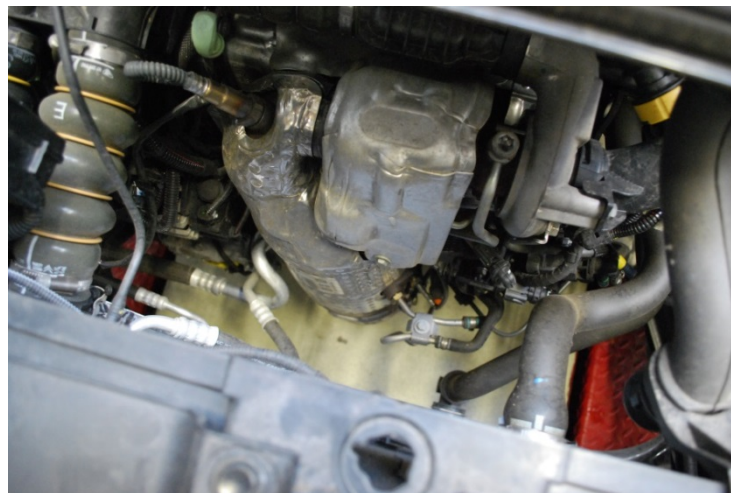
1. *Visual test:* In a first inspection of a vehicle, the visual presence of a DPF was checked. In case of a DPF removal and installation of a straight pipe, the absence of a DPF justifies a 'fail' of the roadworthiness test. In a second inspection, the RDW-inspector knocks on the housing of the DPF. A relatively 'hollow' sound while doing so might indicate a possible DPF removal.

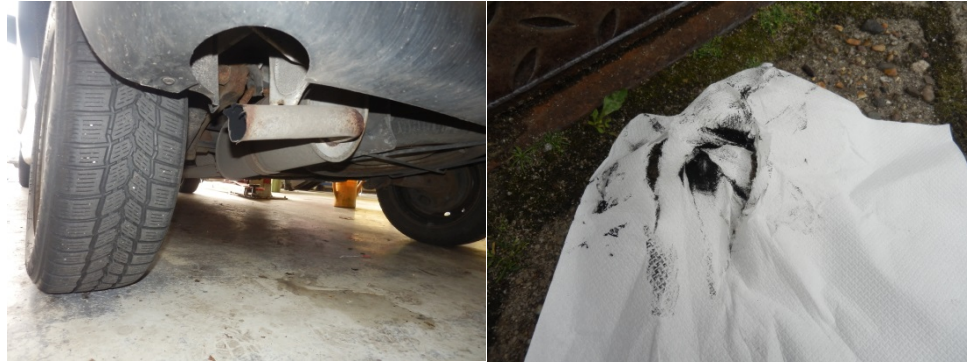
2. *Tailpipe wipe test:* In this indicative test a white tissue is wiped at the inner tailpipe, as shown in Figure 1. The collected soot on the tissue might be an indication of a DPF failure or removal. However, over a longer period of time very small DPF leaks will pollute the internal exhaust system as well. This means a polluted tissue does not necessarily indicate a malfunctioning DPF, but gives motive for further inspection.

Figure 1: Tailpipe and result of inner tailpipe test

At the start of a roadworthiness test a white tissue is wiped over the inner surface of an exhaust. The collected soot on the tissue may have been emitted over a longer period of time and may therefore only indicate a DPF leakage. This result does not yield information about the amount of leakage. This means this tissue test result is only a first indication of the status of a DPF. It indicates if a leakage is present but does not reveal any information on the size of the leakage.

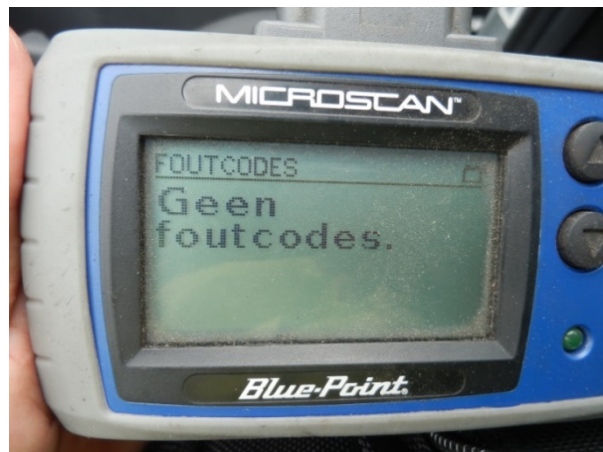
3. *EOBD test:* The On Board Diagnostic system of a vehicle monitors some conditions of the DPF. A simple check at the start of the roadworthiness test will gain information about stored failure information. Certain emission-related malfunctions may be stored in the memory of the engine management system and these may indicate DPF failures. Before the start of the EOBD test, the system checks the status of the 'readiness test'. In a readiness test the EOBD system compares a package of predefined speed and load conditions of the engine which are passed in a type approval emission test with the history of the speed and load conditions of the test vehicle. If the test vehicle has run all predefined speed and load conditions, the readiness test is passed. If the EOBD test fails, it must be replaced by a smoke emission test using the opacity smoke meter.

Figure 2: EOBD reader, displaying the message "No error codes".

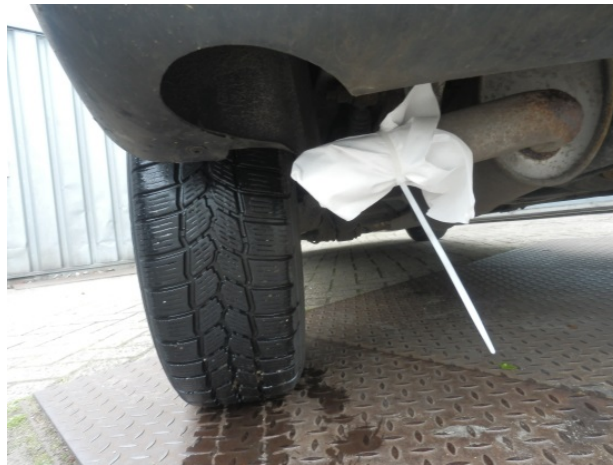
4. *Smoke emission test with white tissue:* A free acceleration test of an engine starts at low idle speed and moves to high idle speed and back. During the test, the gear box is in the neutral position and the accelerator pedal is moved within 1 second to the maximum position loading the engine by its own inertia. This yields a raise of the engine speed and, due to a shortage of combustion air, the engine generates a smoke peak. The emitted particulate matter is stored on a tissue which is mounted at the exit of the tail pipe (Figure 3). After the loading of the tissue it can be compared with a colour swatch which ranges from white to black on a 1-10 scale (Figure 4).

Figure 3: Tissue mounted on a tail pipe for a smoke emission test.

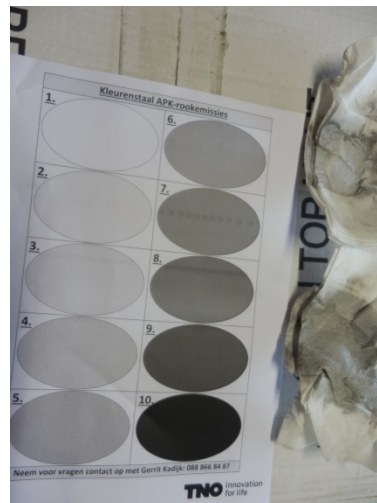
Figure 4: Colour swatch and loaded tissues.

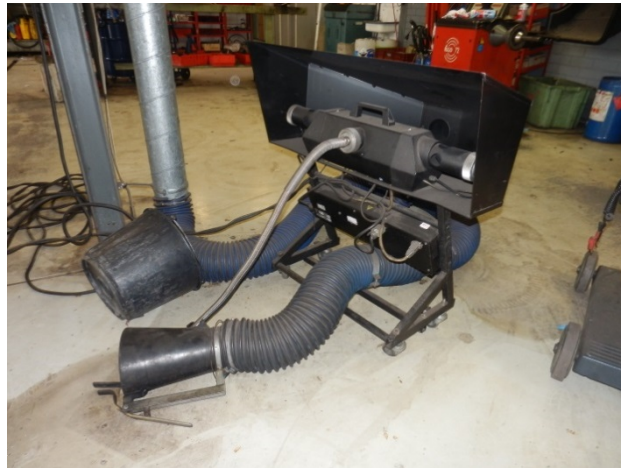
5. *Smoke emission test with opacity meter:* The regular roadworthiness smoke emission test is carried out as a free acceleration test with an opacity meter, shown in Figure 5 and Figure 6. During the test, the engine runs from low-idle to high-idle speed within 1-2 seconds. This generates a smoke peak value. For stabilisation purposes the test must be repeated a few times until the readings are stable.

Figure 5: Opacity meter for a roadworthiness test.

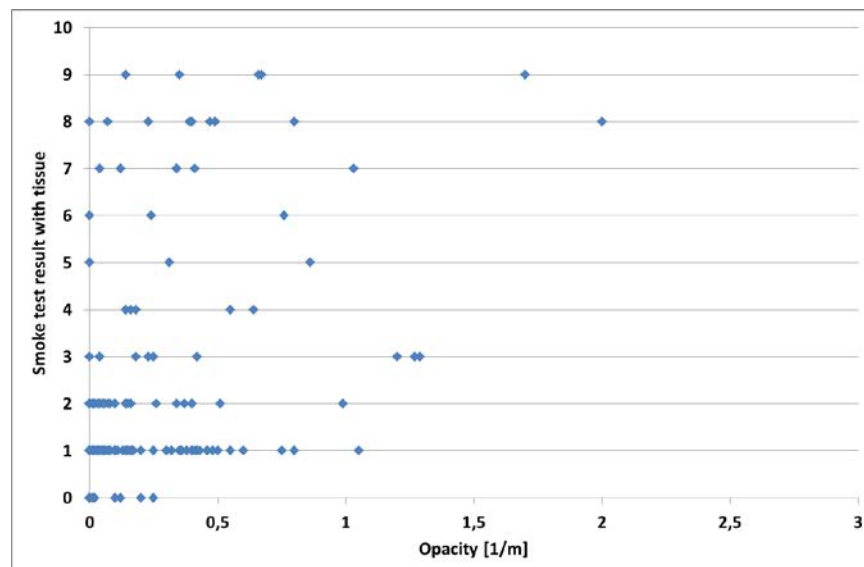
In Figure 7 the correlation between results of the smoke tissue test and the opacity test are shown. The figure shows clearly that there is a bad correlation between these test results. This indicates that soot in the exhaust is stored over a longer period and is released in the smoke emission test with tissue.

Figure 7: Correlation between smoke tissue test results and opacity test results
