# Reduction of Impact Noise of Trams on a Major Bridge

M. Dittrich, C. Bosschaart and P. Wessels  
TNO Technical Sciences, The Hague, the Netherlands

As part of a recent renovation of the Erasmus bridge in Rotterdam, improvements were made to reduce impact noise caused by trams passing a series of rail joints. The bridge includes several different sections including a bascule bridge and is in an inner city location with new adjacent apartment buildings. At request of public transport company RET, TNO investigated the noise situation and proposed a number of noise control solutions in close cooperation with RET and the engineering department of the city of Rotterdam. This paper describes how the noise sources were identified and ranked by monitoring, how diagnostic measurements and analyses were performed to select and evaluate the most suitable noise control measures, and the achieved noise reduction. The main solutions included moving rail joints and introducing new joint types, local stiffening of sensitive bridge deck parts and improved elastic support of the rails.

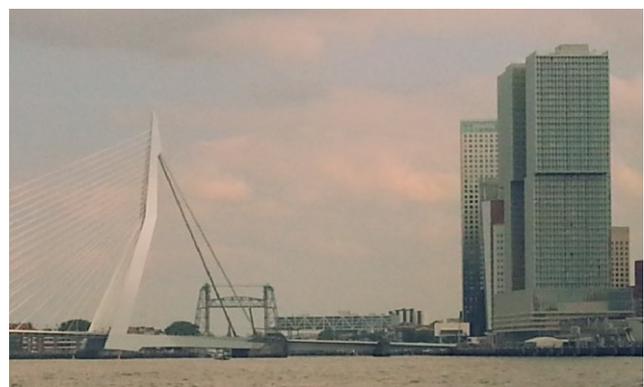
Figure I: Schematic view and photo of the South section of the Erasmus bridge with rail joints numbered and indicated by arrows. "De Rotterdam" building is on the right.  
Photo: C. de Mooij

carriageway with four lanes of road traffic and two tram lines with more than 600 tram crossings each day. The new multi-storey building completed in 2014 called "De Rotterdam" is at its closest point about 120 meters from the centre of the bascule bridge. Each track has five rail joints, 2 either side of the bascule bridge and 3 to allow for expansion or movement relative to other bridge sections. These joints are a source of varying levels impact noise each time a tram passes. A schematic side view is shown in Figure I. Photos showing the view from the building and the bridge structure are shown in Figures II-IV.

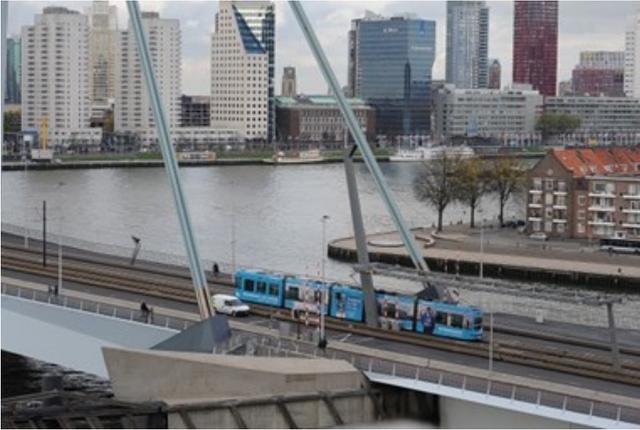
Figure II: View from noise monitoring position on 7<sup>th</sup> floor balcony of "De Rotterdam", with a tram passing joint 4 to 5.

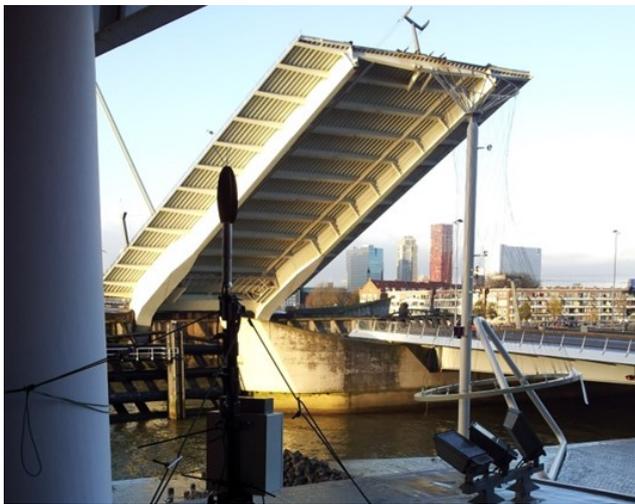
Figure III: Open bascule bridge, northward view, showing main bearing girders and bridge deck with stiffening profiles.

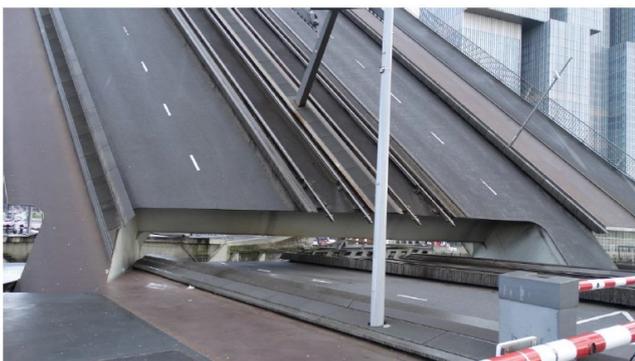
Figure IV: Open bascule bridge with protruding rails. 'De Rotterdam' building is visible on the right.

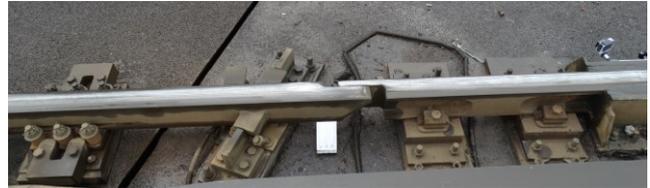
Figure V: Rail joint 4 with from left to right: suspension support, seating support, 2 clamp supports with railpads and far right, embedded rail. The rail on the left moves with the bascule bridge and 'lands' on the seating support which is on a concrete base..

The rail cross-section along this stretch of track varies near each joint, to allow for the varying support structure which must also provide flexibility at the joints of the bascule bridge. The rail joints were initially all splice joints with different types of support (see Figure V), potentially generating structure-borne noise which is transmitted into the bridge structure.

Most of the track beyond the joints was embedded vignol rail with a cork rubber runner and cast rubber embedding, positioned between steel side walls (far right in Figure V).

- position of impacts from time signal analysis of rail vibration; time signal analysis revealed that noise impacts could originate not only from the rail joint gaps but also potentially from the rail seating and other flexible supports at joints 3 and 4, which may generate impact forces under load. Once an impact force generates vibrations in the rail, these can be transmitted to the bridge deck via the different types of rail support (see Figure V);

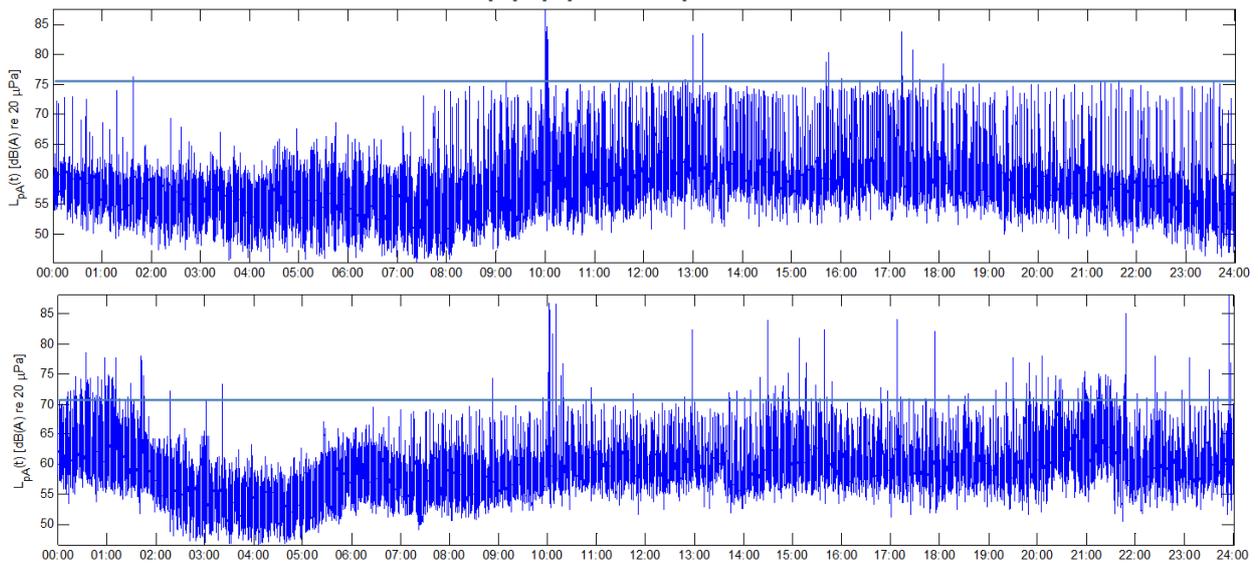
Figure VI: Level history of the A-weighted sound pressure level measured at the building façade over a 24 hour period, before (above), and after modifications (below).

A reference measurement was performed to quantify the noise levels in the initial situation. As the noise levels were known to be highly variable, noise monitoring was performed during several days so as to obtain a representative result. Measurements were taken both at a receiver point on the new building (see Figure II), a balcony on the seventh floor at 120 m from the bascule bridge, and on the bridge itself, both along the tracks and underneath the bridge. The target quantities for noise reduction were the  $L_{pAFmax}$  noise level and the  $L_{DEN}$  noise level. The  $L_{DEN}$  level due to trams is harder to measure as it is more easily contaminated by variable background noise sources, especially once the bridge noise is reduced. Time signals and level histories were registered of a large number of pass-bys, which were also processed just for the duration of the tram movement, so as to minimize the contribution of other sources. This allowed to determine the  $L_{DEN}$  level mainly due to the trams. 24 hour level histories of the sound pressure level at the façade are shown in Figure VI for a single day before and after modifications. These include all the other sound sources. Levels of 64 dB  $L_{DEN}$  including all sources contained 62 dB  $L_{DEN}$  due to trams. A reduction of 3 dB or more in the  $L_{DEN}$  due to the trams was sought. For the maximum noise levels a larger reduction of 10-15 dB(A) of the highest peaks was sought, as they are more critical for annoyance and sleep disturbance.

The effect of the modifications was measured according to the same procedure as the reference measurement [3], 4 months after the bridge renovation was completed. Approximately 5 dB reduction was found in the average maximum noise levels (see figures VI,VII,VIII). The probability of high noise levels at the rail joints has been significantly reduced: the chance of levels above 70 dB(A) has been reduced from 91% to 17%. Also the spread in impact noise has decreased. An overall noise reduction of around 3 dB, from 62 dB to 59 dB was found in the  $L_{DEN}$  level due to trams at the building façade.

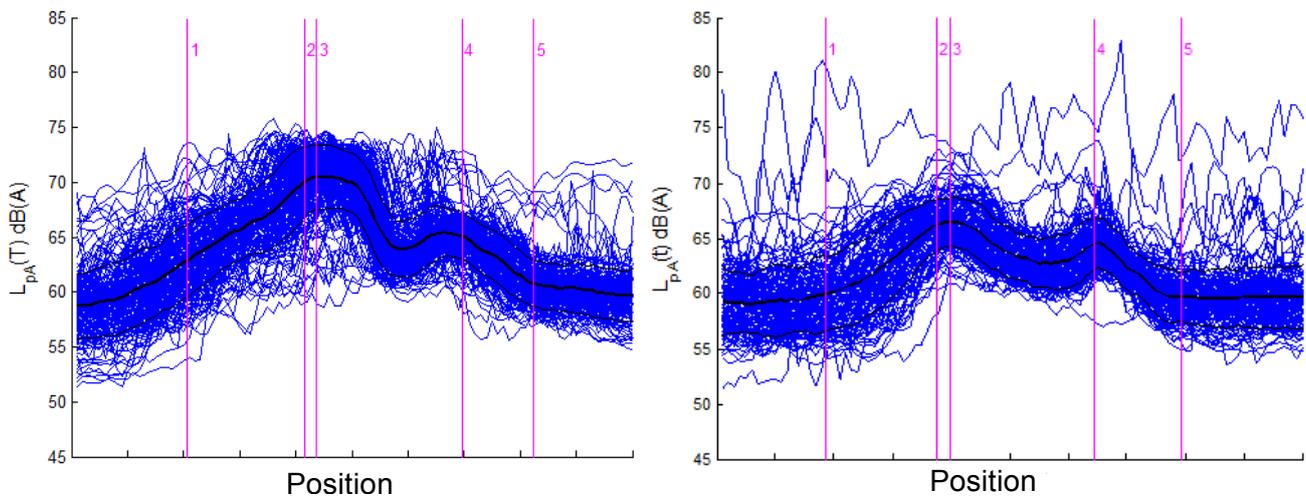
Figure VII: A-weighted sound level histories of tram pass-bys measured at the building façade, scaled to the position of the rail joints (numbered). Left: reference measurement, 369 pass-bys, right: after modifications, 135 pass-bys, both for southbound trams. Black lines indicate the average level history and plus/minus a single standard deviation.

Multiple level histories of tram pass-bys scaled to fit the joint positions are shown in Figure VII, including the average levels and single standard deviation. These show the relative importance of individual joints and the characteristic spread in noise levels. Joints 2/3 and 4 have the highest levels.

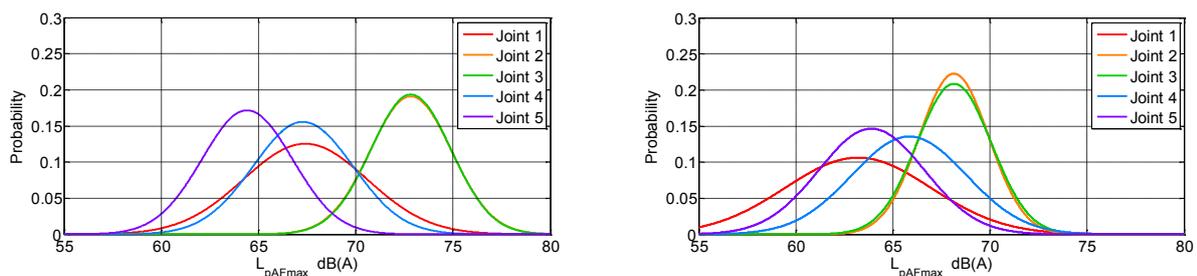
Figure VIII: Estimated normal probability distribution curves of measured  $L_{pAFmax}$  levels for each rail joint, before (left) and after the modifications (right), for northbound trams.

As the variation in maximum noise levels was significant, also normal probability distributions were determined for each joint, showing not only the average maximum levels, but also the probability of high levels occurring. These curves are set out in figure VIII for northbound trams, both for the reference situation and after modifications.

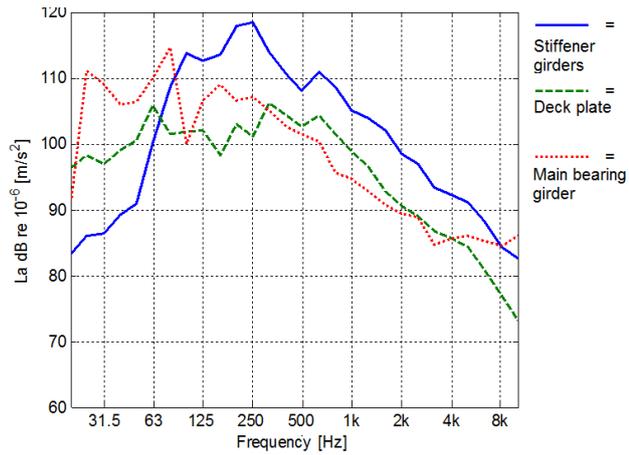
Figure IX: Structural vibration third octave spectra during a tram pass-by at joint 4, on stiffening profile, deck and main bearing girder (all visible in Figure 3).

- structure-borne sound transmission through the rail supports and the bridge structure; the vibration isolation of the rail supports was found to take effect from above 125-250 Hz; the deck stiffeners have a stronger sound radiation than the bridge deck itself or the main bearing girders, above 100 Hz. This is illustrated in Figure IX;

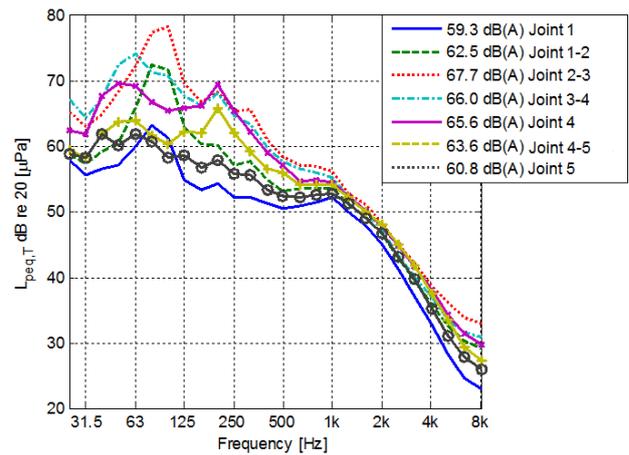
Figure X: Sound pressure third octave spectra at building façade, around each rail joint, average over 4 tram pass-bys southbound.

- spectral ranking of the sound pressure contribution around each rail joint (see Figure X). An indication of the spectral ranking of each joint was obtained by analyzing successive parts of the time signals from the pass-by.

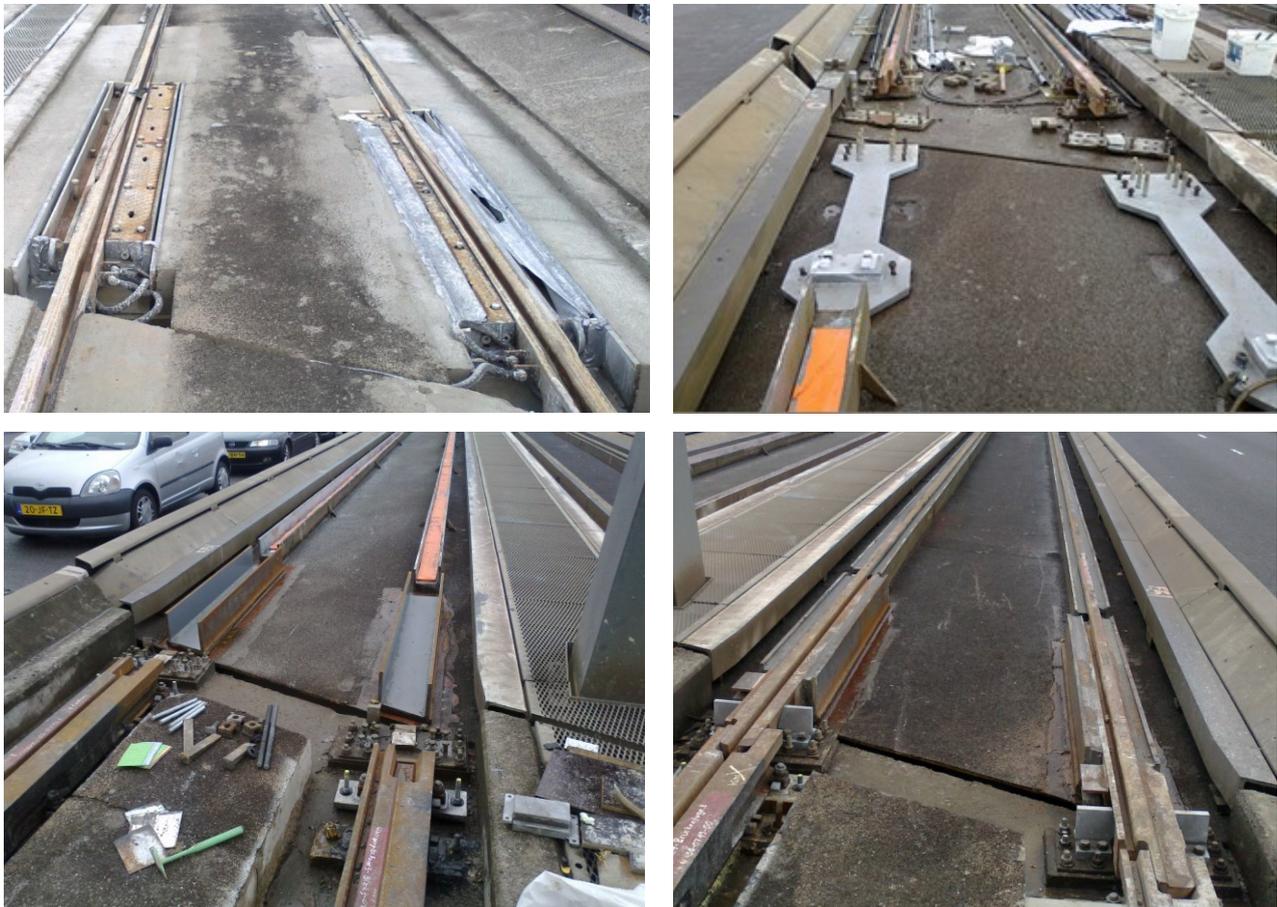
Figure XI: Noise control measures during track renovation. Top left: Diagonal rail joint based in concrete; top right: added mass and stiffness at joint 4; Below : added stiffeners at joint 4, left without rails, right with rails and cork rubber embedding and seatings for bascule bridge rails.

- Renewal of worn rails and rail support and fastener systems (foreseen in any case);
  - Shifting of rail joints towards a solid base (joint 5);
  - Applying diagonal joints on added mass, for joints 1, 2 and 5;
  - Stiffening and mass addition to deck parts on the bascule bridge deck near rail joints 3 and 4 together with added continuous elastic support.
- These modifications are illustrated in Figures XI and XII.

The stiffener configurations were analysed using calculation models to obtain optimal design in terms of size, weight and noise reduction. The input mobility, which determines the injected vibration energy, and thereby the structure-borne noise, was calculated for different stiffener configurations using fundamental mobility formulas from [2]. The bascule bridge deck has a complex inhomogeneous stiffener structure and is relatively thin near the edge of the bridge.

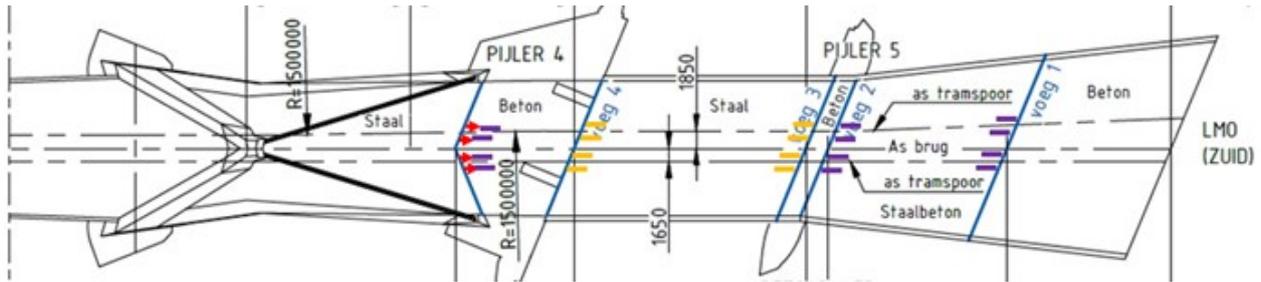
Figure XII: Top view of bridge section with modifications indicated: → = shifted joint, \ = deck stiffening and cork rubber support, \ = diagonal rail joint with cork rubber support and concrete base.
