## THERMAL AND MECHANICAL DAMAGE OF PBX'S

Gert Scholtes, Richard Bouma, Frans Peter Weterings, Albert van der Steen  
TNO Prins Maurits Laboratory  
P.O. Box 45, 2280 AA Rijswijk  
The Netherlands  
Scholtes@pml.tno.nl

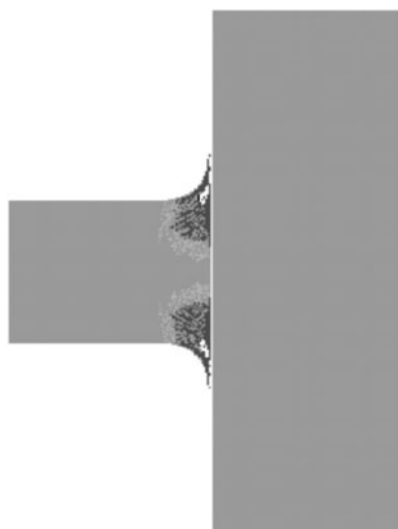
**FIGURE 5b.** Numerical simulation of HU-43 impacting steel at a velocity of  $150 \text{ ms}^{-1}$ .

Figure 5b displays an example of the numerical simulation at an impact velocity of  $150 \text{ ms}^{-1}$ , at the moment of the occurrence of the central core. Various simulations have been performed to match the result of the simulation with the remaining rear part of the cylindrical samples in the impact experiment as displayed in figure 4. The results look very promising but until now a perfect match has not yet been obtained. Future simulations will be focussed on the simulation of tensile strength tests of these materials.

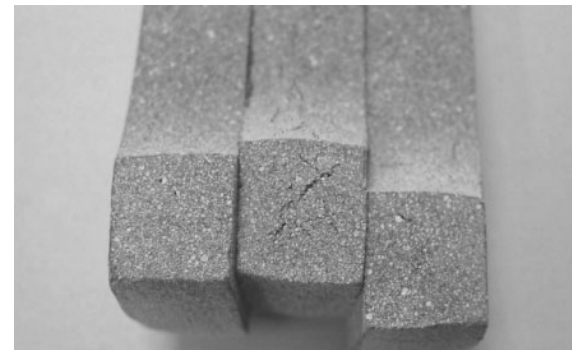
**FIGURE 12a.** Thermally damaged samples of temperatures of respectively 165, 170 and 175°C (for 5 hours) compared to pristine material.

**FIGURE 12b.** Magnification of one of the samples showing cracks after thermal heating.

test [9] of a sample heated at 170°C indicates that the material is quite sensitive (144N and 4 Nm respectively, in comparison with >360N and 20 Nm for pristine material and 324N and 10 Nm for damaged material, for 5 hours at 160°C). In figure 12a, the sample are displayed and compared to the pristine material. It is clear that an oxidation process has been taken place, shown by the darkening of the samples. Compared to the pristine material the samples that were held at 165°C, for 5 hours, showed a sample mass loss of 0–0.05 g, at 170°C a 0.1 g and at 175°C 0.25 g mass loss. Also the form of the cylinders changed due to the heating. The GDM samples also became longer compared to the pristine material. In the magnification of the sample at 175°C (figure 12b), cracks are shown indicating a high level of damage has occurred already during heating. This type of damage will probably have a major influence on the sensitivity of the explosive, which will be revealed by the experiments performed in the next test series.
