Use and conservation of Rhenish tuff

Weathering of tuffstone vs. replacement Background and choices

Timo G. Nijland¹ & Rob P.J. van Hees^{1,2}

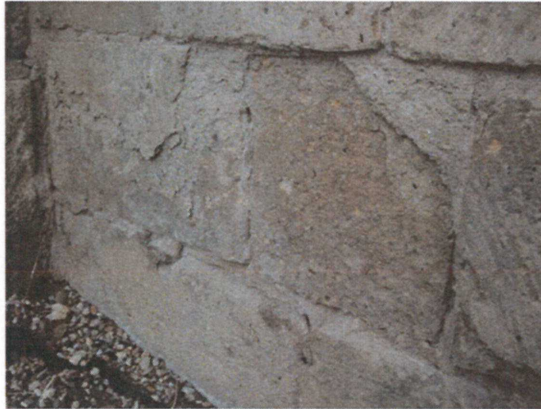
Fig. 2. Exfoliation of Weibern tuff directly above the ground level on the Grote Kerk, Oosterbeek (picture R.P.J. van Hees, 2002).

In Dutch climate, tuffstone may show different types of damage, such as efflorescence, exfoliation (Fig. 2), spalling (Fig. 3), scaling, powdering and cracking. Besides the frequent occurrence of hair cracks, cracking in particular occurs in panels and ornaments with a relatively high length / width ratio. Cracking of panels seems to be a kind of damage mostly associated with Ettringen tuff (Fig. 4), though this may be an artefact of the way different tuffs are used in architecture. Cracking in ornaments with a relatively high length / width ration, such as mullions, occurs in both Ettringen as Weibern tuff (Fig. 5).

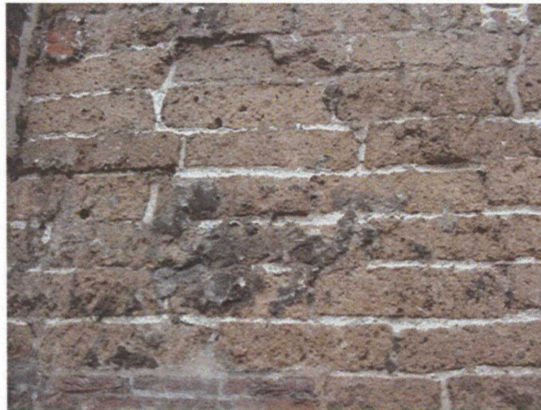
Fig. 3. Spalling of 11th century Römer tuff on St. John's church, Utrecht (picture S. Brendle, 2002).

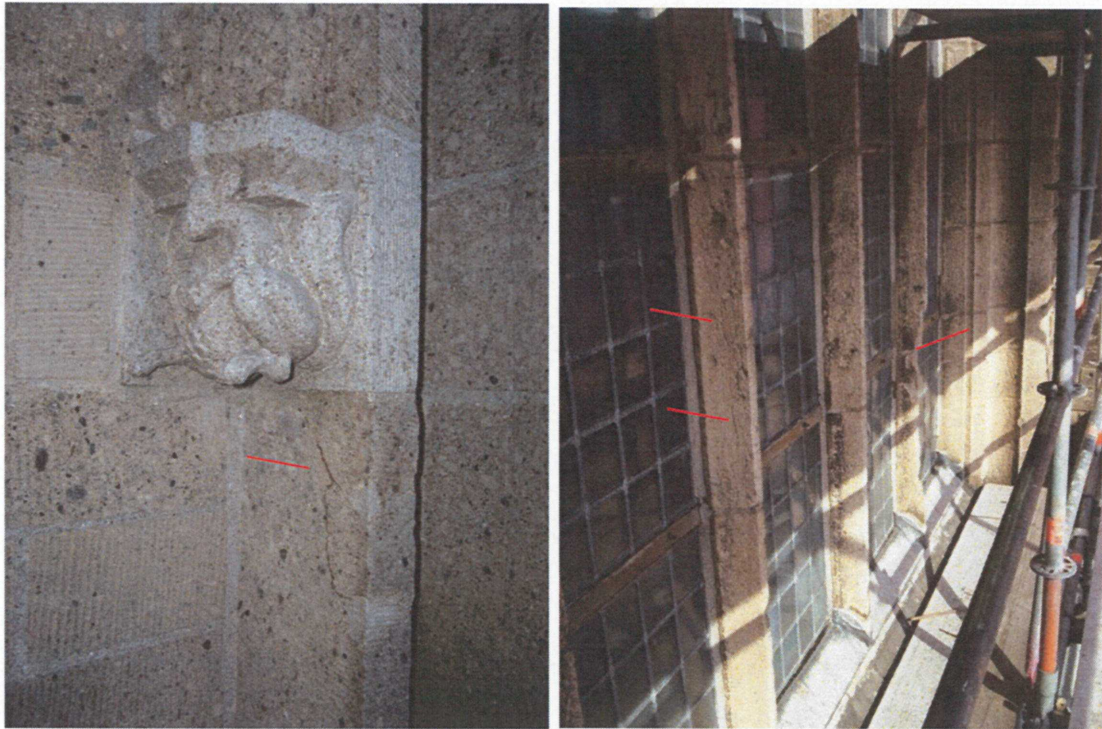
Fig. 5. Cracking in Ettringen (left) and Weibern (right) mullions at Eusebius' church, Arnhem and St. Peter's church, Leiden, respectively (pictures T.G. 2009 & 2005).

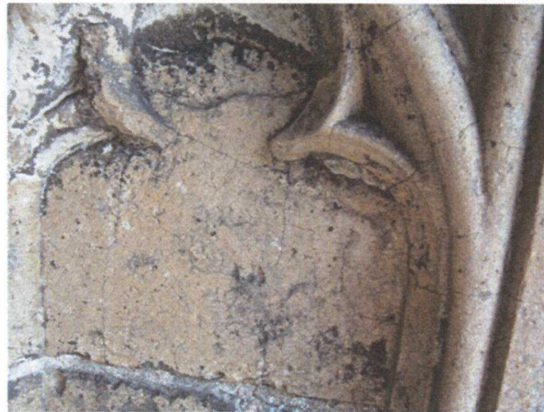
Fig. 6 Example of the formation of a hard, dark crust with craquelé on Weibern tuff at a pinnacle of St. John's cathedral, 's-Hertogenbosch (picture T.G. Nijland, 2006).

Besides this cracking, that is evidently undesirable, occasionally another phenomenon occurs: an elaborate network of craquelé cracks develops in a relatively hard outer layer on the tuffstone, that seems to protect it from further weathering (Figs. 6-8); this seems to occur in particular on Weibern tuff.

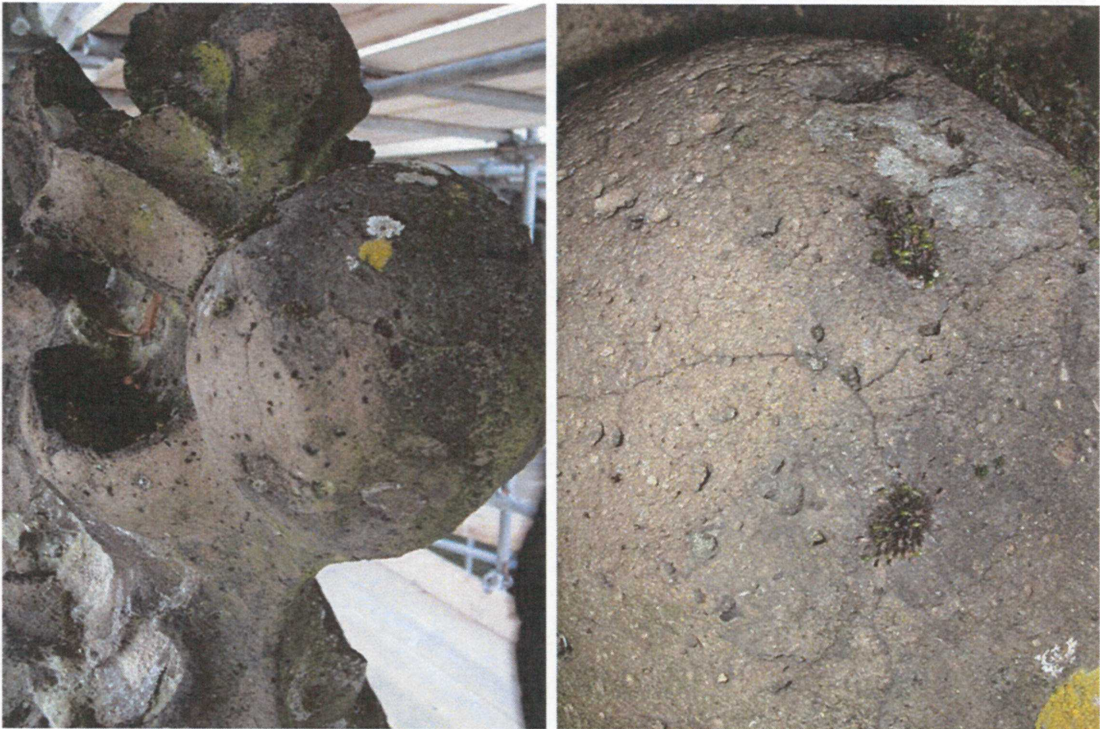
Fig. 7. Example of the formation of a hard, dark crust with craquelé on Weibern tuff ornaments on the rampant arches of St. John's cathedral, 's-Hertogenbosch (pictures R.P.J. van Hees, 2003).

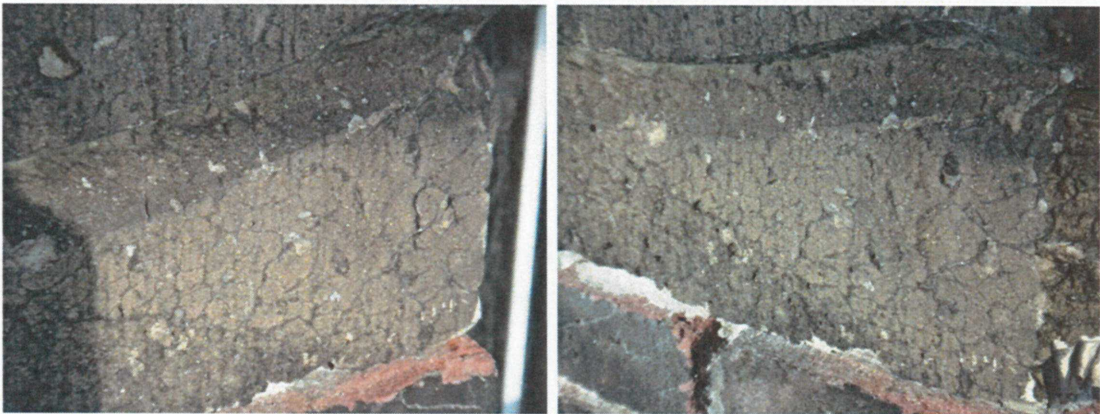
Fig. 8. Example of the formation of a hard, dark crust with craquelé on Ettringen tuff at the uppermost part of the tower of the Faculty of Architecture, TU Delft (pictures T.G. Nijland, 2014).

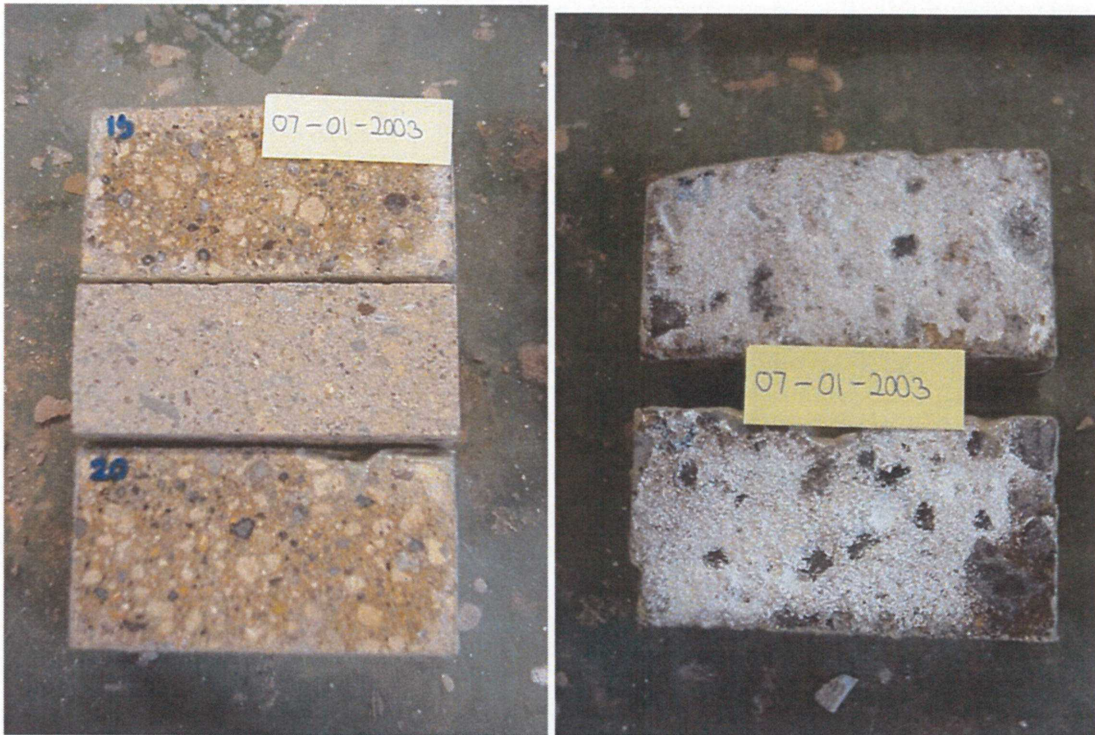
Fig. 9. Ettringen (left) and Römer (right) tuff in an accelerated salt crystallization test with Na_2SO_4 after 4 weeks (from Brendle, 2003).

Salt crystallization – In particular Weibern and Römer tuff appear to be susceptible for weathering due to dissolution and recrystallization of soluble salts, both in the laboratory as in practice. In the laboratory, Römer tuff shows damage with both NaCl as Na_2SO_4 (Fig. 9, 10). Damage due to these salts is also shown in practice (Fig. 11). In contrast, Ettringen tuff does not even show efflorescence in the same laboratory tests nor any damage (Fig. 9, 10). This results should, however, be treated with some precautions. It is not likely that in this case, salts accumulate behind the surface (cryptoflorescence), and will cause damage on the long term. Field observations do, however, not suggest that this is the case.

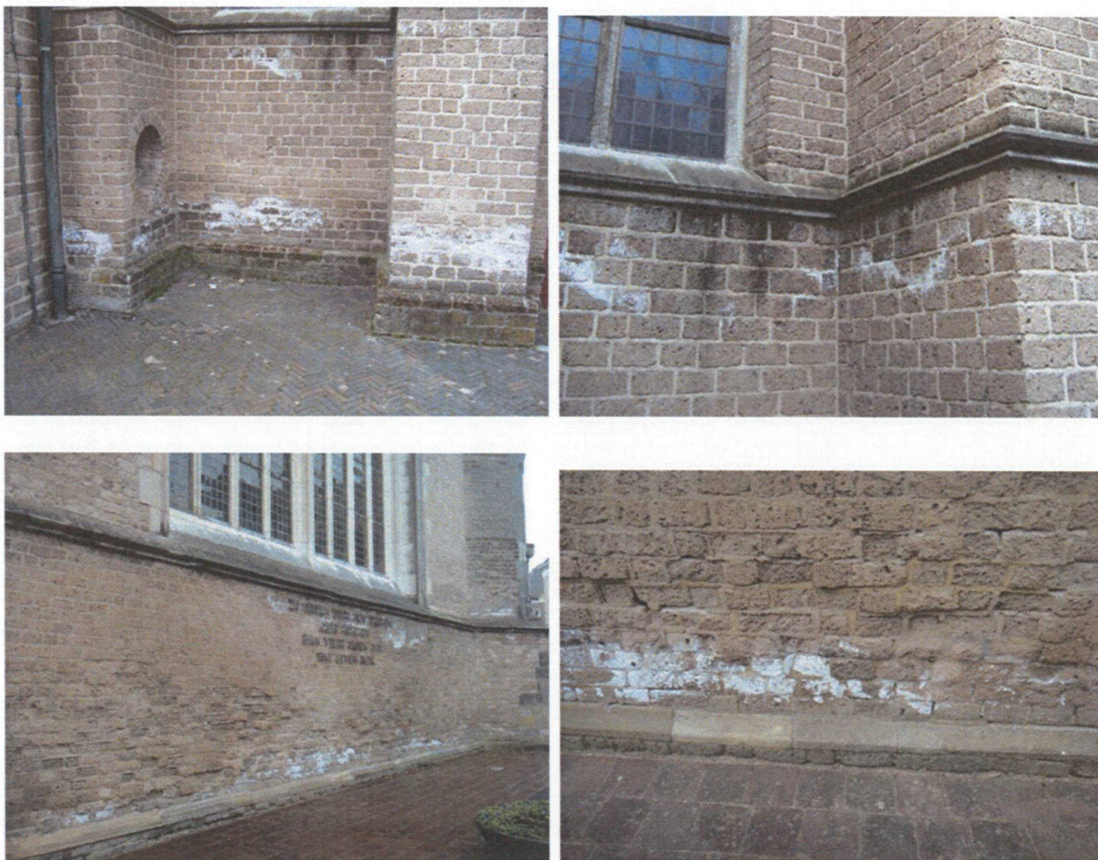
Fig. 11. Salt damage on Römer tuff due to Na_2SO_4 on St. Peter's church, Utrecht (pictures T.G. Nijland, 2010) and St. Lebuïns church, Deventer (pictures T.G. Nijland, 2013).

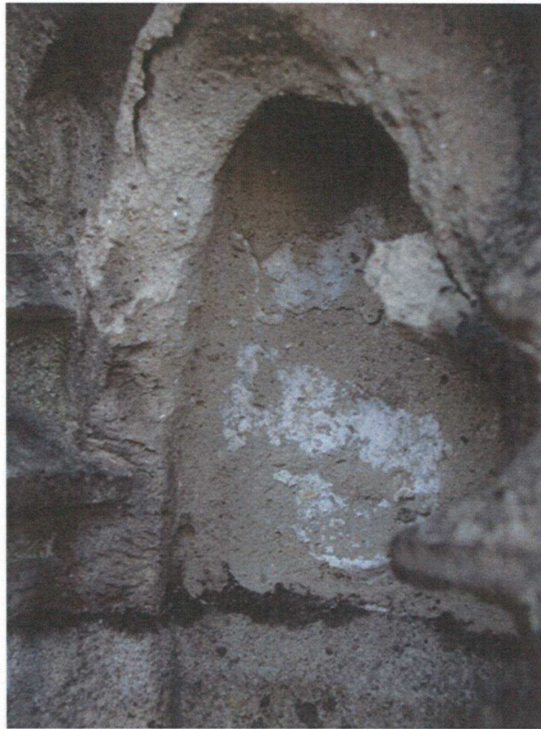
Fig. 12. Salt damage on Weibern tuff due to Na_2SO_4 on a pinnacle on St. John's cathedral 's-Hertogenbosch (picture R.P.J. van Hees, 2002).

Weibern tuff has so far only been tested in accelerated salt crystallization experiments using Na_2SO_4 . In these test, clear damage occurs in the form of spalling and powdering (Nijland & Van Hees 2003). Also in practice, this type of tuffstone shows damage due to salt weathering (Fig. 12, 13).

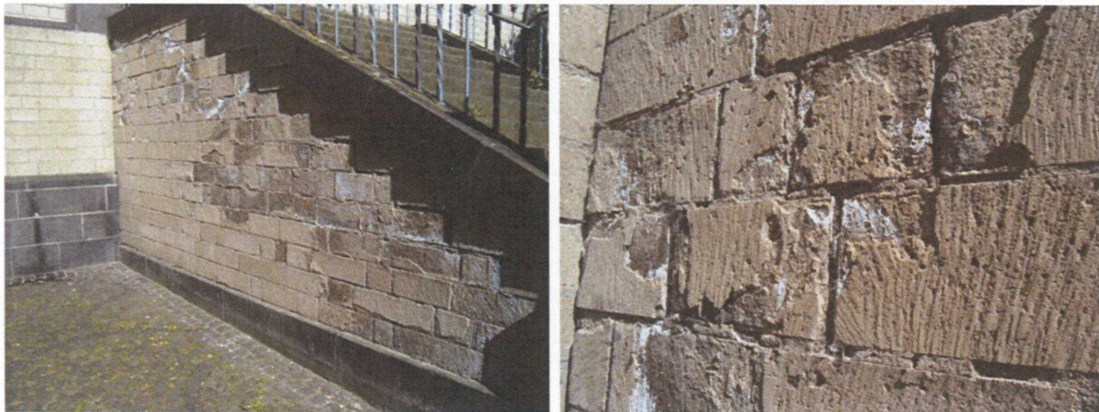
Fig. 13. Salt damage of Weibern tuff, St. Maria im Kapitol, Cologne (pictures T.G. Nijland, 2009).

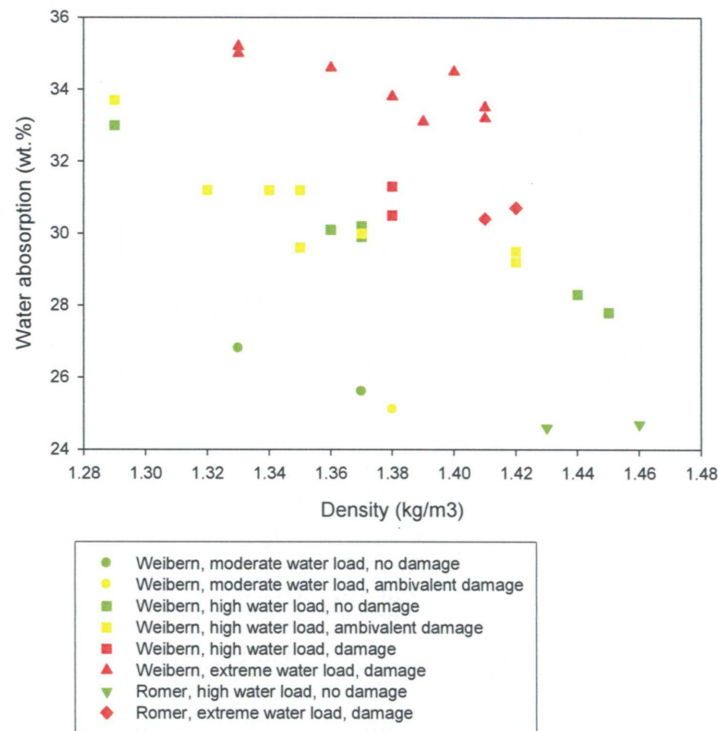
Fig. 14. Compilation of TNO's results with respect of freeze-thaw resistance of tuffstone according to NEN 2872:1989.

Freeze-thaw – The occurrence of damage to natural stone due to freeze-thaw cycles depends on several factors, including the number of cycles, the amount of moisture in a stone, the possibilities of a stone to dry, and porosity, pore size distribution and water retention of a stone. TNO has performed several freeze-thaw tests on both Weibern and Römer tuffstone over the years, using the so-called *zandkistvriesproef* according to Dutch standard NEN 2872:1989. Figure 14 shows a compilation of the results of these tests in which also water absorption and density of the stone have been determined. From figure 14, it appears that a relationship exists between the ratio of water absorption versus density and the occurrence of frost damage

Test specimens have been preconditioned at moderate, high and extreme moisture loads according to the standard. At extreme moisture load, both Weibern and Römer tuffstone show typical frost damage (Fig. 15). As far as Römer tuffstone is concerned, damage occurs in the variety with abundant xenoliths, as used in restorations over the last decades. Tests on classical Römer tuff show that, even when preconditioned at extreme moisture load, this tuff can be frost resistant (Nijland & Van Hees 2003).

At high moisture load, Römer tuffstone does not show any damage. Weibern tuff shows sometimes no damage, sometimes ambiguous damage; ambiguous in the sense that evidently, the damage does not follow the typical pattern of frost damage, but, for example, after testing a very narrow vertical hair crack occurs. The same holds for Weibern tuff preconditioned at moderate moisture loads. Given experiences in practice, this ambiguous damage is not considered as frost damage. Weibern tuff in particular has, compared to Römer tuff, a relatively high number of small pores combined with a high porosity (Nijland et al. 2005b). It seems likely that the difference in frost resistance is related to these different pore characteristics.

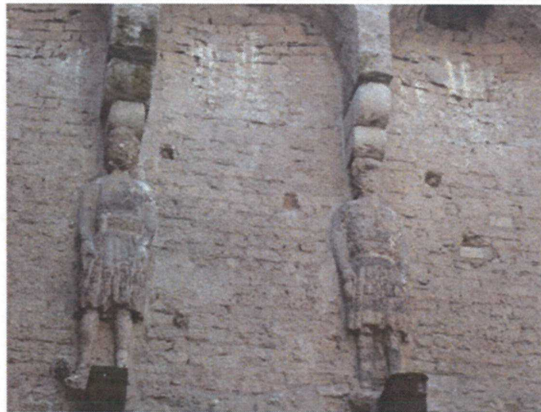
Fig. 17. Sculptures in Römer tuff dating back to about 1200 in the Kompfporte, Andernach (picture T.G. Nijland, 2009).

Answering these questions would considerably help to conserve tuffstone heritage, that sometimes proves to have a quite acceptable durability (Fig. 17, 18).

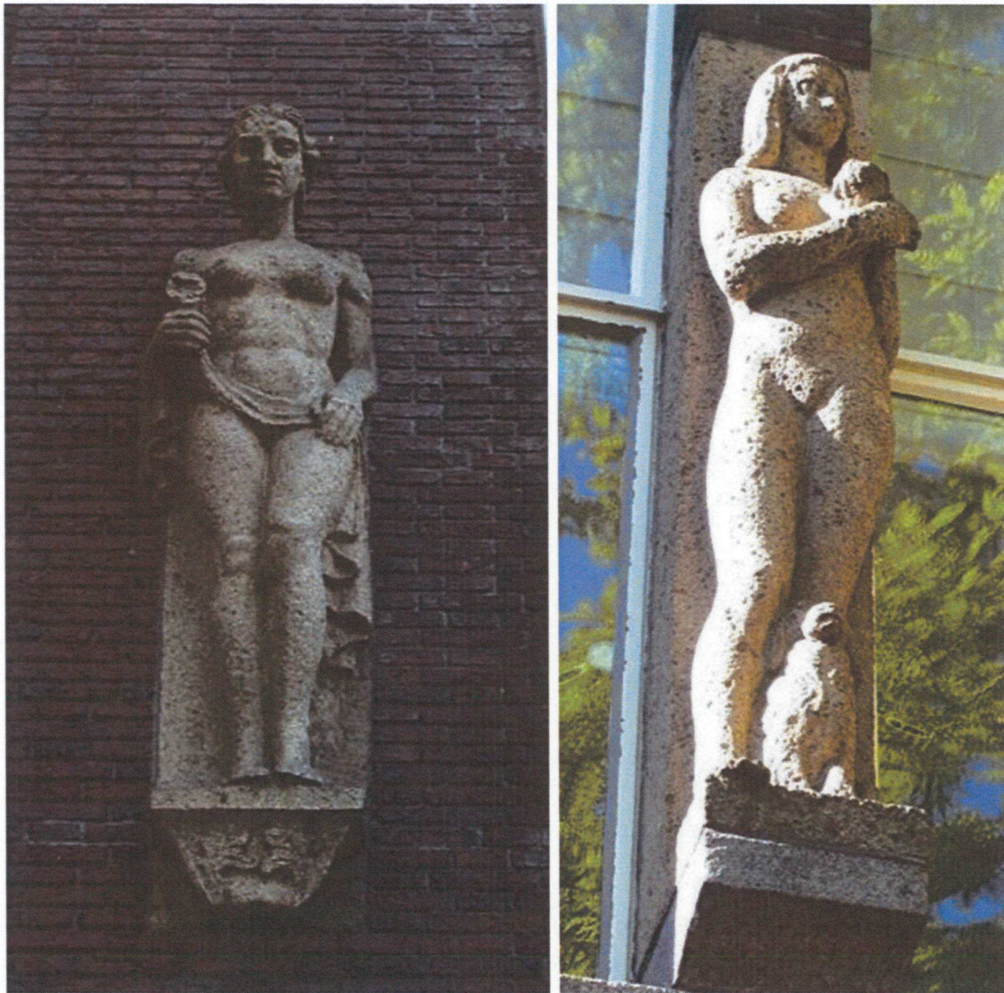
Fig. 18. Ettringen tuffstone sculptures at the façade of Schiedamse Vest 89, Rotterdam, renovated by architect J. Wils in 1942 (pictures T.G. Nijland, 2010).
