# Investigations into corrosion in SV Purmerend BWC system

M.K. Cieplik  
P.G.T. Heere  
J. Kuipers  
M.C. Carbo  
E.W. Schuring

May 2016  
ECN-L--16-047

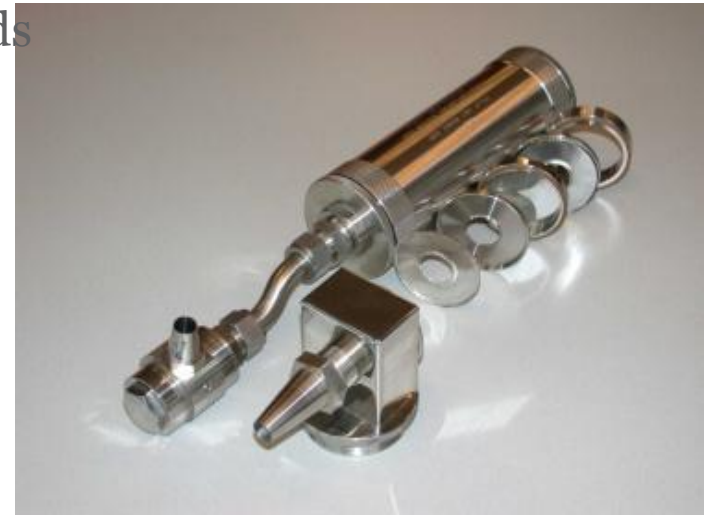
## *Cascade impactor*

University of Washington PILAT V impactor:

- 12 stages (pre-cutter/PDP, 10 jet stages)
- minimum cut-off:  $<0.2 \mu\text{m}$
- all stainless steel
- deposition substrates/filters:
  - non-greased stainless steel
  - backup filter: none to prevent water/acids

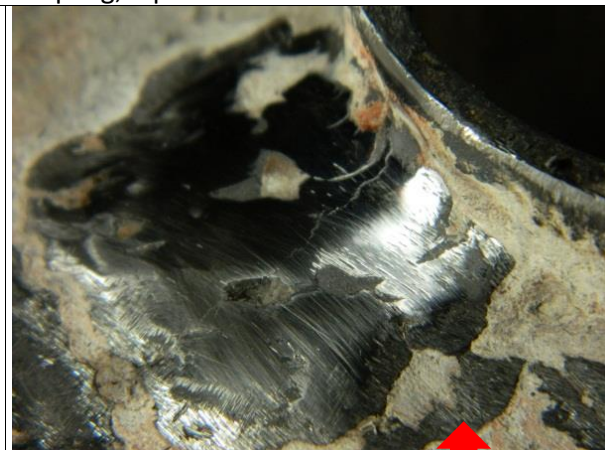
Pipe A12 and A13 (red arrows indicate crack)

- ECO inspection (K11)
  - Some, yet limited corrosion in 1<sup>st</sup> pass, while 2<sup>nd</sup>/3<sup>rd</sup> pass basically intact, except for ruptured welds and ripped off/spalling off oxide layers due to mechanical removal of the ash deposits

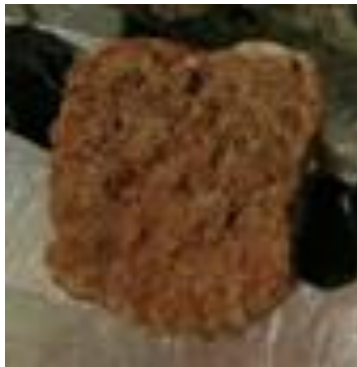
*deposits top part ECO: red, loose stuff from 1<sup>st</sup> pass tube*

- Please note the Fe and Cl enrichment!
- So this is likely the fine material stripped off the wall and ending up in the fine fraction?!
