## 386. Energy efficient renovation of dwellings: lessons learned

### **Abstract**

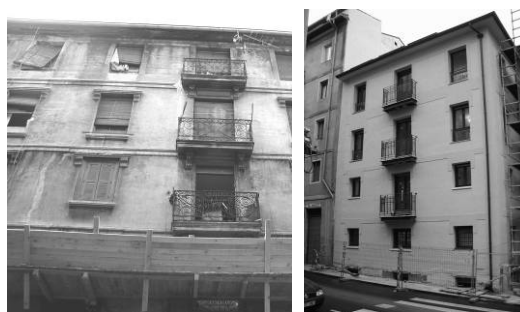
*Fig 1. The Spanish Demonstration building, before (left) and after renovation (right).*

The Spanish building is located in the old historical centre of Bilbao. A four storey building with brick walls and tiled roof, it was built in 1910 and partly renovated in 1960. Pictures of the building before and after renovation are shown in Fig. 1.

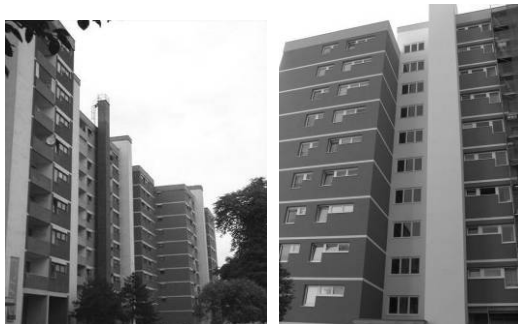
Fig 2. The Austrian Demonstration building, before (left) and after renovation (right).

The Austrian building consists of two adjacent blocks of flats in Graz. They were built in 1975-76 as social housing and that is still their function today. The flats are heated through district heating. Pictures of the building before and after renovation are shown in Fig. 2.

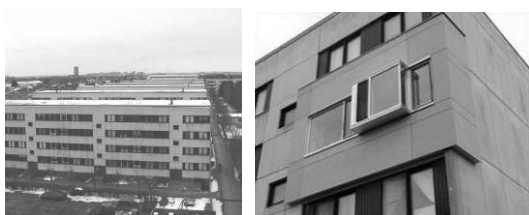
Fig 3. The Danish demonstration building, before renovation (left). On the right a single test apartment with external insulation.

The Danish project consists of 3 out of 12 blocks of apartments in the Gyldenrisparken area in Copenhagen. They were constructed between 1965 and 1969 from prefab concrete elements. The buildings are connected to a district heating system. Pictures of the building before renovation and during renovation are shown in Fig. 3.

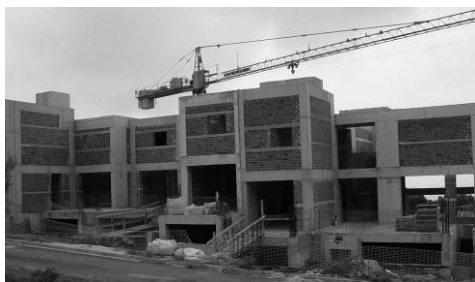
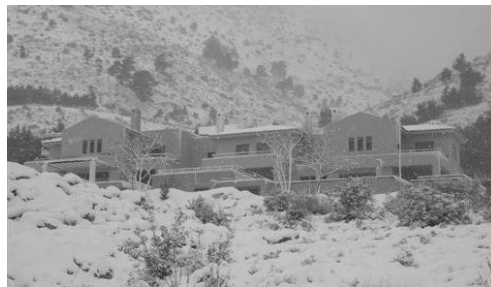
Fig 4. The Greek Demonstration building, during construction and after completion. The picture above shows that weather conditions can be severe and good thermal insulation will pay off.

The Greek project is located on the outskirts of Athens, consisting of 4 buildings, each containing 2 dwellings. Being the only new built project, construction started in 2005 and was scheduled to end by mid 2008. The buildings are of concrete frame structure, with brick walls. Pictures of the building during and after construction are shown in Fig. 4.

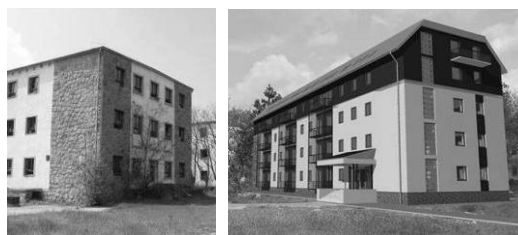
Fig 5. The Hungarian Demonstration building before renovation (left) and artist impression of post-renovation state, showing the rooftop apartments (right).

Finally, the Hungarian project is a former military complex in Budapest. Three out of a total of eleven 3-storey building blocks of bricks/concrete construction were to be renovated. Unfortunately, the project had to be withdrawn by the end of 2007 before renovation started. Pictures of the building before renovation and artist impression of the post renovation state, including rooftop apartments are shown in Fig. 5.

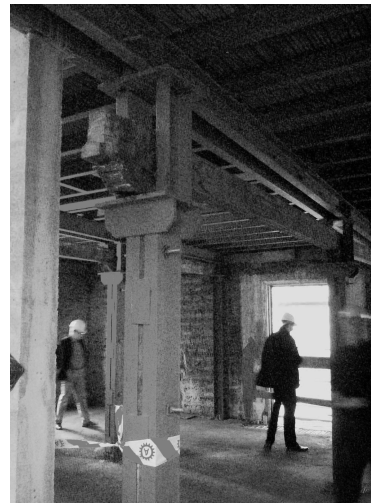
*Fig 6. Structural reinforcements were necessary in the Spanish project.*

Different setbacks were experienced between projects. In the Spanish project it was the bad condition of the building, aggravated by the lack of information about the building in general and the building foundations in particular. The extensive and expensive structural

reinforcements that were necessary, resulted in a substantial increase in renovation cost (see Table 2. Fig. 6 shows the added steel structure supporting the old parts of the building.

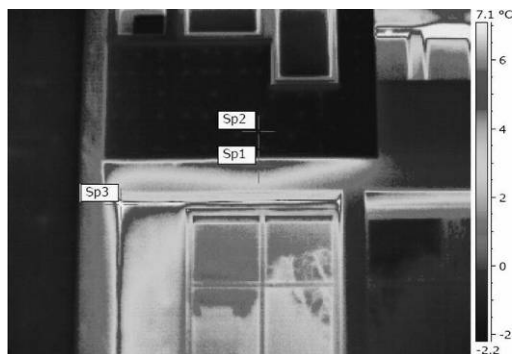
Fig 7. High temperatures on the outside of the entrance ceiling revealing missing thermal insulation, detected with IR-photography in the Austrian project

In the Austrian project, IR (Infrared) photography revealed missing parts of insulation of the building envelope, as shown in Fig. 7, which were used to persuade the contractor to repair the construction fault. In the Danish project, repeated blower door tests in the course of the renovation proved very useful to correct failures in achieving the air-tightness required.

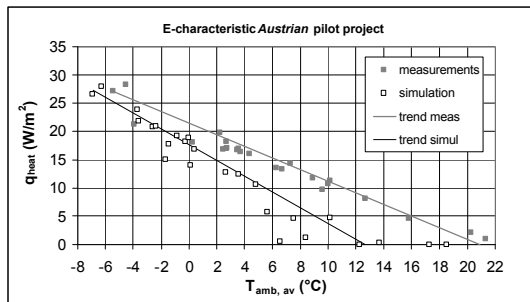
Fig 8. Energy signature comparing the measured (grey symbols and line) and simulated (black symbols and line) energy consumption in the Austrian project

Since the main heat losses of a building are proportional to the difference between indoor and outdoor temperature, periods with lower ambient temperature will show higher heating demands for space heating. When the data points are plotted in a graph, the slope of the line through the data points is a measure of the heat losses of the building, as shown in Figure 8.

In Fig. 8 the weekly energy consumption (expressed in  $W/m^2$ ) is plotted versus the average ambient temperature, thus producing the 'energy signature'. Since the Austrian housing project has relatively small windows, as can be seen in Fig. 2 (approx 17% of the façade), few problems are expected from the disturbing effect of solar radiation mentioned previously.

A number of things are apparent from Fig 8. First, the slope of the grey trend line differs from the black by about 25%, a value which is rather good for a first result. In fact, the slope of the black simulations trend line is higher than that of the measurements, implying higher heat losses per degree of temperature difference between indoor and outdoor. The most plausible cause is an overestimation of the ventilation rate in the model. It is questionable whether the tenants open their windows enough in wintertime to achieve sufficient ventilation rates because open windows will cause cold draughts. Measurement of the ventilation rate which could shed light on this issue is not foreseen in the Austrian project.

A second observation from Fig 8 is that the grey measured data points are higher than the simulation data points. Possible causes are: 1) an overestimation in the model of the internal heat gains from electrical appliances, people etc. Overestimating the internal heat gains means that the heating system needs to deliver less heat in order to keep the building heated. However, the internal heat gains in the model were set to 4 W/m<sup>2</sup>, following the Austrian ÖNORM EN 832, which is a rather conservative value. Alternatively, 2) the indoor temperature in practice may be higher than the value assumed in the model (20°C). As a high rate of tenants are immigrants from southern or tropical climates, it is very well possible that they set the heating to a higher temperature than 20°C. Fig. 8 shows that a parallel shift of the simulation data points to the right by approx. 4°C would roughly make both sets of data points coincide. That means that an indoor temperature of 24°C in stead of 20°C could account for the difference between measurement and simulation. Measurement of the indoor temperature in a number of apartments is foreseen in the remainder of the project, but these data were not available at the time of submission of the paper. In addition, a survey will be carried out among the tenants, but likewise these results are not yet available.
