› **INDOOR CLIMATE LABEL**
B4B WEBINAR | PIET JACOBS & DAVID KEYSON

› INDOOR CLIMATE LABEL

PILOT SURVEY & INSPECTION IN FME BUILDING

› PILOT CONTINUOUS MONITORING PROVINCIAL HOUSE SH

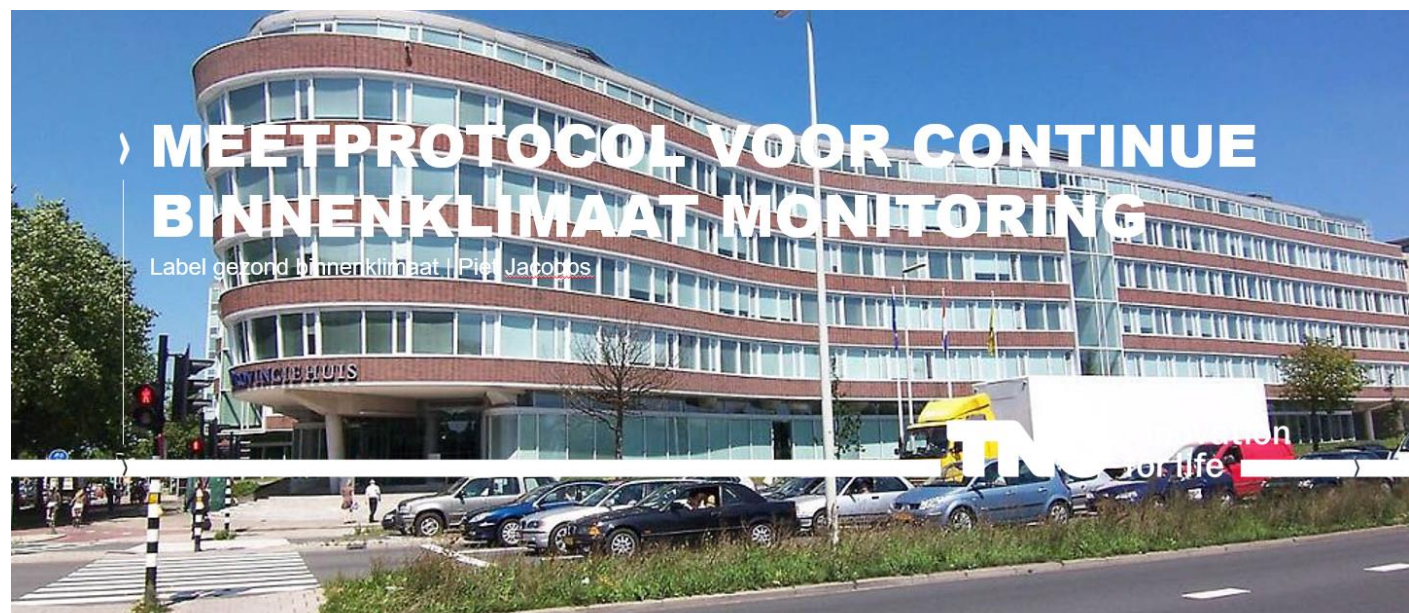
PROVINCIEHUIS ZUID-HOLLAND

37 measurement locations: April 2019 t/m half Februari 2020

- Temperature
- RH
- CO₂

Limited spread in label between rooms
 → 4 – 6 sensors would be sufficient

The cause for Temperature class C was
 switching on the heating too late

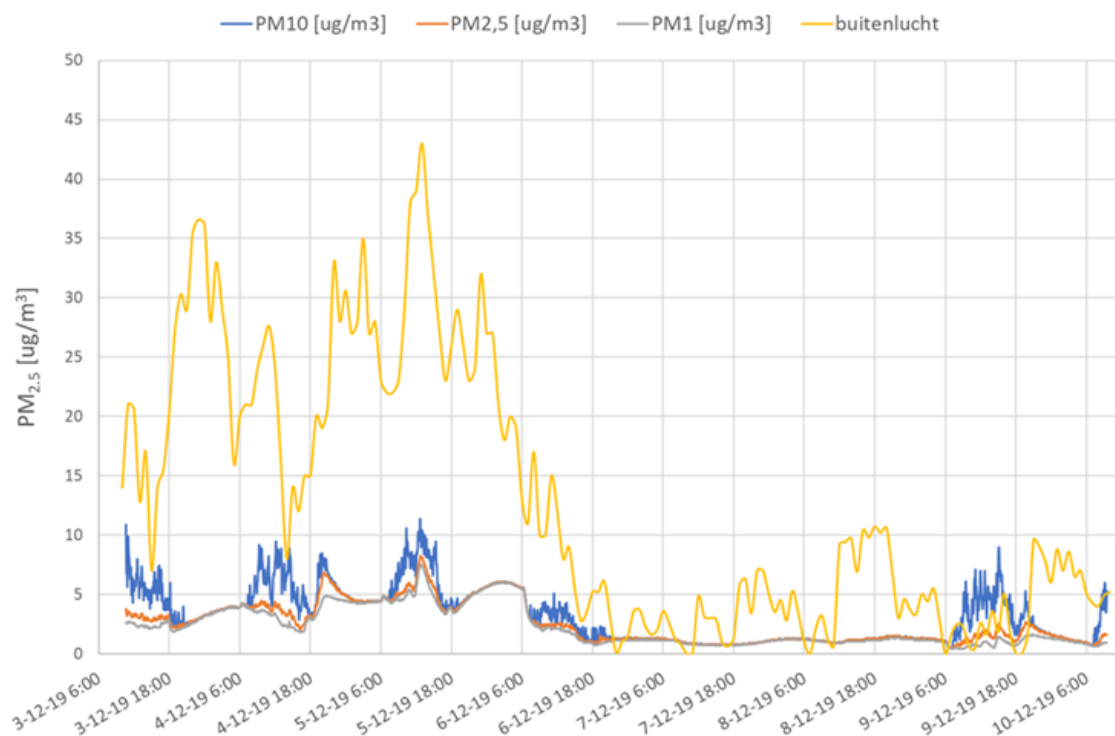
PM2.5 – FINE PARTICULATE ACCORDING TO VLA MEASUREMENT PROTOCOL

Class A: Indoor/Outdoor < 0.25

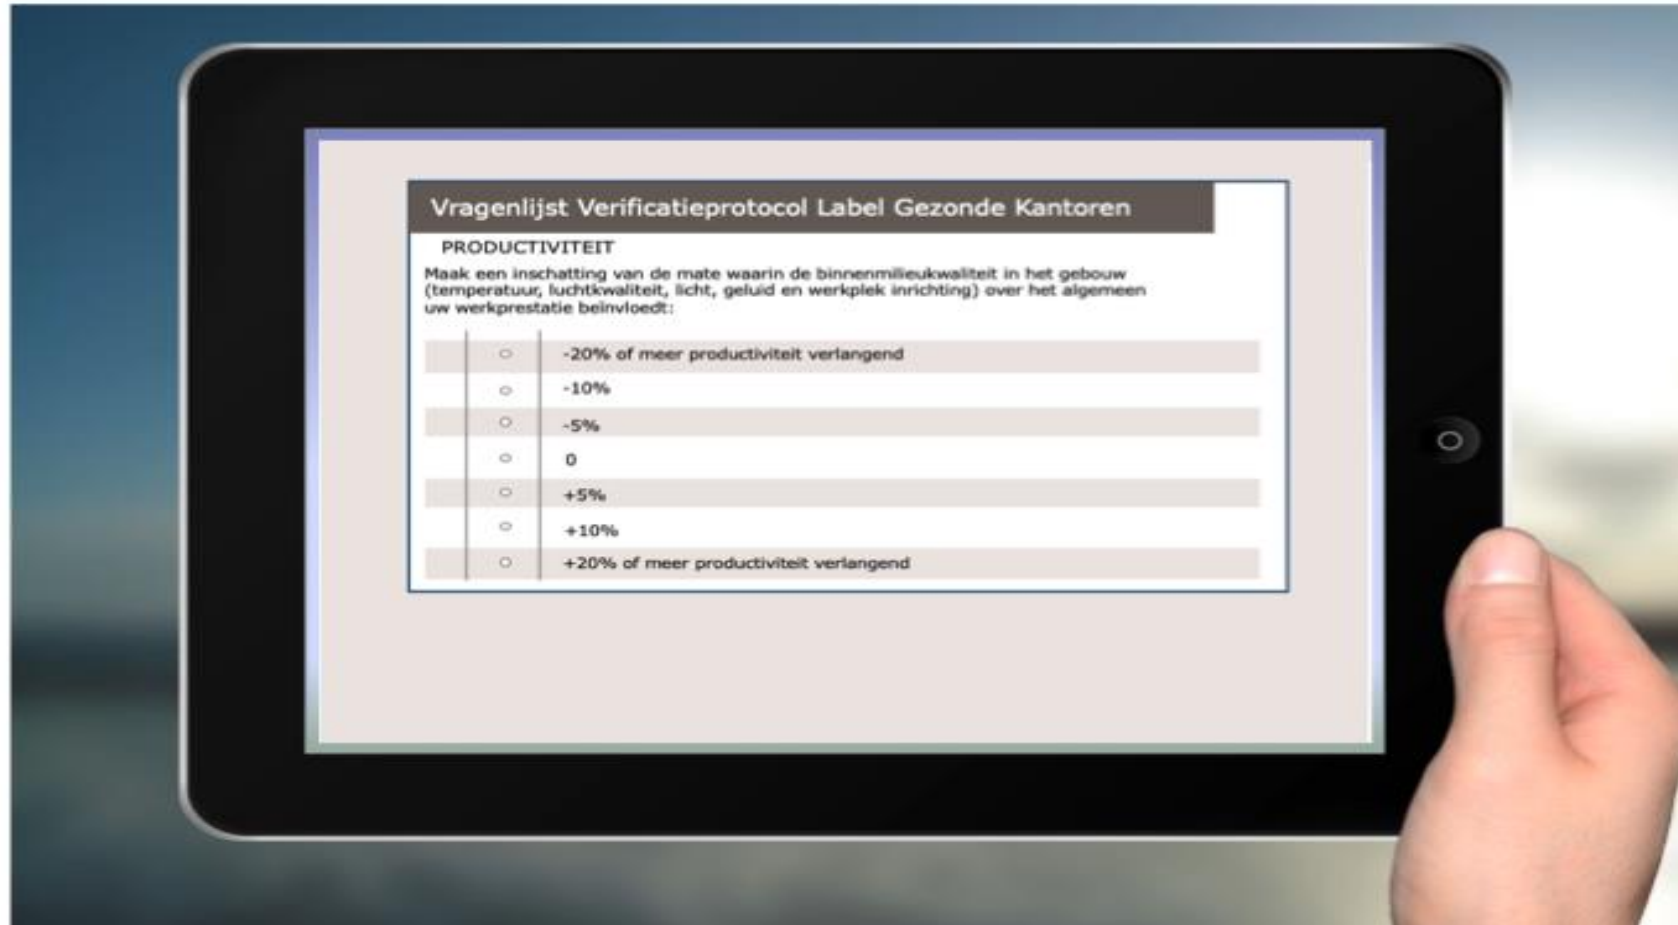
USER COMFORT SURVEY, SAMPLE SCREEN

Sample screen of user survey

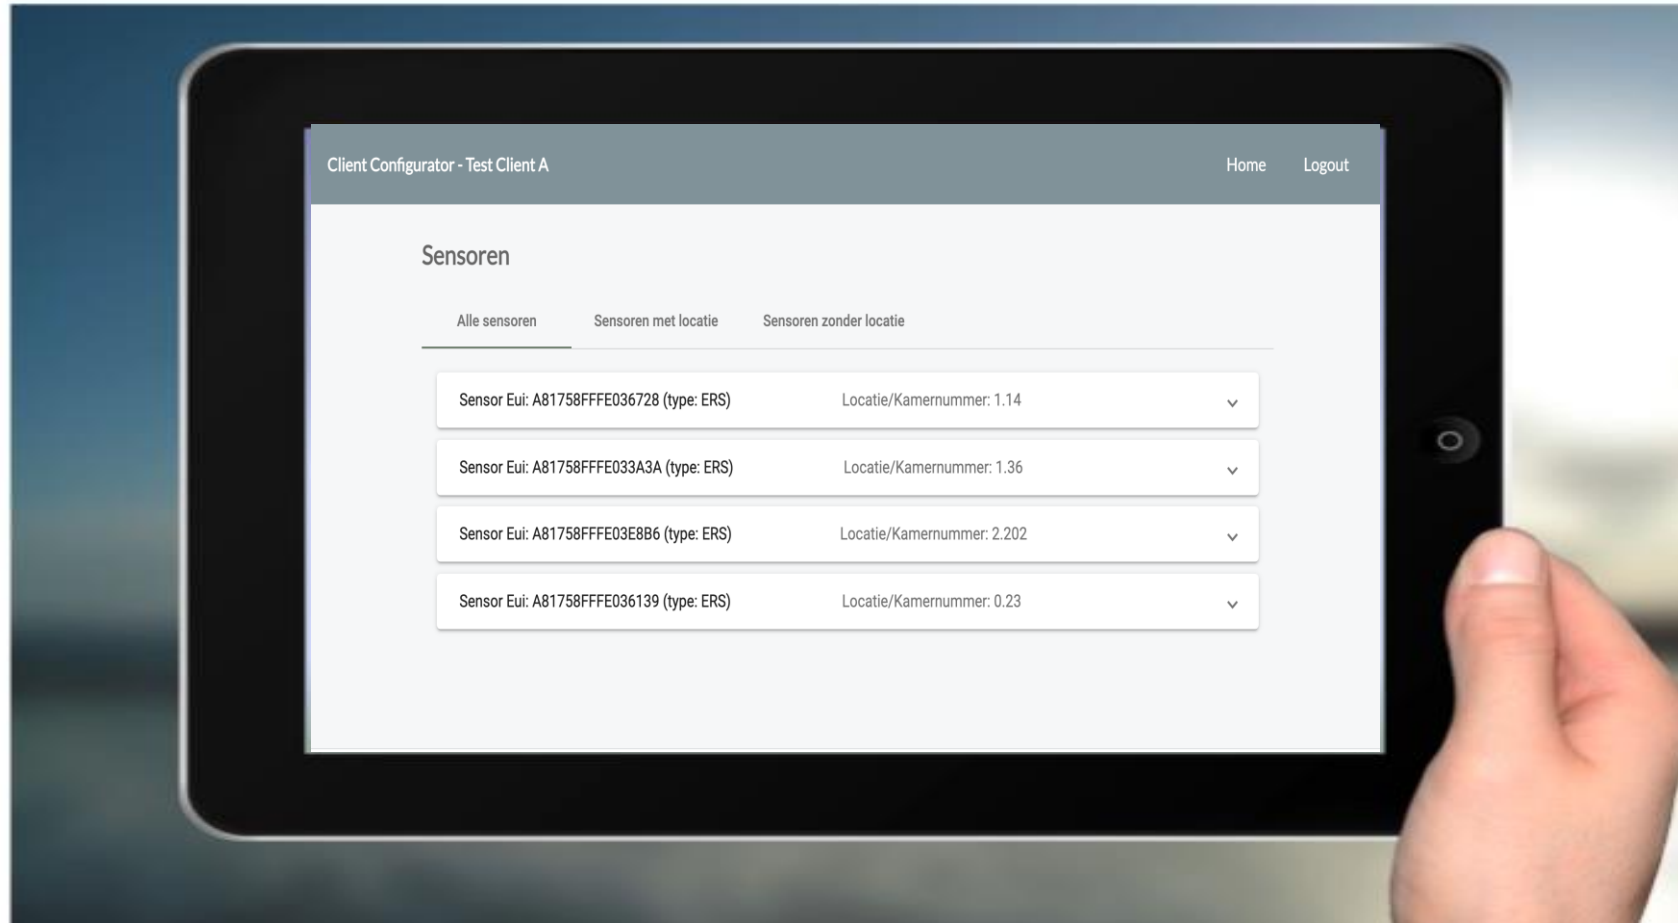
CLIENT CONFIGURATOR

Screen capture of sensor registration application

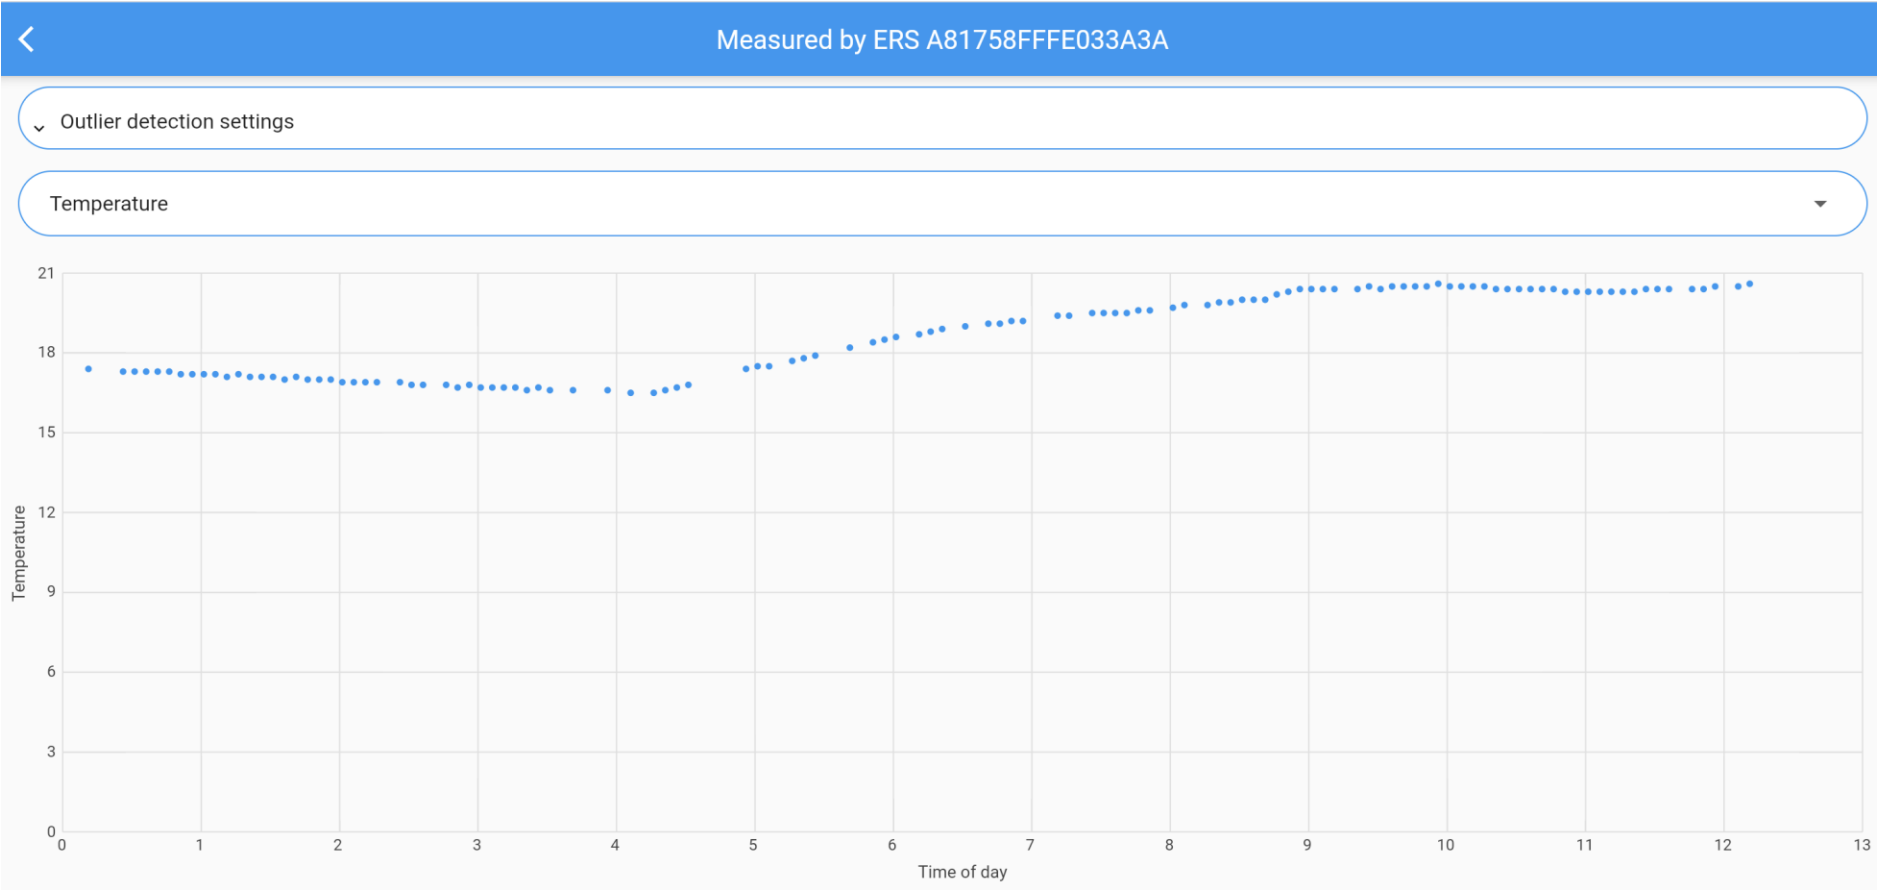
Real-time data display application to check sensor data stream
