Damage Categorization in Full-Scale, Full-Composite Ship Hull Under High-Energy Impacts by Unsupervised Learning–Enabled Acoustic Emission Monitoring and Laser Shearography Inspection

Pedro A. Ochôa[1] | H. J. den Ouden[1] | Michiel Hagenbeek[1] | Nan Tao[2] | Andrei G. Anisimov[2] | Roger M. Groves[2]

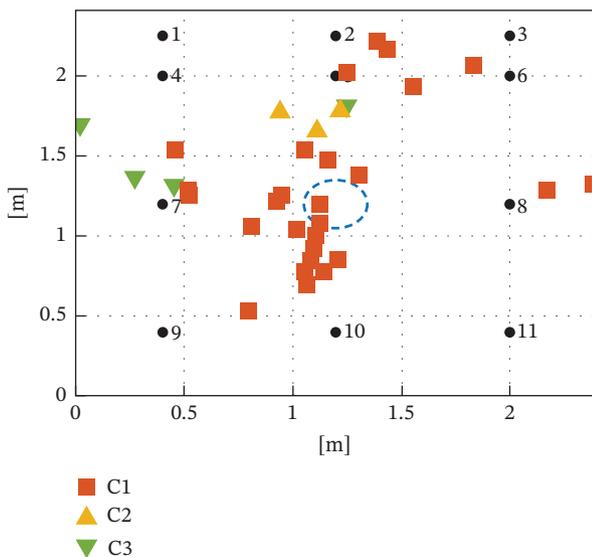
FIGURE 3 | Acoustic emission sensor positions and estimated locations of the damage events for all impacts. The approximate impact location is indicated by the blue dashed circle.

Core crushing/cracking (C1) occurrences formed most of the high event density region around the impact location, although some of them could also be located in the top and right sides of the hull wall. This was the predominant damage mechanism during all the impacts, as previously demonstrated in Figure 5(b). Some matrix cracking (C2) events were located relatively close to the majority of the core crushing events, just slightly above the center of the hull wall. Finally, some skin-core debonding (C3) events were found mostly along the left side of the hull wall.

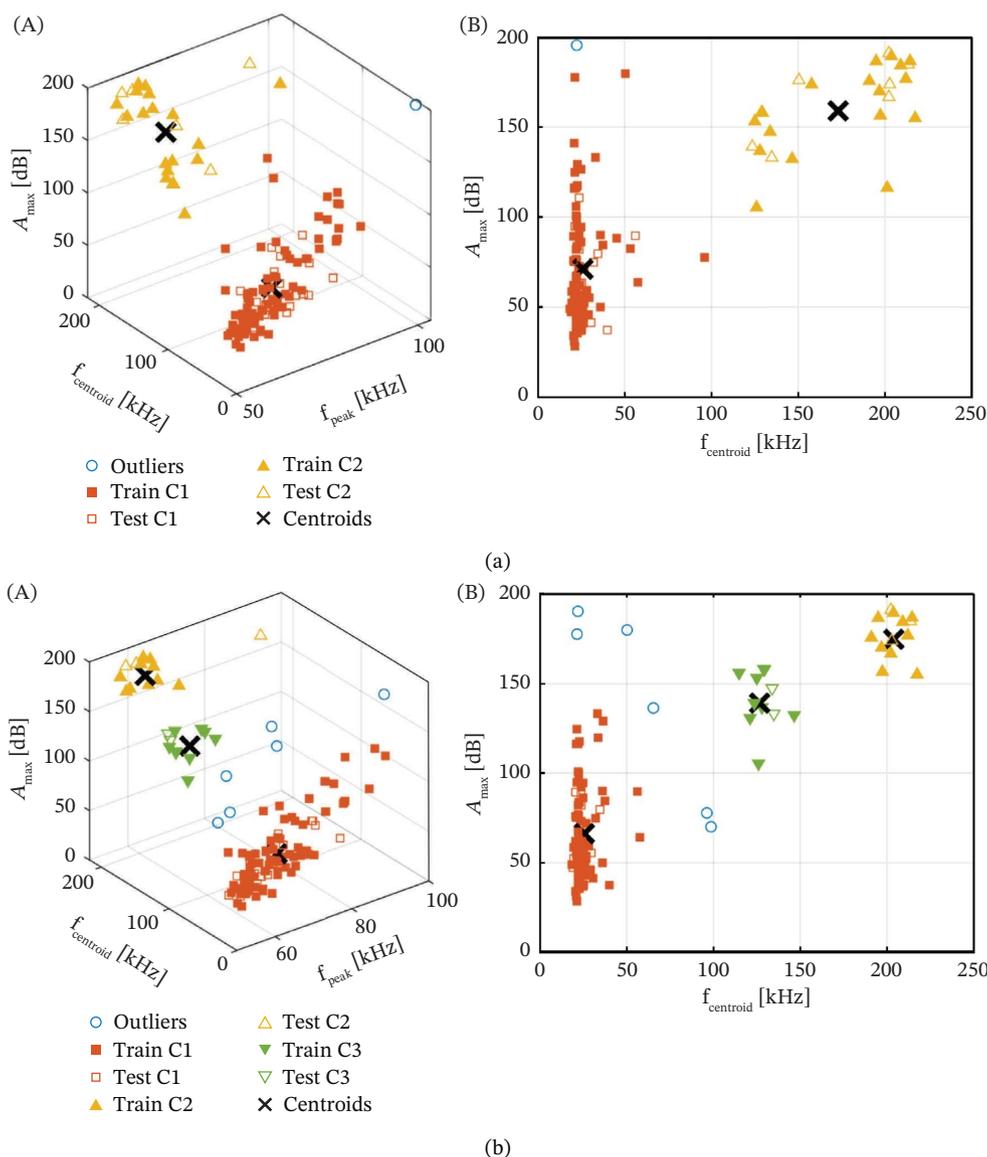
A common recommendation for relatively small datasets is to use 70% of the available data for training and 30% for validation or testing [40]. An example of a two-cluster solution obtained with this split and the three most relevant features is presented in Figure 5(a). If amplitude (A_{max}) and centroid frequency (f_{peak}) are considered, the separation between Cluster 1 (C1) and Cluster 2 (C2) is clear, apart from some fuzzy points in between the two clusters. Looking carefully at C2, it is possible to distinguish two regions within that cluster, one between 125 and 160 kHz, and another one between 190 and 220 kHz. By looking at a three-cluster solution obtained with the 70/30 data split and the three most relevant features plotted in Figure 5(b), one can immediately recognize the two previously identified subregions as now being Clusters 2 and 3. Hence, it is possible to conclude that because the separation between these two subregions is much smaller than the separation between them and C1, the random data point shuffling prior to clustering has a strong influence in the identification of these two regions as separate clusters.

These results point to the possibility that damage occurred predominantly in the form of core crushing/cracking during the impacts, which may have subsequently induced some skin-core debonding, along with some matrix cracking events. It is good to

FIGURE 5 | 3D ((a), A) and 2D (A, right) views of the two-cluster solution obtained with 70/30 data split and the three most relevant features. 3D ((b), B) and 2D (B, right) views of the three-cluster solution obtained with 70/30 data split and the three most relevant features. A few apparent data point discrepancies between (a) and (b) relate to how the entire clustering framework has been implemented*.

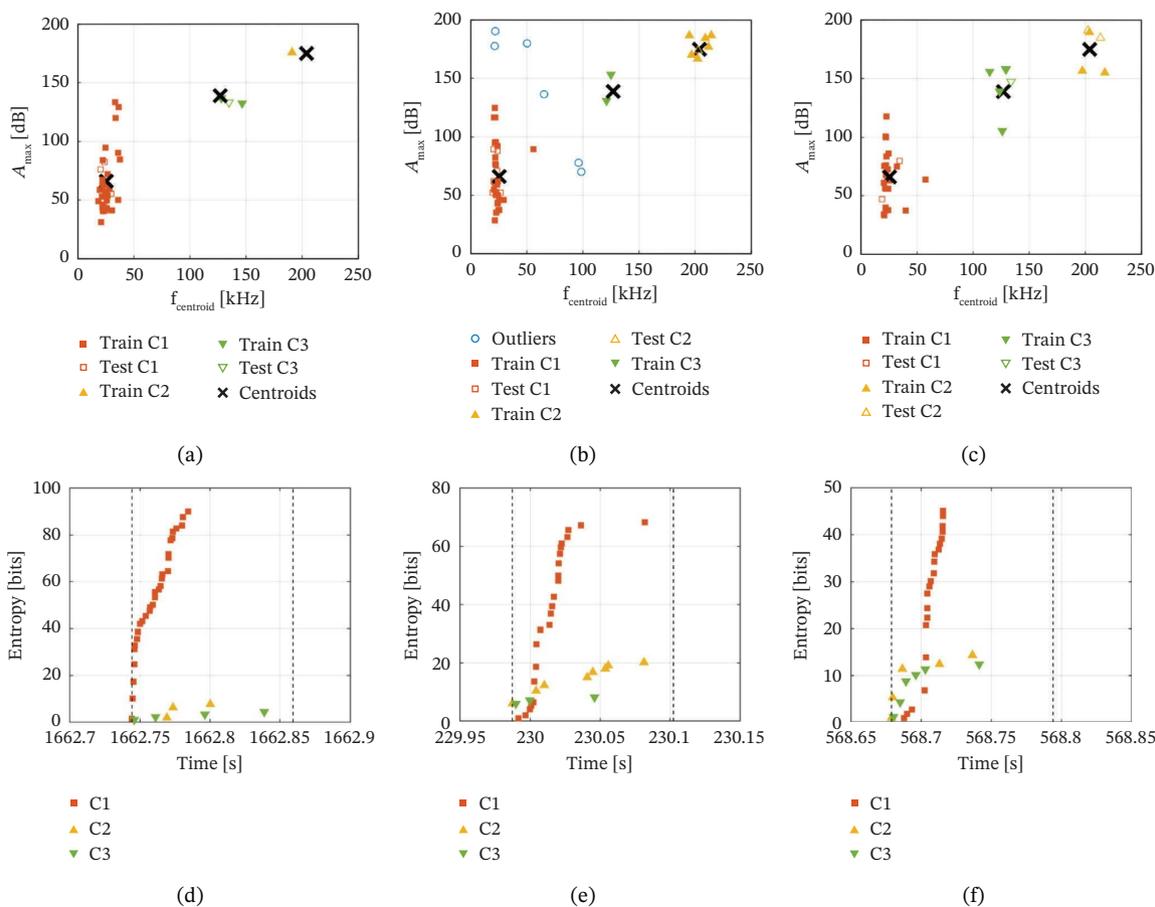
FIGURE 6 | (a–c) 2D views of the three-cluster solution obtained with 70/30 data split and three most relevant features, separately plotted for each impact. (d–f) Cumulative information entropy as a function of time for the training and testing datasets, for each impact. The time interval indicated by the vertical dashed lines corresponds to the duration of the impact.

For Impact 1, it is clearly visible that C1 points occur right from the start of the impact and at a high rate, while C2 and C3 occur at a very low rate and C2 points only start 0.025 s later. This sequence of occurrences is in accordance with the damage mechanics explained in Section 1 of the support material [24]. For relatively large core thicknesses and in out-of-plane loading scenarios, core crushing/cracking tends to have the lowest onset energy threshold. The significant reduction of core stiffness weakens the core-skin bond, thereby leading to skin-core debonding when the bond strength is exceeded by interface stresses. At the same time, high skin stresses caused by impactor contact and skin flexion are expected to induce skin matrix cracking. So, skin-core debonding (C3) and skin matrix cracking (C2) only occur after some accumulation of core crushing/cracking (C1). For Impacts 2 and 3, points from all three clusters occur right from the start of the impact and at comparable rates, which seems to indicate the progression of the damage mechanisms initiated in previous impacts.

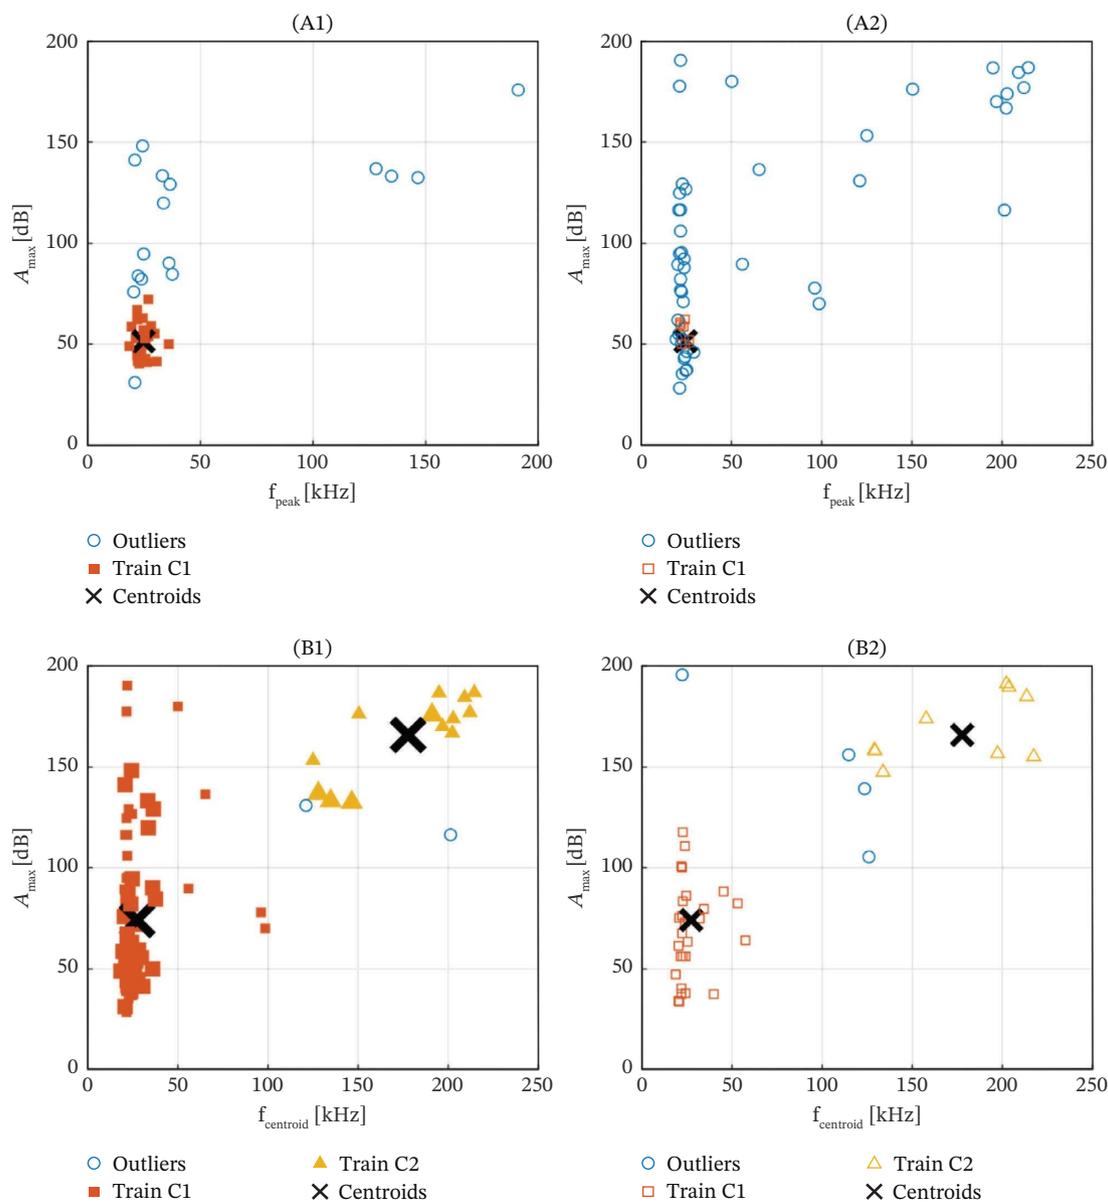
6.1.2.1 | Impact 1 for Training and Impact 2 for Testing.
The clustering solution obtained with Impact 1 as the training dataset and Impact 2 as the testing dataset and with the three most relevant AE features is presented in Figure 8. As seen in Figure 8(A1), only one cluster is found and 37.2% of the Impact 1 data points are considered outliers, meaning that the DBSCAN algorithm could not find more than one properly formed dense region. With only one cluster, it is not possible to compute silhouette values, because there is no intercluster distance to be taken, and as such, there is no quantitative measure of the suitability of the clustering solution. Nevertheless, the obtained cluster corresponds to the same damage mechanism type that was identified in Section 6.1.1 as being core crushing/cracking.

When testing the categorization of the Impact 2 dataset according to trained Cluster C1 (see Figures 8, A2), only a small fraction of the points is successfully classified as core crushing/cracking, while around 92.5% is considered outliers. The existence of only one cluster is very detrimental for the correct categorization of the damage events that occurred during Impact 2, because there is basically no flexibility to account for the inherent variability within each damage mechanism type. As a result, Impact 2 data points that are not within the optimal vicinity radius (hyperparameter *eps* as determined during the DBSCAN training process, see more about the hyperparameter optimization in the publicly available Supporting Material [24]) of the closest cluster centroid are considered testing outliers.

FIGURE 8 | Row A—2D views of cluster solution obtained with Impact 1 as the training dataset and Impact 2 as the testing dataset, and with the three most relevant features: (A1) trained cluster; (A2) tested categorization of Impact 2 dataset. Row B—2D views of cluster solution obtained with Impacts 1 and 2 as the training dataset and Impact 3 as the testing dataset, and with the three most relevant features: (B1) trained clusters; (B2) tested categorization of the Impact 3 dataset.

outliers when the training was performed with only Impact 1 data are now included in Clusters C1 and C2, and only two Impact 2 points are considered outliers. However, while C1 is quite compact (apart from six points on the diagonal transition between C1 and C2) and has a frequency signature that is strongly correlated to core crushing/cracking, C2 is more dispersed and cannot be unambiguously correlated to a single damage mechanism. Instead, it includes frequency signatures typically associated with skin-core debonding and matrix cracking (as explained in Section 6.1.1.1). This situation is due to the considerably lower number of points in C2 than in C1 and shows that core crushing was by far the predominant damage mechanism taking place during the impacts.

The existence of two clusters allows the great majority of the Impact 3 points to be classified, leaving only 10% of outliers in the region between clusters C1 and C2. Because the trained C2 centroid was between 150 and 200 kHz, and no third cluster was found below 150 kHz, the points below 125 kHz that are still far away from C1 remain ambiguous.

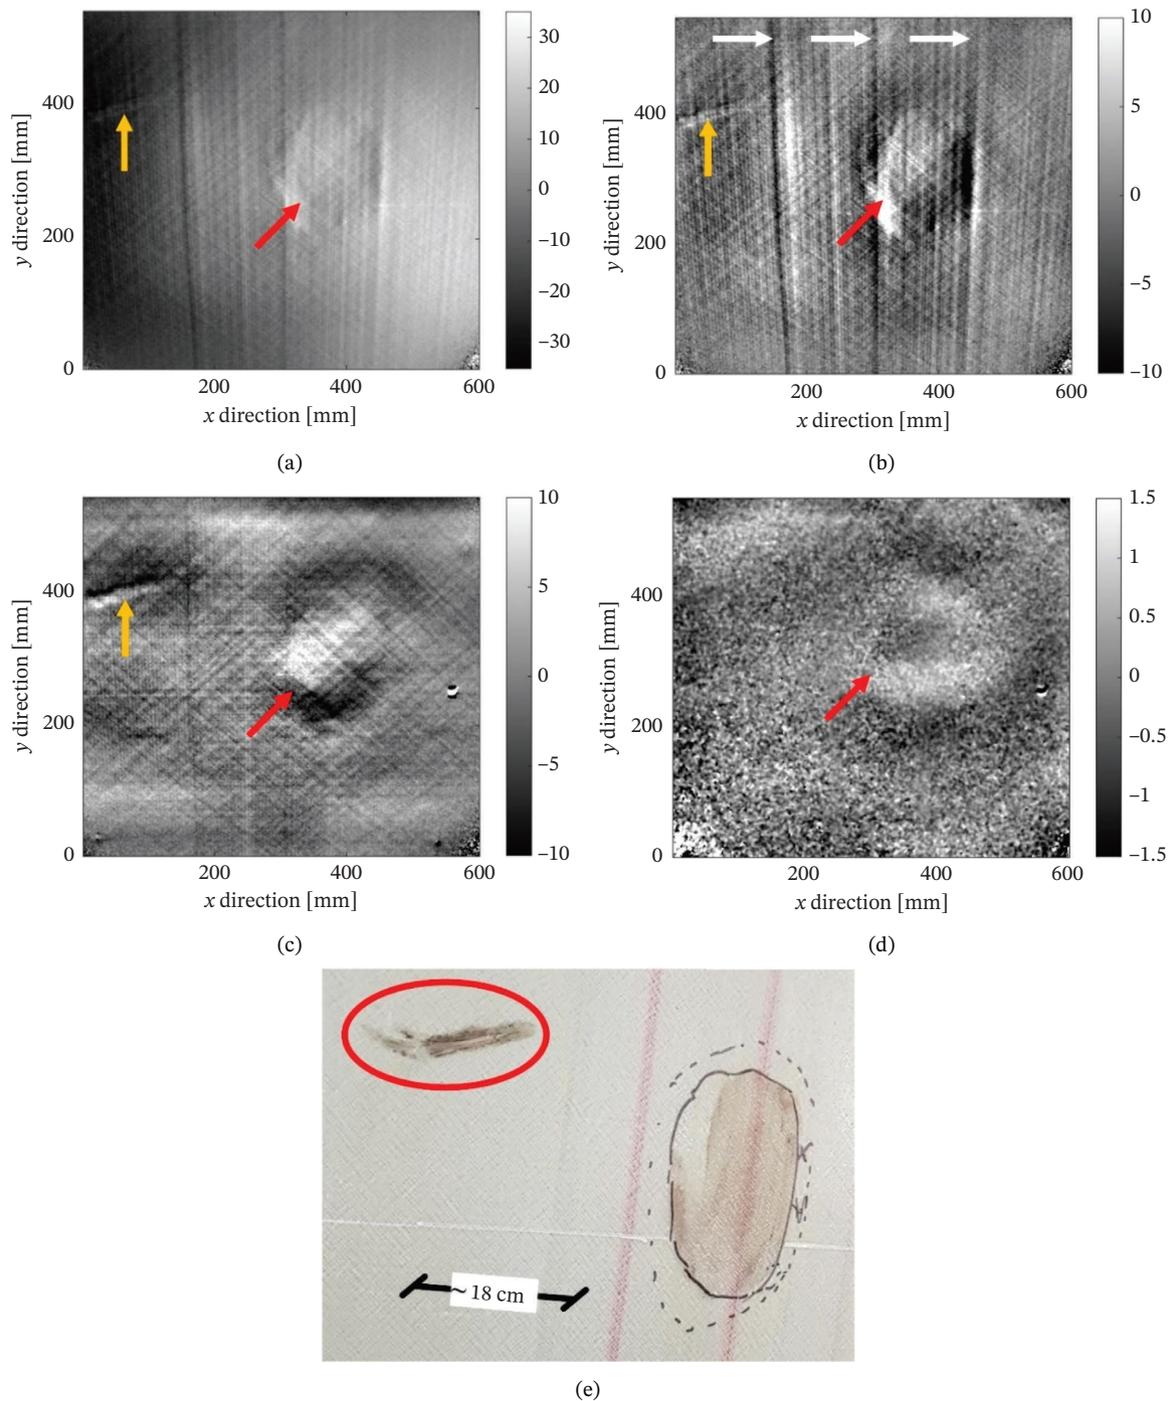
by a curve fitting process [33], which provided compensated phase maps (Figures 9(b), 9(c), 9(d)). The compensated phase maps for thermal loading and x and y shears (Figures 9(b), 9(c), respectively) both reveal the presence of the strain anomalies due to the impact damage (indicated by the oblique red arrows in Figures 9(a), 9(b), 9(c), 9(d)). The results for mechanical loading (Figure 9(d)) reveal the same damage. The strain anomalies found are likely to correspond to skin-to-core debonding.

The fact that the same defect was detected by both thermal and mechanical loading demonstrates the reliability of shearography inspection. It can be noted that the inspection results from mechanical loading (Figure 9(d)) seem to be blurry, which is likely to be due to the rigid body motion of the hull section induced by the loading procedure. The vertical orange arrows in Figure 9(b) and c are more difficult to interpret. They could indicate some skin matrix damage that may have been caused by the scraping of the impactor against the hull wall during the bouncing of the impactor after actual impact (red ellipse in Figure 9(e)). In addition to impact damage, in the compensated phase map for thermal loading and x shear, the vertical line–shaped anomalies (indicated by three white horizontal arrows in Figure 9(b)) seem to be associated with composite plie overlaps.

As a result, shearography captured three damage types (delaminations, fiber breakage, and matrix cracking) due to its high sensitivity to stiffness variations caused by impact damage. At macroscopic damage of this scale and severity (high impact energy of around 20 kJ), all these failure modes occur simultaneously and are therefore detected together.

The contact area of the impactor on the hull wall was clearly marked with rust dust left by the impactor head. After each impact, the area on and around the impactor contact area was inspected visually (with the naked eye) and by coin tapping [42–46]. After the second impact, evidence of some skin-core debonding was identified by coin tapping, as a duller/more damped sound in the impact area could be heard compared to the less damped sound outside the untouched area. This area was less than 20×30 cm, as depicted in Figure 9(e).

FIGURE 9 | (a–d) Shearography inspection results (units in radian): (a) Original phase map with thermal loading and x shear; (b) compensated phase map with thermal loading and x shear; (c) compensated phase map with thermal loading and y-shear; (d) compensated phase map with mechanical loading and y-shear. The red and yellow arrows indicate possible damage locations discussed in the text. (e) Rust marks left by the impactor on the hull wall. The scratch due to bouncing is highlighted by a red ellipse. The mark on the right is due to the actual impact. The sound difference limits from the coin-tapping inspection (see Section 6.2.2) were marked: continuous line for unambiguous differences, dashed line for ambiguous differences.

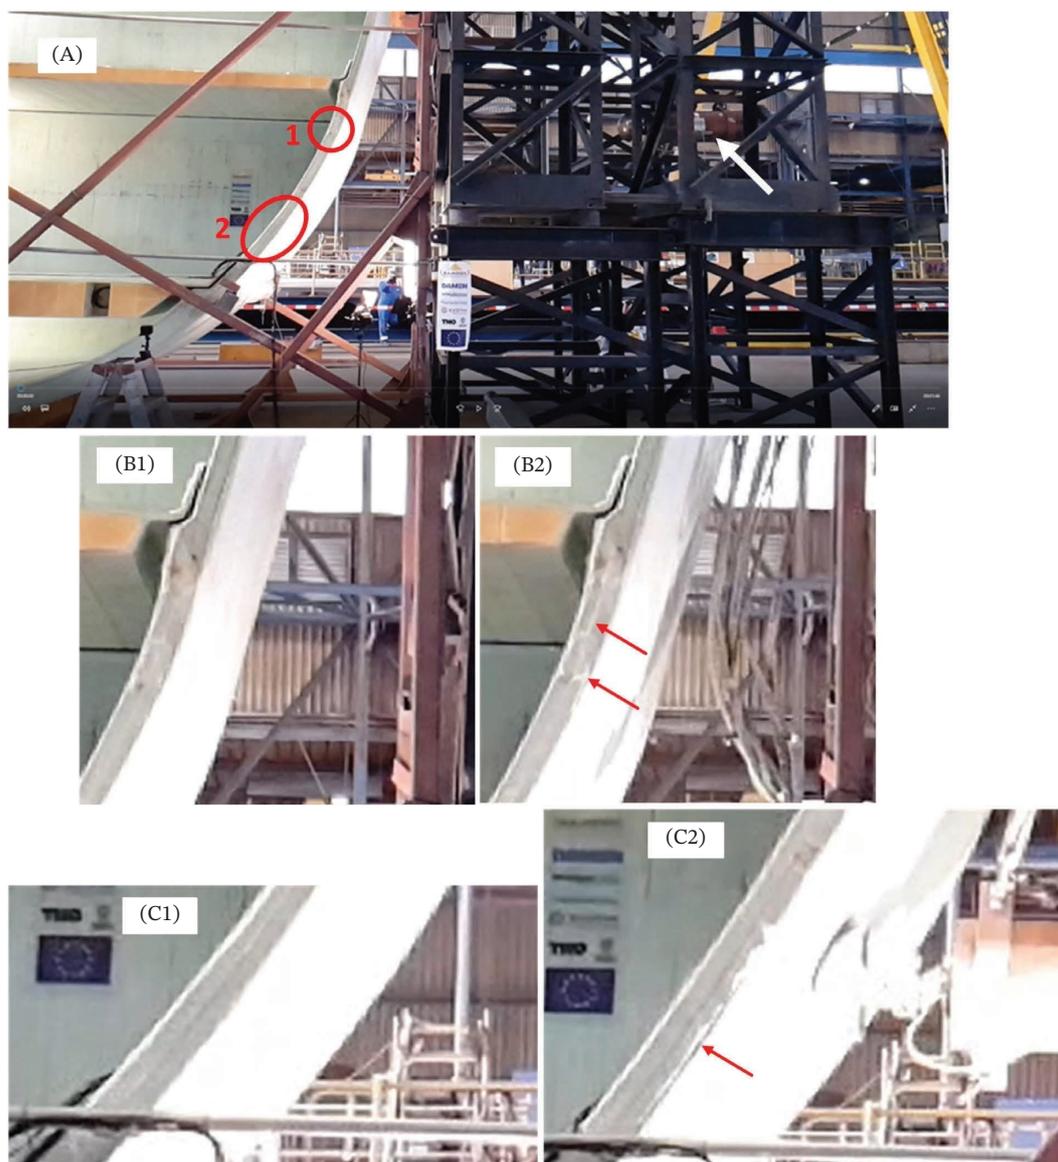
In the slow-motion video of Impact 2 (included as the second video in the support footage, see the Data Availability section), it is possible to witness the generation of local damage locations in two regions along the hull-wall edge facing the high-speed camera (indicated in Figure 10(A)).

Those occurrences are described in this section by resorting to video screenshots from the instant before the impact, the moment of impact, and the instant immediately after the impact. In Figure 10, Row B, one can observe that there is some sandwich-core crushing/cracking visible on the edge of the hull wall. This cracking may be connected to some skin-core debonding. In Figure 10, Row C, it is possible to see that the flexural action during the impact induces a whip effect, which in turn generates some peeling, and thereby some skin-core debonding at the edge of the hull wall.

FIGURE 10 | (A) Screenshot from high-speed camera video of Impact 2, before impact (note the impactor in falling position, indicated by the white arrow on the right). Areas of Interests 1 and 2 are highlighted by red ellipses. Row B—zoomed-in views of Area 1: (B1) before the impact; (B2) immediately after the impact. Arrows indicate the damage. Row C—zoomed-in views of Area 2: (C1) before the impact; (C2) at the moment of impact. The arrow indicates the damage.
