### TNO report

TM-04-D009

## Roadside Infrastructure for Safer European Roads: Road-scene analyses of ten accident sites

This report describes the road scene analyses performed by TNO Human Factors of the ten accidents.

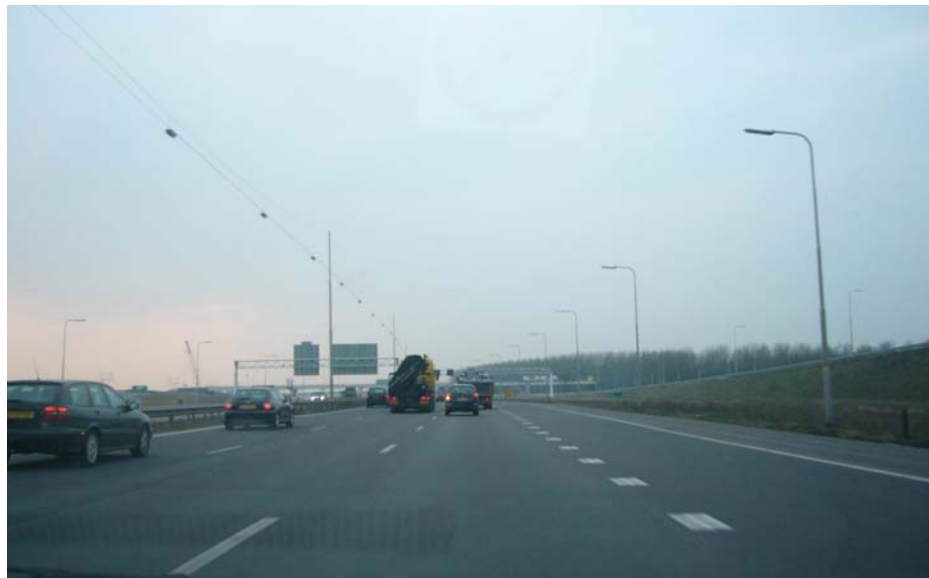
The road described is a three-lane motorway (one-directional) with a hard shoulder. Before the position that the driver ‘wanders’ of the road an entrance lane is added to the motorway on the right side (see Fig. 8). The block markings indicate the entrance lane.

Figure 8 – Three-lane motorway with an entrance/acceleration lane on the right driving toward location 2.

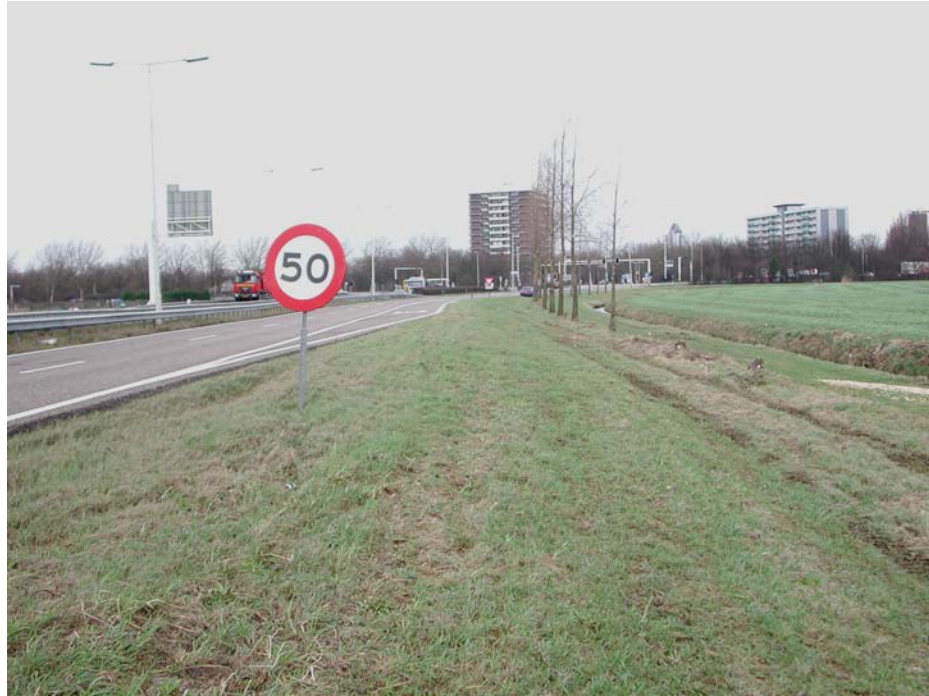
The road on this location is a secondary road. This road connects the motorway with the build up area beyond and is essentially an off ramp transitioning into a secondary road. A bus lane is added to the right side of the two lanes of the secondary road (see Fig. 15). The vehicle left the road just before the bus lane starts approximately at the location of the 50km/h sign (see Fig. 15) that he just misses.

Figure 15 – Approach location 3 during daytime.

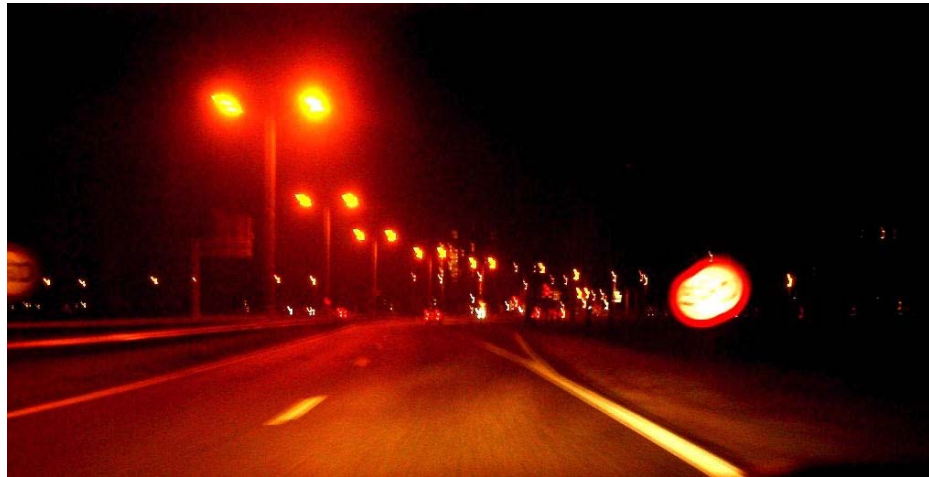
Figure 16 – Approach location 3 during nighttime.

The nighttime picture (Fig. 16) shows that the bus-lane markings in combination with the public lighting on the left side seem to indicate that the road goes more to the right than it actually does.

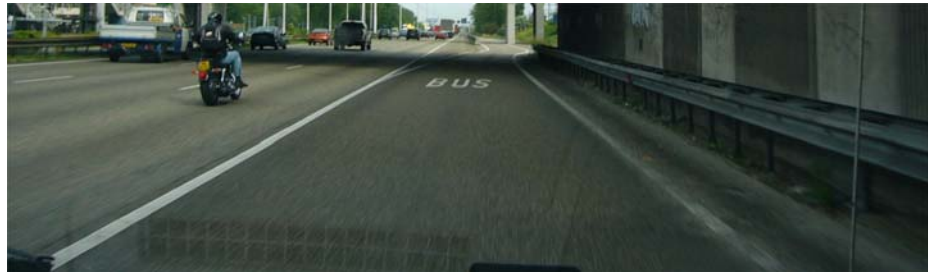
The motorway is a three-lane motorway with a shoulder. The speed limit is 120 km/h. The motorway passes a noise barrier and after that a crossover passes the motorway. Prior to the crossover the shoulder is designated as bus lane for about 100 metres. At about 25 metres after the shoulder changes into a bus lane, it passes the noise barrier. The wall is shielded with a guardrail (see Fig. 20).

Figure 20 – Location 4 noise barrier (wall) and pillars of the crossover.

We recommend extending the barrier such that the general traffic can not easily travel onto the bus lane as well as shielding the pillar itself. We can imagine that the emergency/break-down area can be used by busses as a ‘waiting’ area during busy hours. We recommend, however, that the design of the area be then changed into a design that fits this function and does not resemble a break down area with an emergency pole.

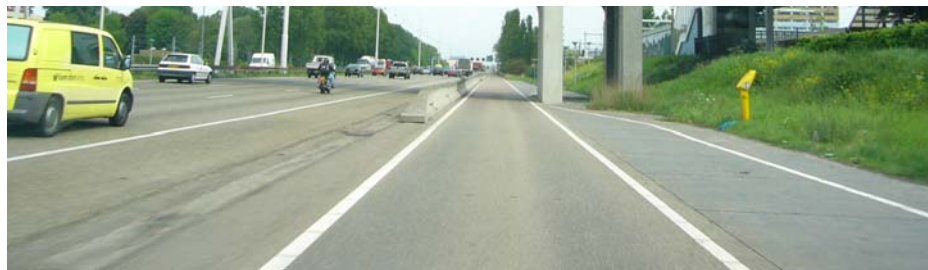
Just after this wall the bus lane changes direction in a curve to the right, leaving the shoulder. The shoulder and bus lanes are semi-separated by a concrete barrier. Right after the noise barrier ends, a breakdown emergency area is constructed on the right side of the bus lane with an emergency pole (Fig. 21). This emergency area can be reached from the main motorway.

Figure 21 – Bus lane semi-separated by concrete barrier, location 4.

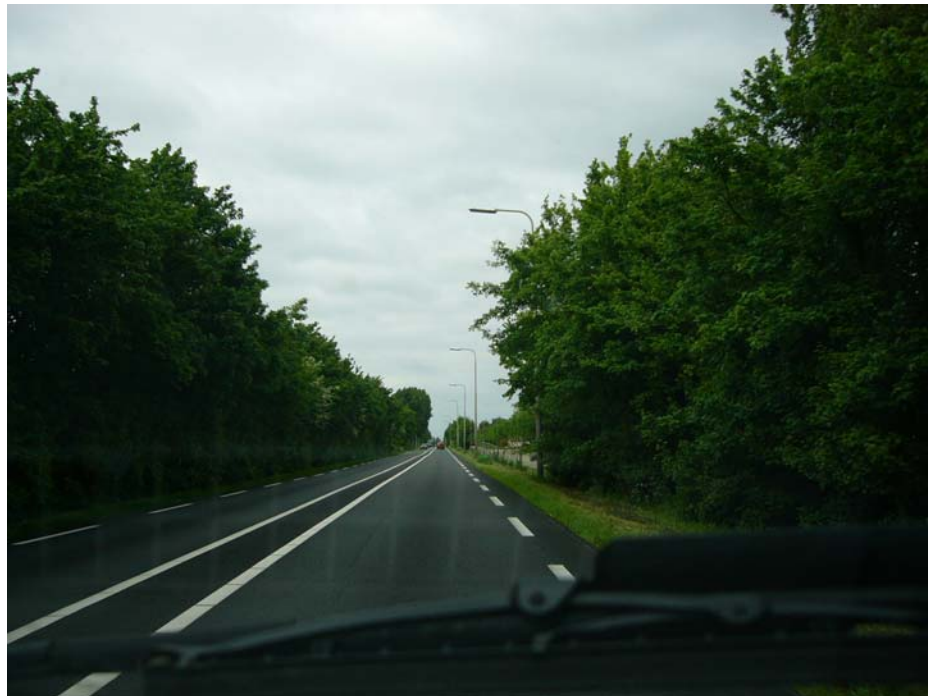
At this location a driver left the road on the right hand side due to fatigue. The road has two lanes for each direction one, not physically separated (see Fig. 26). The driver hits a light pole and swerves to the left side of the road where he hits the guardrail. He is able to re-enter the road on the left side briefly but then leaves the road again on the left side crossing a bike lane and hitting a tree eventually.

The road described is a secondary road with a speed limit of 80 km/h with a sustained road safety design. The road has a widened median and discontinuous markings on the right and left side (see Fig. 26). Bushes are positioned on the side of the road as well as light poles on almost the complete stretch of road. The vertical alignment of the road is slightly elevated at the place where a secondary road crosses under the road. This position is marked with a guardrail and green lamellas/panels positioned on top of the guardrail on the right side (see Fig. 28). At this point however the vehicle had already left the road. A parallel road is positioned to the right side of the road, most of the time invisible to the driver, except for small sections such as can be seen in Figure 27.

Figure 26 – Road scene 300 metres before accident location 6.

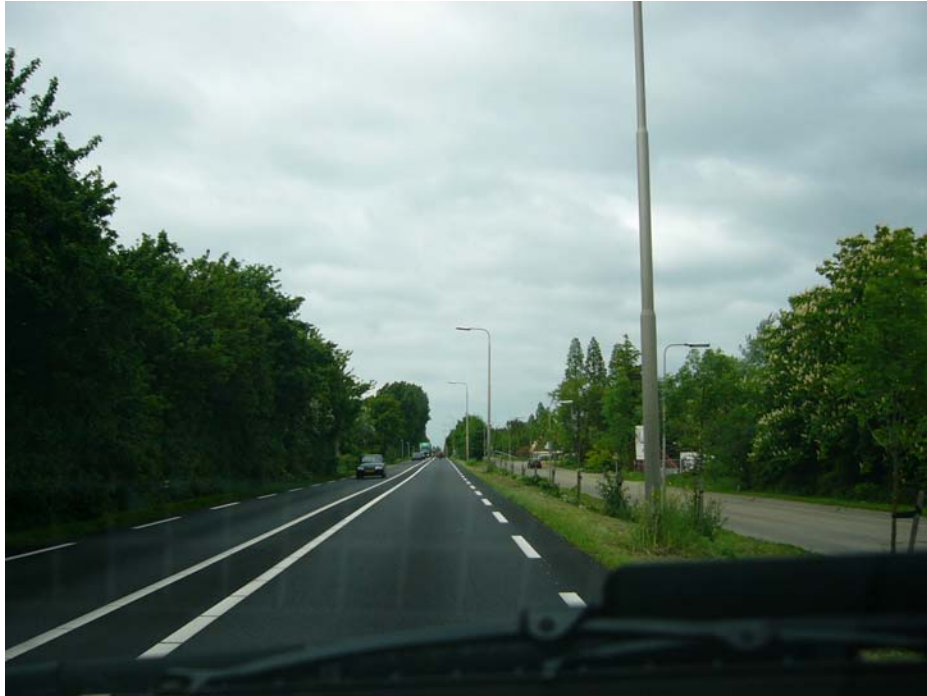
Figure 27 – Location 6, 150 metres before vehicle leaves the road.

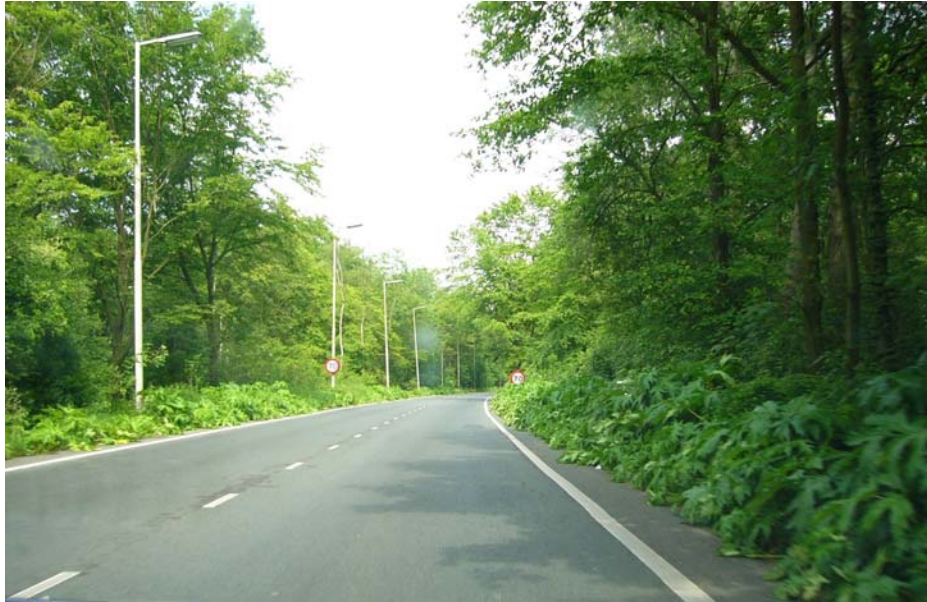
The road described is a secondary one-way two-lane road (the other direction is separated from the other with a median with bushes and trees) with a speed limit of 70 km/h from a build-up area to the main motorway network. The road has a number of curves and has bushes and trees alongside the whole stretch (see Fig. 29). The accident occurred after the last curve to the right before an intersection with traffic lights signalling the end of the stretch before entering the main motorway network (see Fig. 32). Light poles are positioned on either the right or left side or both. Parallel to the road on the right side is a bike lane that can not be seen from the road itself. The light poles alongside this road can be seen but are not misleading as to where the main road is leading.

Figure 29 – Approach trajectory 600 metres before accident location 7.

The main result of this analysis is that this road invites the driver to drive faster than the 70km/h speed limit, especially for the frequent user. The road has a layout including trees on the side of the road that give enough guidance to speed. The road design of the curves allows a higher speed limit as well. Once a driver has decided to show willingly unsafe behaviour by speeding there are no places where he is forced to lower the speed limit in a safe manner. The curve where the accident occurred has been known to have more accidents and is located at the end of the road connecting a build up area with a motorway system. The barrier that is placed now does induce a lower speed limit and as such will probably be beneficial to prevent high speeds at this location. It is advised that in order to keep the speed down on this road more measures like this should be put in place.

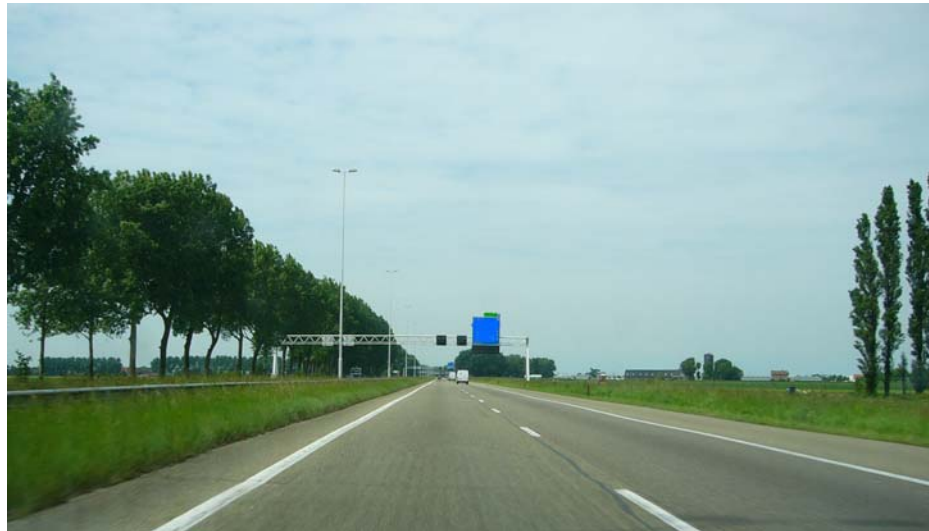
Figure 35 – Approach trajectory location 8.

Figure 35 shows the approach trajectory before the vehicle leaves the road just beyond the blue route navigation sign in the picture (see Fig. 36). This approach trajectory is representative for the whole road in fact the road looks pretty much the same for about 3 kilometres up until this point.

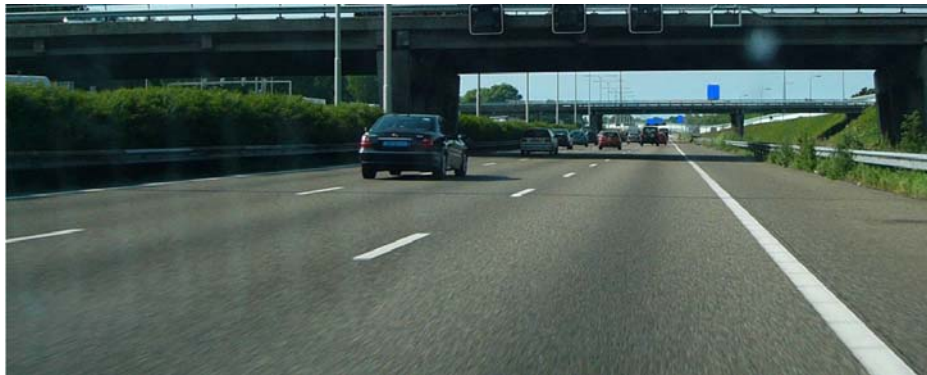
The road described is a three-lane motorway. The motorway passes under two viaducts (see Fig. 38). After the viaduct an entrance lane on the right that is higher located than the main motorway merges with the three-lane motorway. Just before the merge zone a route information sign is located positioned on a pole to note the direction of the entrance and exit zone following. This pole is located behind a guardrail that starts at about 10 metres before the position of the pole. The motorway has a continuous shoulder. The entrance lane has a sound barrier (see Fig. 39).

Figure 38 – Approach trajectory, location 9, before two viaducts (600 metres).

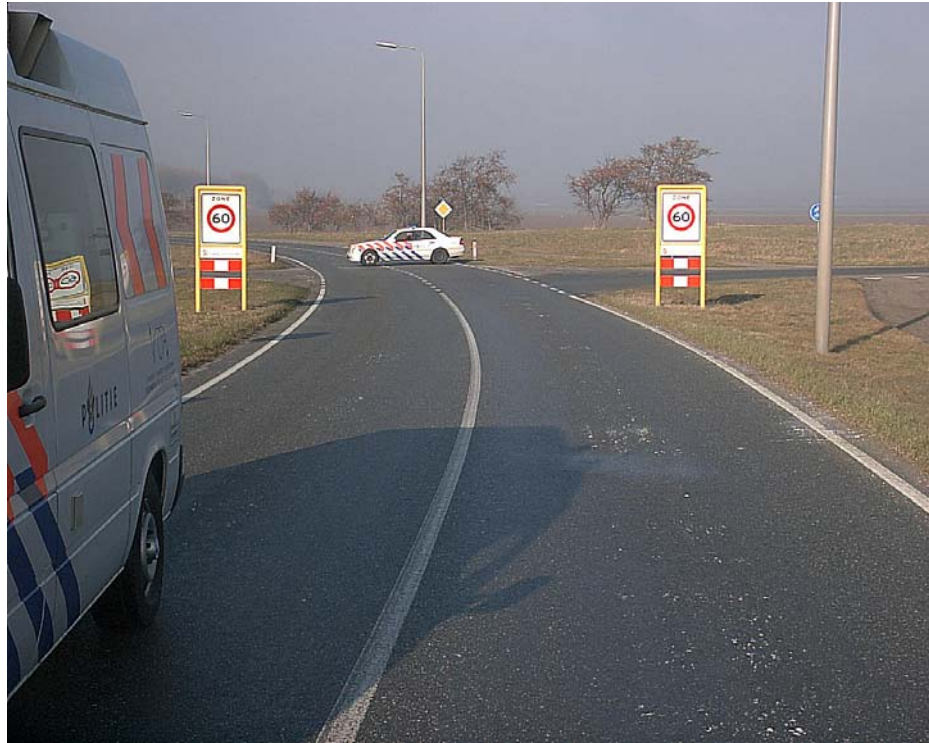
The road described is a rural road that originally had an 80 km/h speed limit. Due to new regulations the road has been given a new speed limit of 60km/h enforced by signs at the beginning of the road describing that this is a 60 km/h zone (see Fig. 42). It is a common rural road with curves to both left and right in a sparsely build-up area. The

Figure 42 – Start of 60 km/h zone location 10 (about 2 kilometres before accident location).

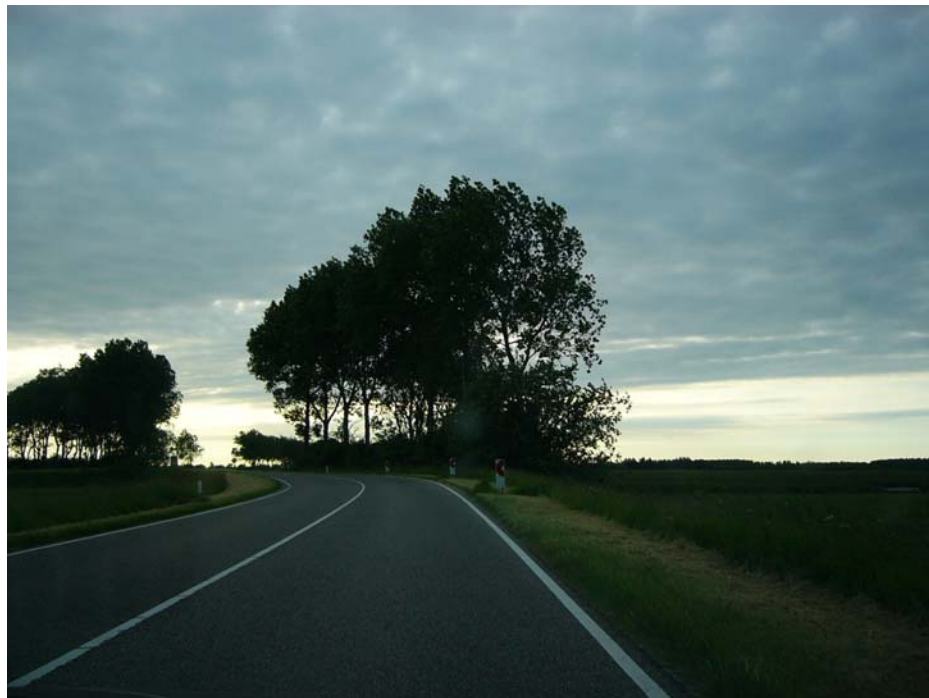
road has trees and bushes on the left and right side in a discontinuous manner (see Figs 43 and 44).

Figure 43 – Curve to the left before accident location 10.

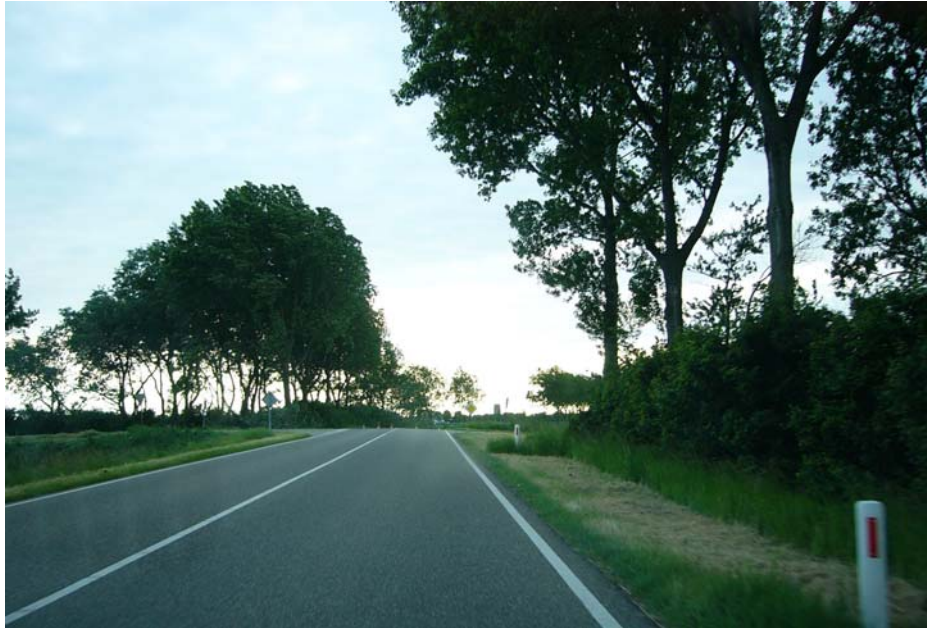
Figure 44 – Road scene 100 metres before accident location 10.
