Investigation of the Aalma el-Chaab incident

TNO 2023 R12286 – 26 January 2024

Author(s)	Not disclosed
Classification report	TNO Public
Report text	TNO Public
Number of pages	70 (excl. front and back cover)
Sponsor	Reuters News & Media Limited
Project name	Reuters investigation

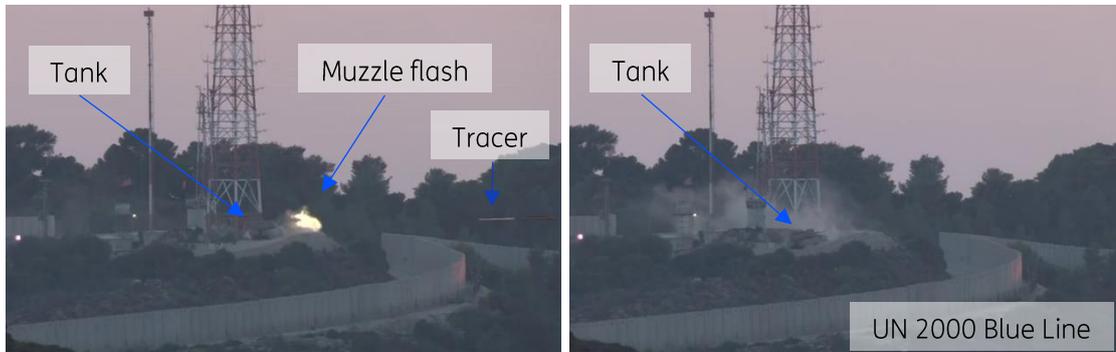
The live feed recording of Reuters [Issam live footage.mp4] and the AFP footage [AFP Footage.mp4] show an Israeli main battle tank (Merkava) driving up a ramp and firing a round with a tracer over the UN 2000 Blue Line into Lebanon. After the shot it retreats from the ramp, potentially to avoid being targeted with anti-tank weapons, see Figure 7. About thirty and forty-five seconds later, distant bursts of arms fire can be heard.

Figure 7 Reuters live feed recording, showing an Israeli tank firing from a ramp behind the UN 2000 Blue Line; the muzzle flash and round tracer are clearly visible (left). After firing the tank retreats from the ramp (right).

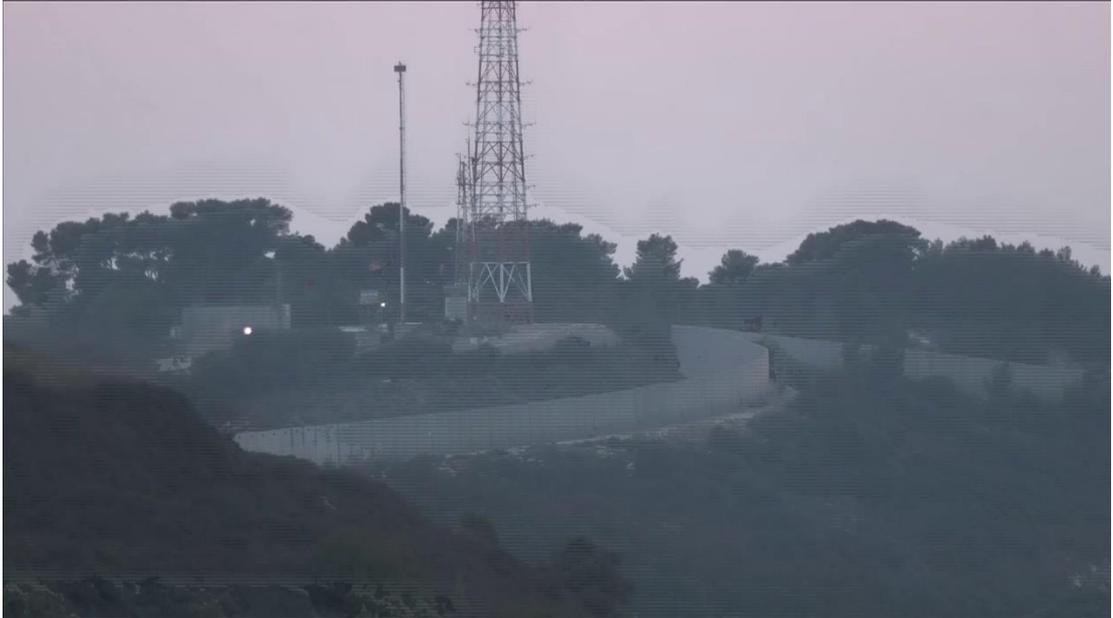
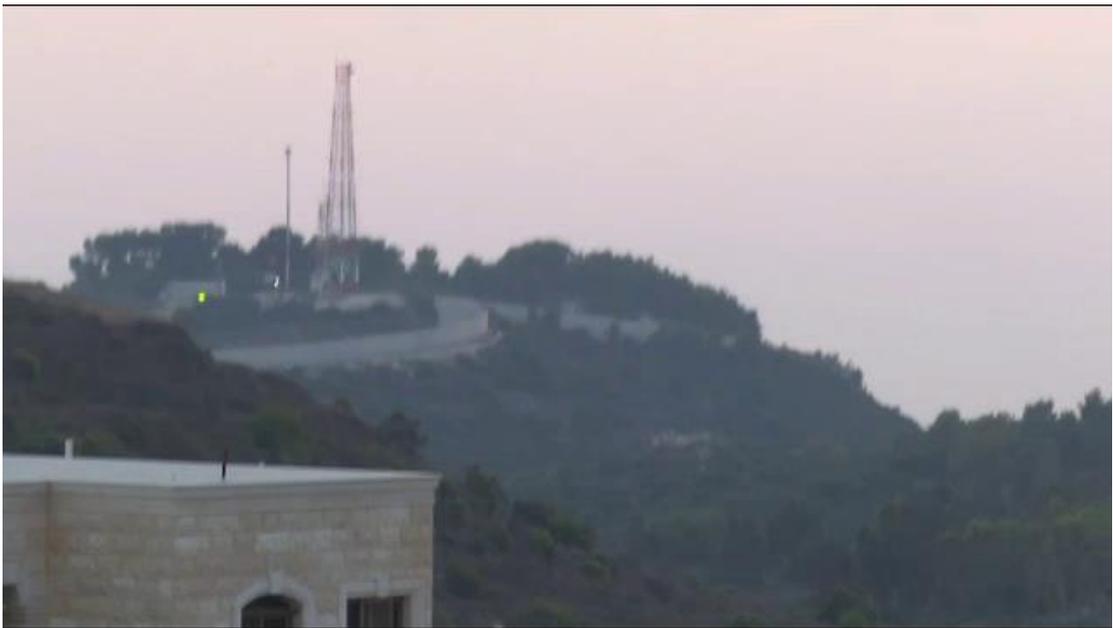
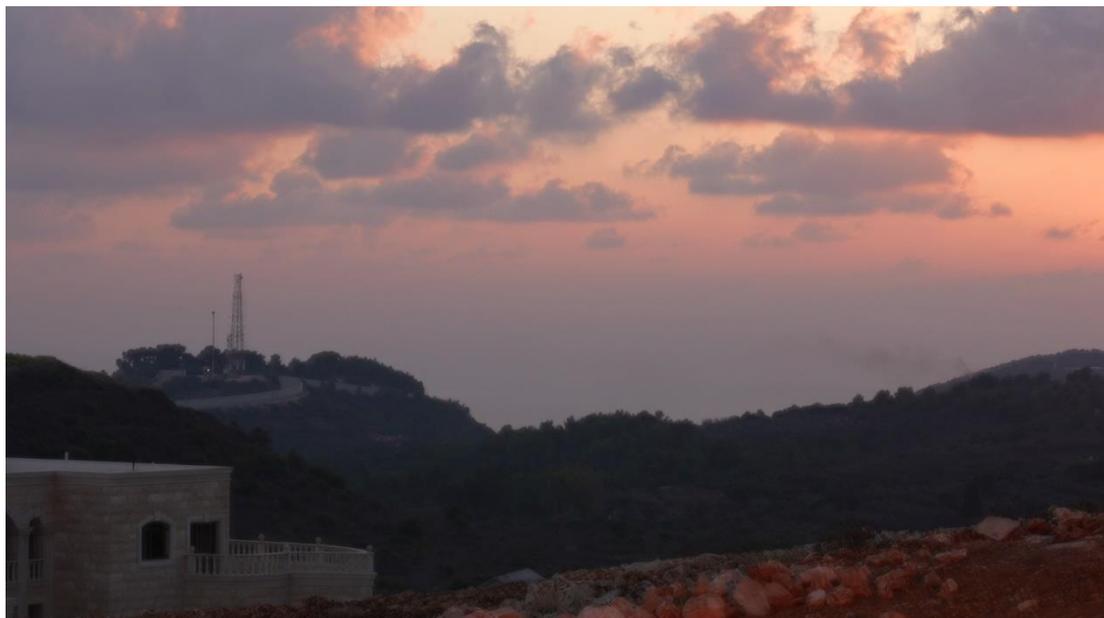
At the moment of the first strike, the Reuters, Al Jazeera and AFP cameras were pointed towards the location near the Hasulam Cave where an Israeli main battle tank fired a round one minute earlier. All recordings demonstrate a slight blur, and the rock formation on the right lights up red on the AFP footage, but none of the recordings show a muzzle flash or smoke at the Israeli position near the Hasulam Cave at the moment of the incident, see Figure 8, Figure 9 and Figure 10.

Since Kinetic Energy (KE) rounds of main battle tanks are usually fired using a muzzle velocity of 1500 to 1750 m/s, and High Explosive (HE) rounds of main battle tanks with 750 to 1000 m/s, the time of travel is at least 1 and 2 seconds respectively, over about 2 km. Since all cameras recorded at a frame rate of 25 frames per second, a muzzle flash or smoke from a round launch would have been visible on the recordings if a round was fired from that location. This demonstrates that the round in the first strike was not fired from the Israeli position near the Hasulam Cave.

Figure 8 Reuters live feed recording at the moment of the first strike [Issam live footage.mp4].

Figure 9 Al Jazeera recording at the moment of the first strike [Al Jazeera footage. Helicopter, both strikes.mp4].

Figure 10 AFP recording at the moment of the first strike [AFP footage.mp4]. The rock formation on the right lights up red.

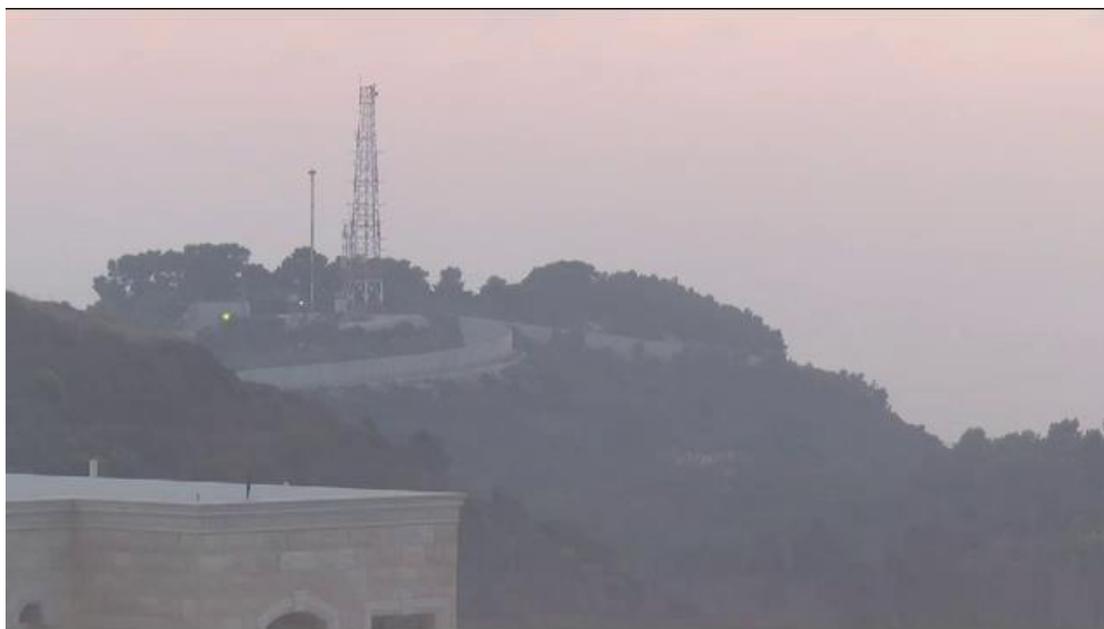
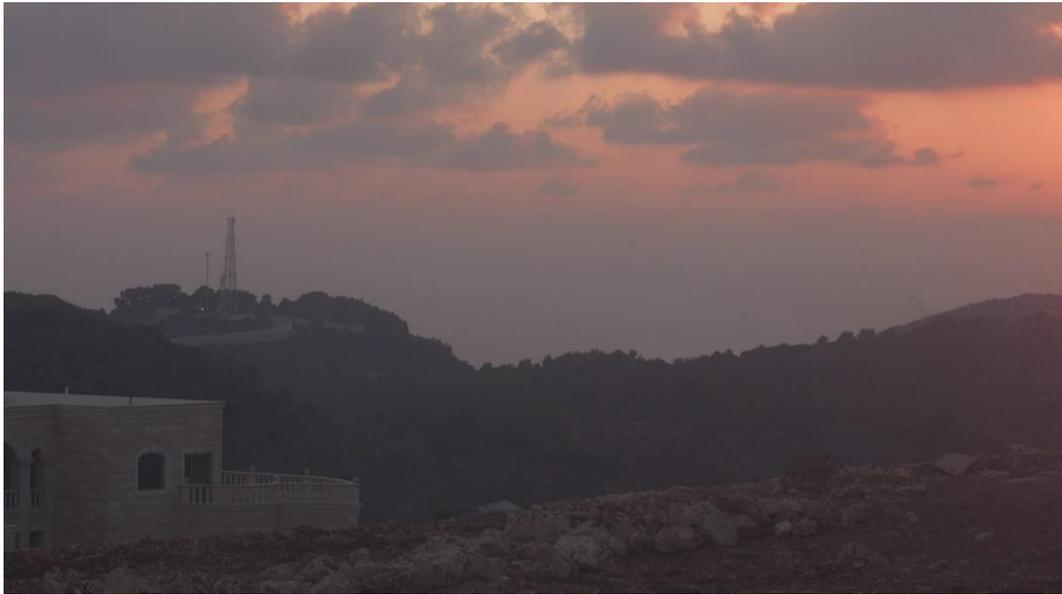
After the first strike, the Al Jazeera and AFP cameras remain filming the Israeli position near the Hasulam Cave and both record the second strike, see Figure 11 and Figure 12. The absence of a muzzle flash or smoke from a round launch on both recordings, demonstrates that the round in the second strike was not fired from the Israeli position near the Hasulam Cave.

Figure 11 Last frame of the Al Jazeera recording before the second strike [Al Jazeera footage. Helicopter, both strikes.mp4].

Figure 12 Last frame of the AFP recording before the second strike [AFP footage.mp4].

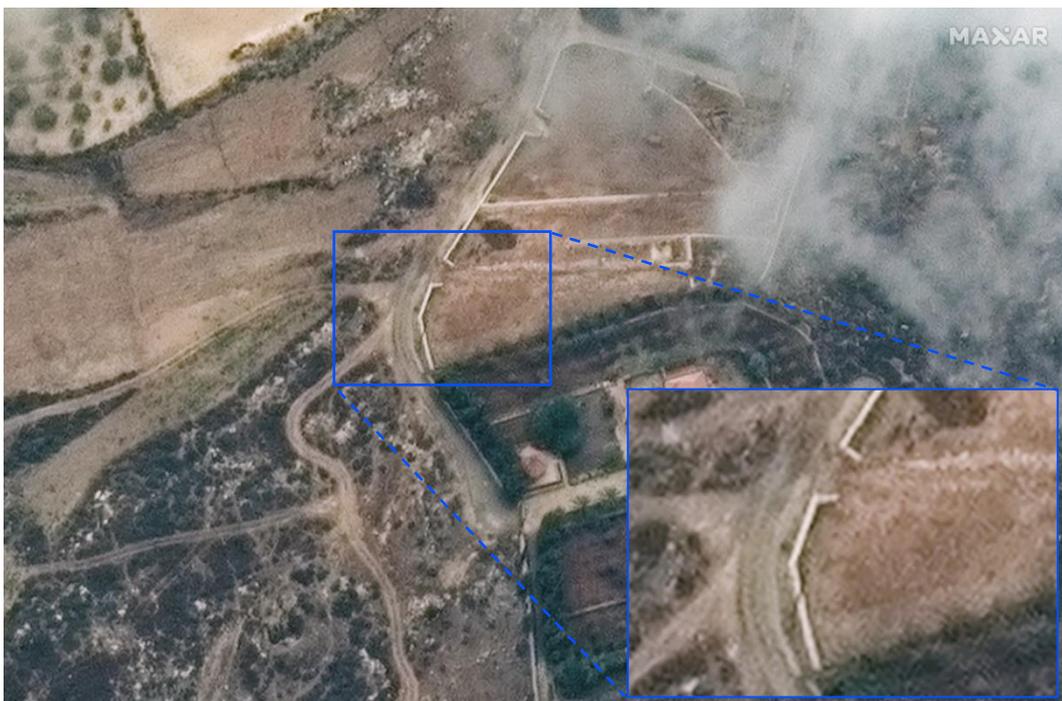
A MAXAR satellite image taken on 12 October 2023, one day before the incident, shows no signs that the scene of the incident was involved in an earlier ammunition strike. This satellite image is displayed in Figure 13. Cratering, debris or burn marks are not observed at or near the incident location. This is also the case for the photograph shown in Figure 1 made by Issam Abdallah about one hour before the incident. Because there is no evidence of an earlier strike, there is no doubt that the debris observed at the scene is related to the incident on 13 October 2023.

Figure 13 MAXAR satellite image from 12 October 2023, showing no signs of an earlier ammunition strike.

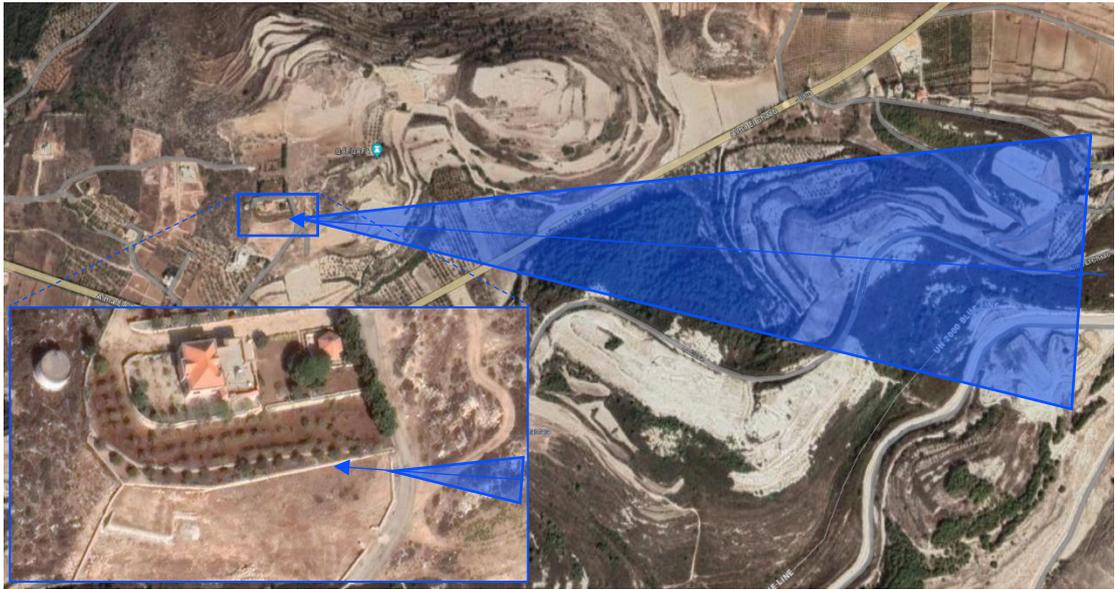
The debris pattern is also observed on a MAXAR satellite image from 26 October 2023, see Figure 16. The image shows the hole in the wall, just north of the utility pole and the burnt wreckage of the vehicle. The white spot represents the hood of the car. The estimated direction of fire based on the debris pattern, including a ten-degree error margin, is indicated. This direction and error margin are then transferred to a Google maps image to illustrate the direction of fire plotted over a wider area. It is clear that the ammunition article that hit the stone wall was fired from the east - southeast.

Figure 17 Estimated direction of fire based on the debris field behind the stone wall, with a plus minus ten-degree error margin [Google maps].

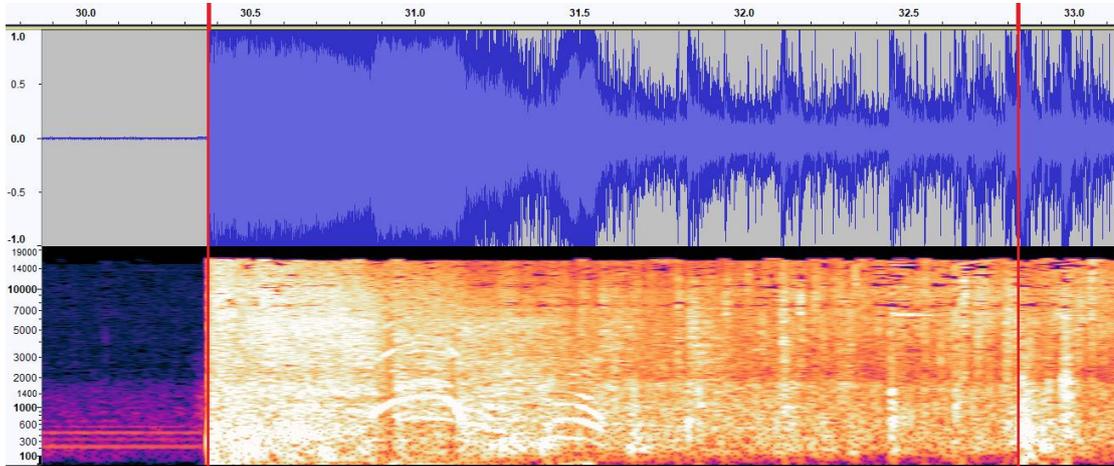
The audio waveform and spectrogram⁴ of the time period around the first strike are shown in Figure 18. The red lines indicate the sound of impact and hypothesized muzzle blast. The impact sound can clearly be recognized in the waveform and spectrogram by the sudden spike in sound level. This is not that obvious for the muzzle blast.

Figure 18 Audio waveform and spectrogram of the time around the first strike. The impact sound is indicated by the red line on the left, the hypothesized muzzle blast is indicated by the red line on the right.

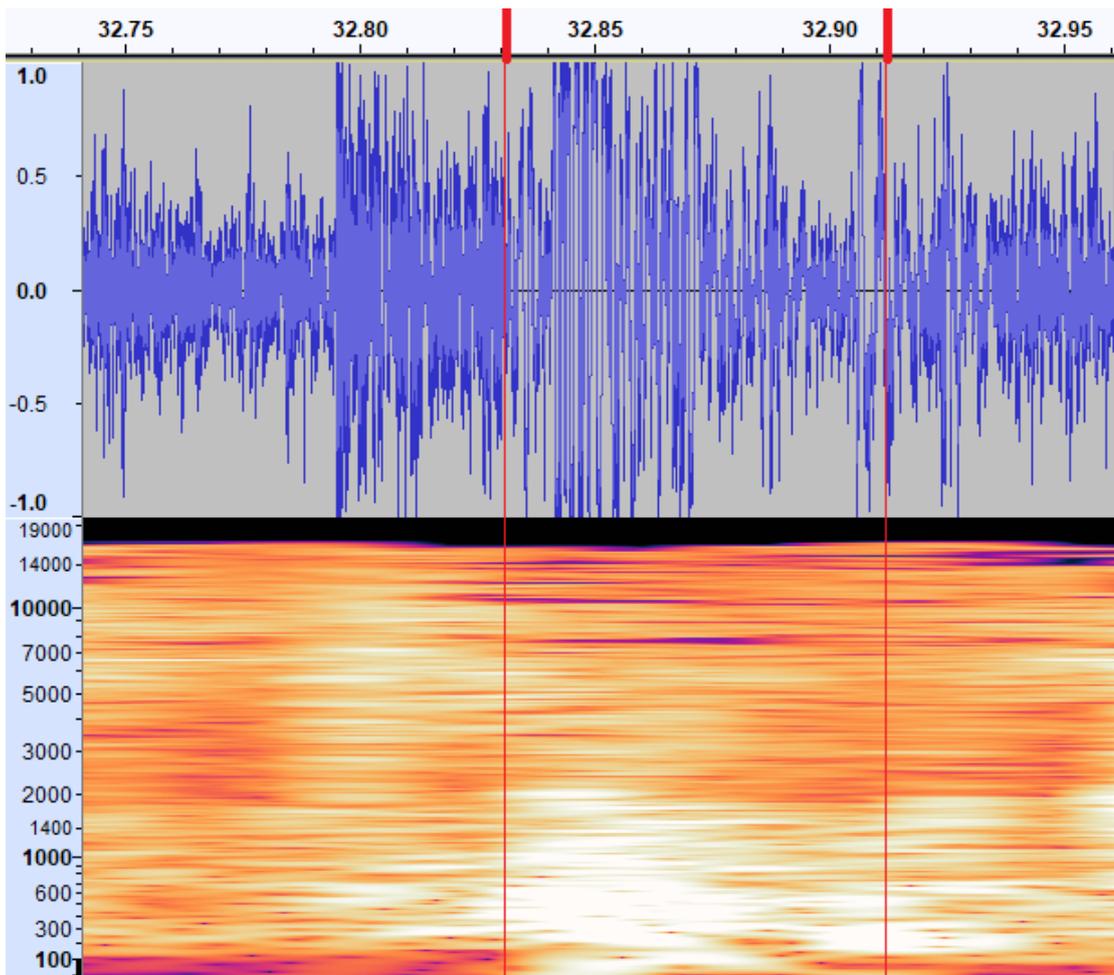
However, when looking at the waveform in more detail, a sudden change in amplitude and frequency can be observed, see Figure 19. The spectrogram (shown in the same figure) shows a sudden peak in low frequency sound at this point.

Figure 19 A detailed view of the waveform and spectrogram of the hypothesized muzzle blast after the first strike, showing a change in amplitude and frequency in between the red lines.

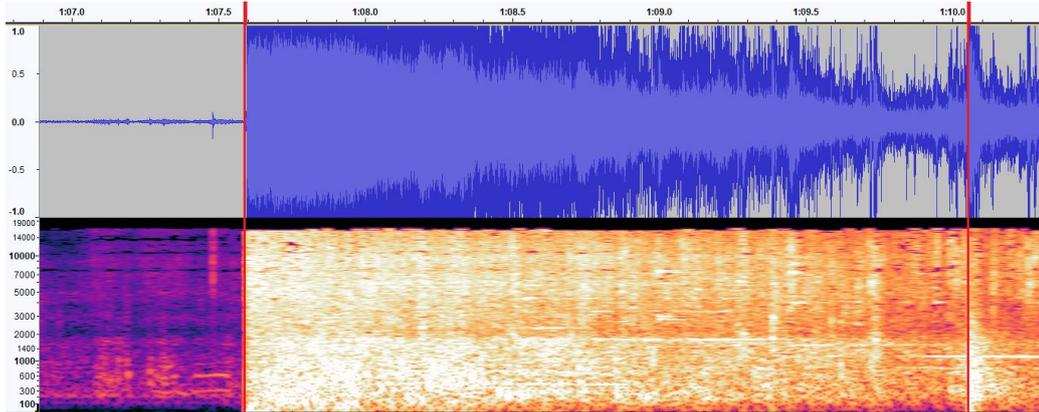
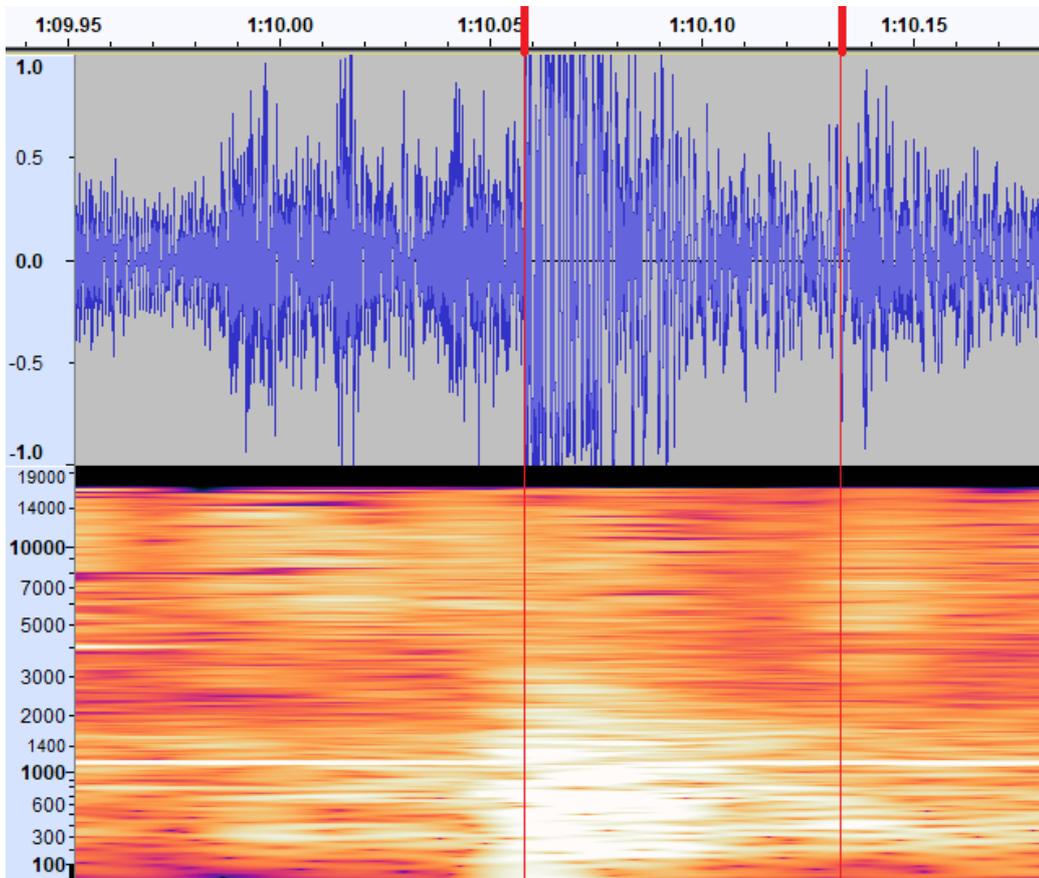
An identical analysis is performed for the second strike. Figure 20 and Figure 21 present the audio waveform and spectrogram of the time around the second strike and a detailed view of the waveform and spectrogram of the hypothesized muzzle blast, respectively. Comparing Figure 21 to Figure 19 shows a similar duration and change in amplitude and frequency for both muzzle blasts, as well as a similar low frequency pulse in the spectrogram. Furthermore, the interval between the sound of strike and muzzle blast is also similar for both strikes. For the first strike this interval equals 2.457 seconds, and for the second strike 2.463 seconds.

Figure 20 Audio waveform and spectrogram of the time around the second strike. The impact sound is indicated by the red line on the left, the hypothesized muzzle blast is indicated by the red line on the right.

Figure 21 A detailed view of the waveform and spectrogram of the hypothesized muzzle blast of the second shot, showing a change in amplitude and frequency in between the red lines.

The fact that the change in waveform and spectrogram are similar and that the intervals are nearly identical strengthens the hypothesis that the “thud”-like sound indeed relates to the muzzle blast for both strikes.

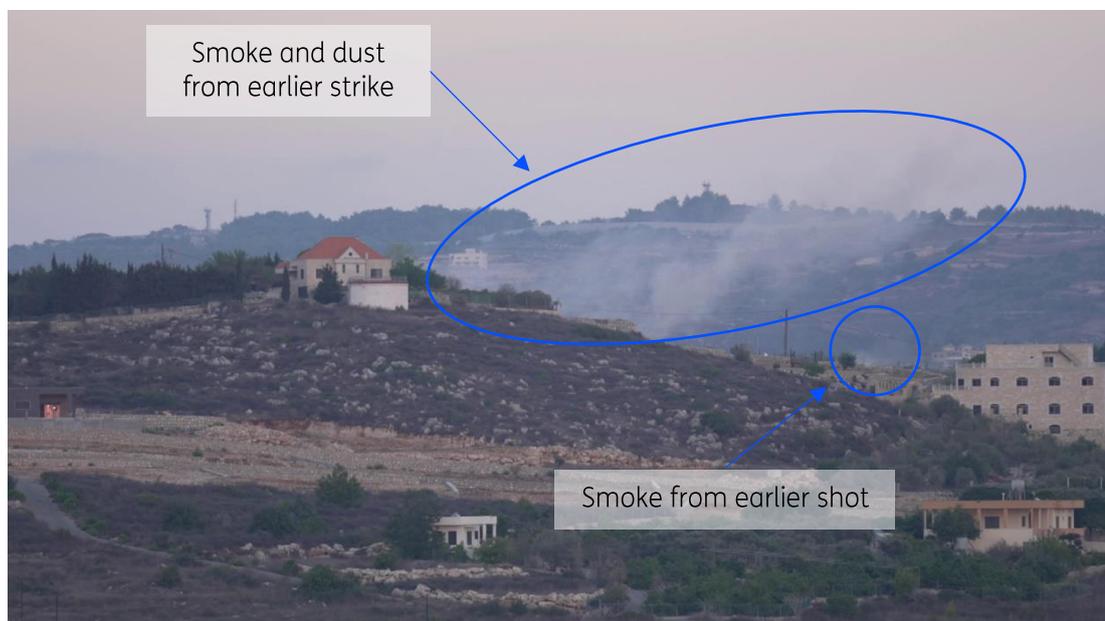
In the RAI footage [ISSAM ABDALLAH .mxf] from a viewpoint in Aalma el-Chaab, the firing and impact of the second round can be seen and heard. This footage also shows smoke and dust clouds indicative of the firing and impact of an earlier shot, see Figure 22. The sequence of events of the second shot is clockwise presented in Figure 23; a muzzle flash is seen, followed by an ammunition travelling through the air, visualized by a tracer and smoke trail, followed by a fire ball at the moment of detonation, which launches the hood and other vehicle parts into the air. The smoke and dust clouds arising from the firing and strike location prior to the second shot demonstrate that the journalists were hit twice from the same firing point.

Figure 22 Still from RAI footage [ISSAM ABDALLAH .MXF] prior to the firing of the second shot. The smoke and dust clouds reveal the firing and impact of an earlier shot.

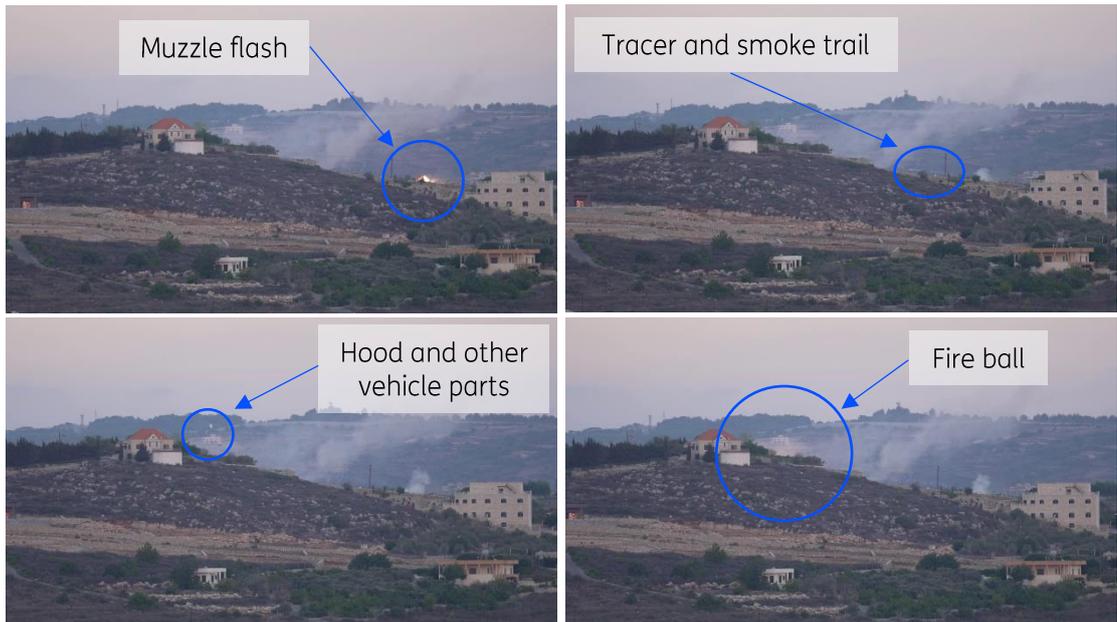
Figure 23 Stills from RAI footage [ISSAM ABDALLAH .MXF]. Muzzle flash of firing of the second round. Tracer and smoke trail of ammunition round. Fire ball lighting up the location of the journalists. Hood and other vehicle parts blown into the air (clockwise).

In [ISSAM ABDALLAH .MXF] both firing and impact of the second round are visible (see Figure 23). With 36 +/- 1 frames recorded at 25 frames per second (based on the codec), one derives $T_0 = 1.44 +/- 0.04$ s. In [Al Jazeera footage. Helicopter, both strikes.mp4] both the impact and muzzle blast are audible at the strike location. From sound analysis follows that $(T_1 - T_0) = 2.460 +/- 0.003$ s (see section 3.2.1.1).

⁹ In Figure 23, the projectile seems to come from below while the firing point is actually at a higher elevation than the strike location. Note however that the height of the strike location is obscured by a hill and that the UN 2000 Blue Line in the far distance is at 600 m above sea level. Drawing a height profile from the camera, via the strike location towards the UN 2000 Blue Line, would show that the firing point is at the same level for the RAI camera as the four storey house seen at the right of Figure 23. This means that the camera is tilted slightly upwards from the horizontal plane.

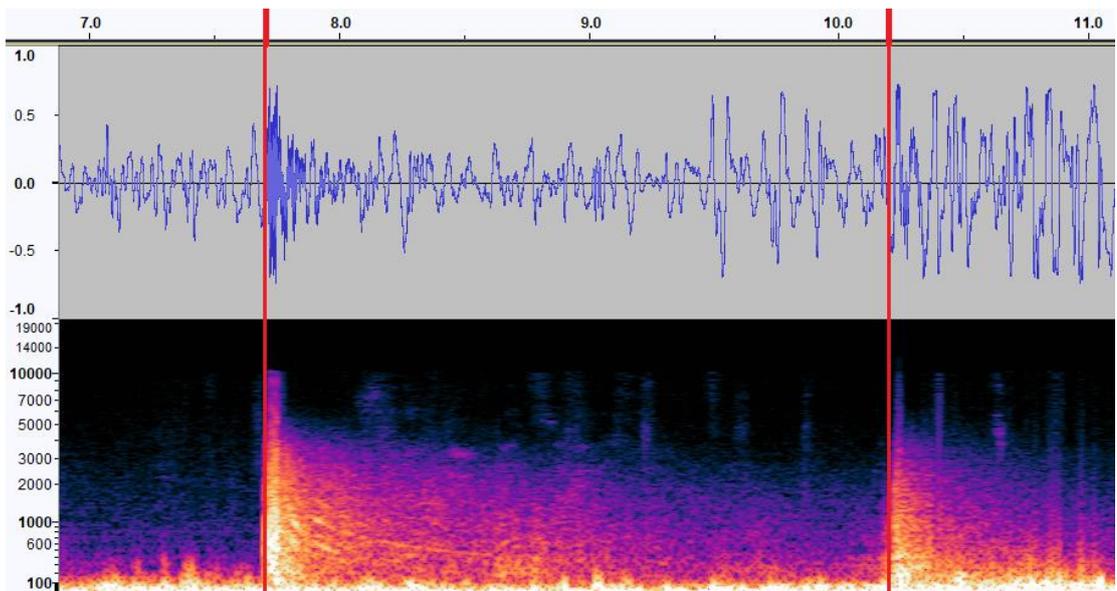
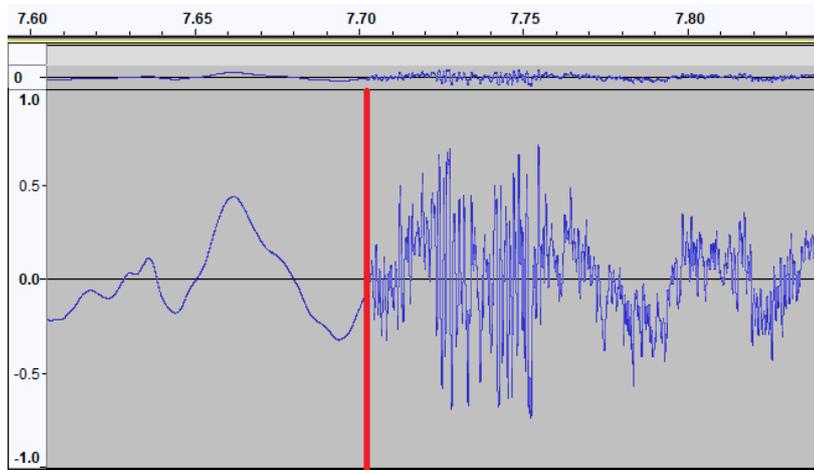
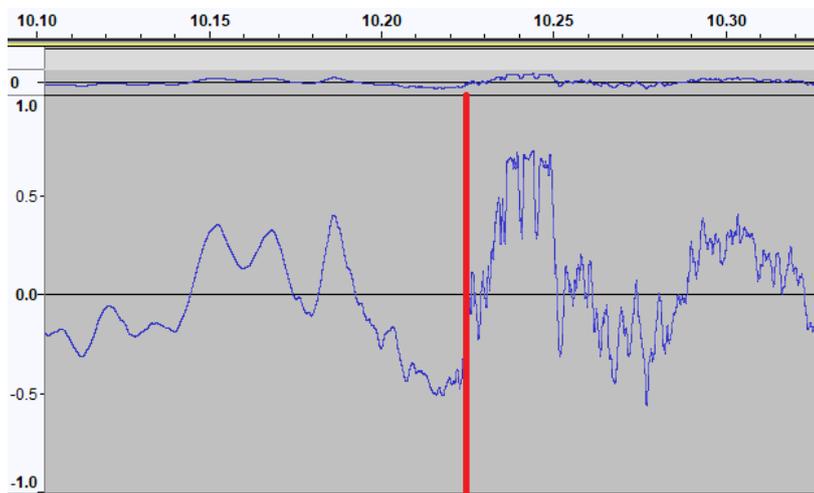
Figure 24 shows the waveform and spectrogram corresponding to the second shot, with red lines indicating the sound of impact (left) and the sound of firing (right). Figure 25 and Figure 26 show a detailed view of both sounds⁵. From the waveform data, it is determined that the time between seeing the firing and hearing the firing equals 8.51 seconds. And that the time between seeing the detonation and hearing the detonation is 4.54 seconds. This information can be used to calculate the distances between the firing point and the camera viewpoint, and between the strike location and the camera viewpoint, as detailed in section 3.2.2.

Figure 24 Audio waveform and spectrogram extracted from [ISSAM ABDALLAH .mxf] corresponding to the second shot.

Figure 25 Audio waveform corresponding to the detonation of the second shot.

Figure 26 Audio waveform corresponding to the firing of the second shot.

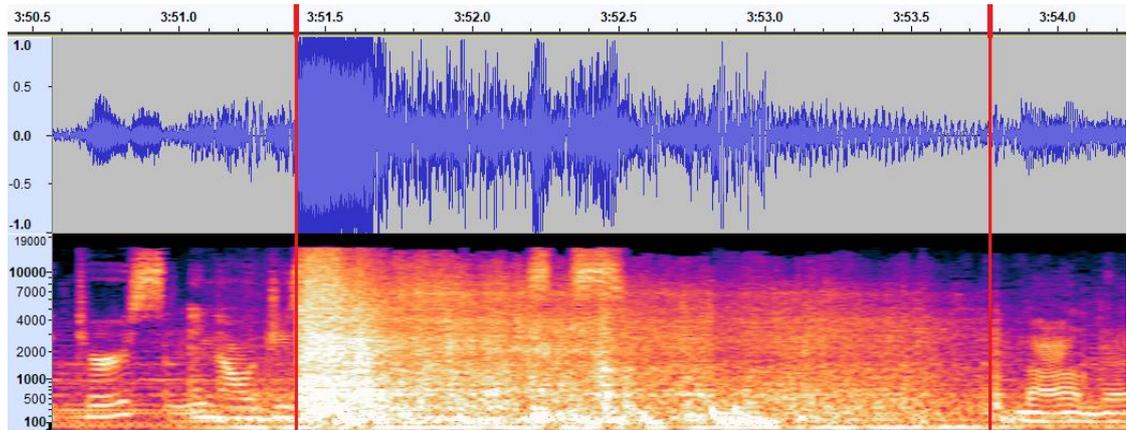
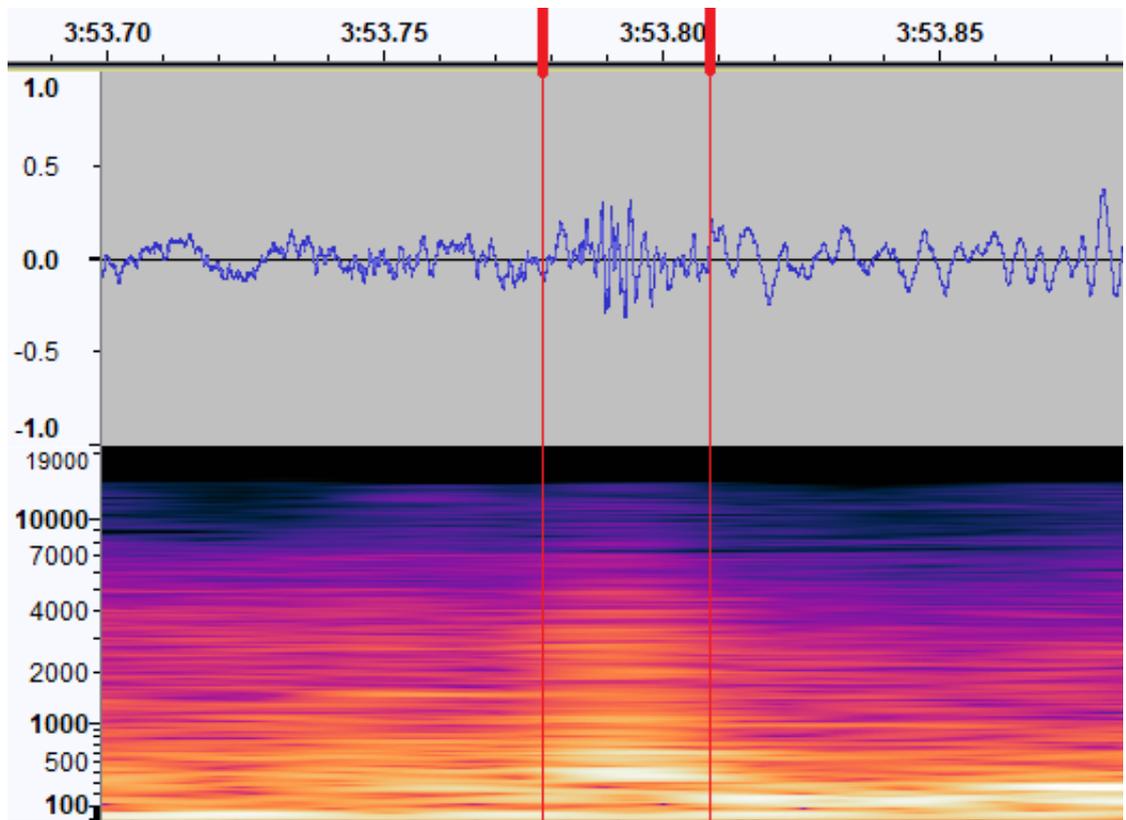
Approximately 100 meters southwest of the strike location, a film crew from LBCI also captured the audio of the second strike. The audio waveform and spectrogram of this recording are shown in Figure 27. As was the case for the audio analysed in the preceding sections, both the sound of impact, as well as the muzzle blast, can be distinguished, and are indicated in the figure by red lines. Figure 28 shows a detailed view of the audio from the muzzle blast. A change in amplitude and frequency can be seen in the waveform, and a peak in low frequency sound can be seen in the spectrogram. The interval between the sound of strike and muzzle blast is 2.378 s, which is consistent with the interval determined in section 3.2.1.1.

Figure 27 Audio waveform and spectrogram extracted from [YouTube: Death of Reuters reporter Issam Abdallah What happened on the Lebanese Israeli border] corresponding to the second shot.

Figure 28 A detailed view of the waveform and spectrogram of the hypothesized muzzle blast of the second shot, showing a change in amplitude and frequency in between the red lines.

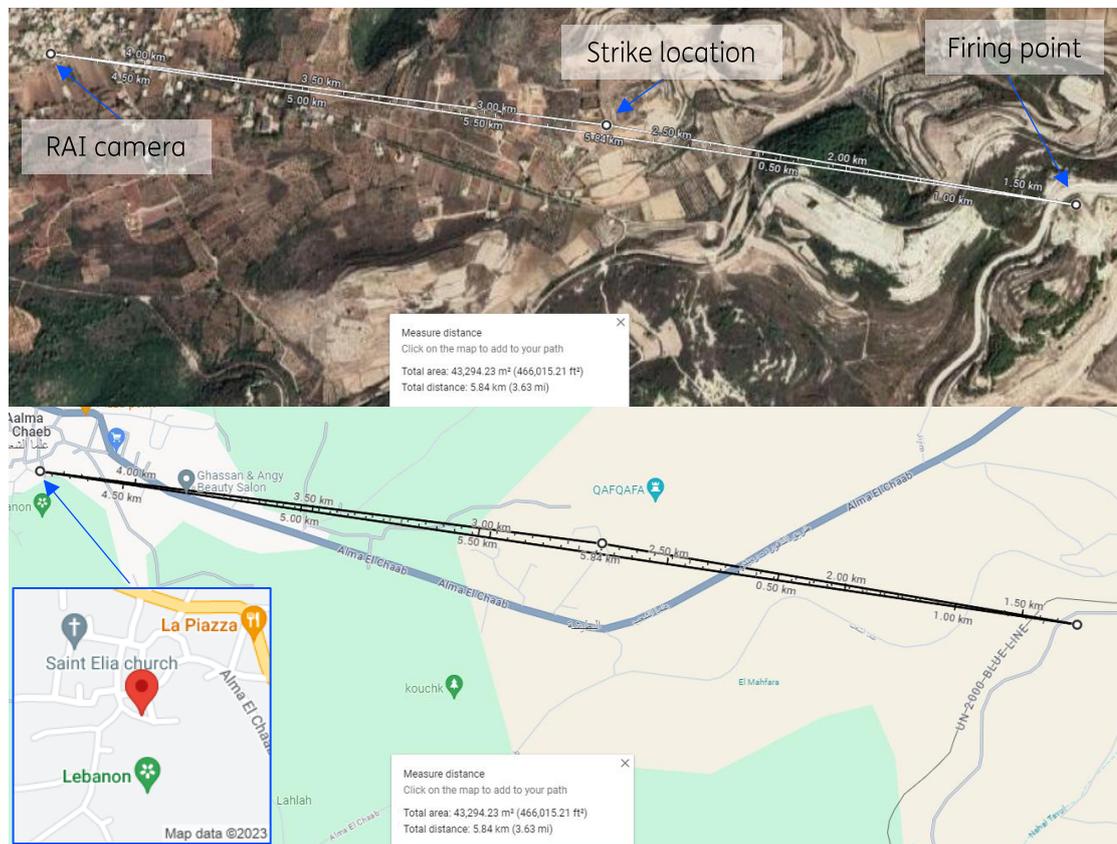
The distance between the RAI video location in Alma el Chaab and the strike location is calculated based on the 4.54 s time delay between the visible and audible detonation in [ISSAM ABDALLAH .MXF], and equals 344.3 m/s * 4.54 s = 1563 +/- 11 m. In a similar way the time delay between the visible and audible firing is 8.51 s and gives a distance of 344.3 m/s * 8.51 s = 2930 +/- 13 m between the firing point and the location of the RAI camera. Three sides of a triangle are now known; the distance between firing point and strike location (1.34 km), between RAI camera and strike location (1.56 km) and between RAI camera and firing point (2.93 km). The firing point is determined by triangulation, see Figure 29. The approximated coordinates of the firing location using Google Maps are 33°05'57.3"N 35°12'44.3"E, with an accuracy of +/- 17 m. The location of the firing point is confirmed visually using landmarks in the RAI video.

Figure 29 Locations of RAI camera (left), strike location (middle) and firing point (right), in satellite and default map view [Google maps]. The total (rounded) distance of 5.84 km equals the triangle perimeter with sides 1.34, 1.56 and 2.93 km.

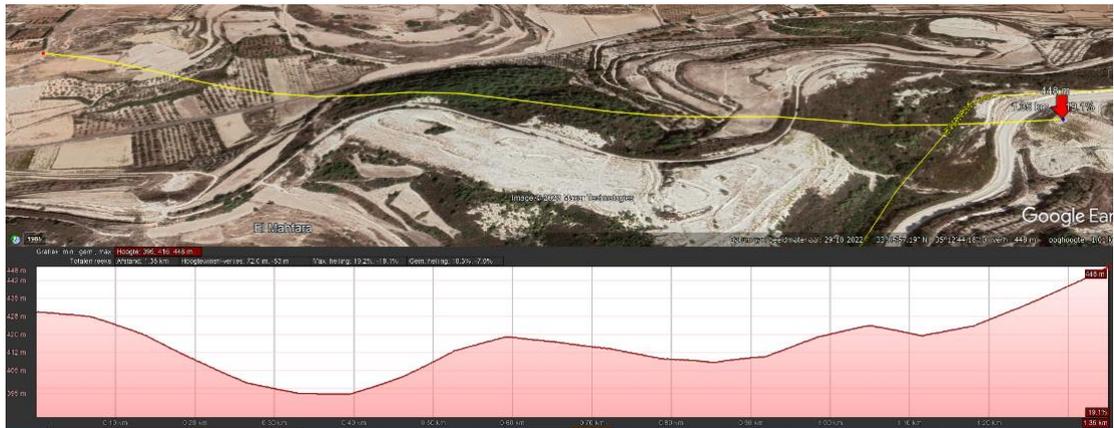
The firing point was at 448 m and the strike location at 429 m above sea level. There are two hills in between the two locations as shown in Figure 30. The line of sight is 10 m above the crest of the hill at 600 m from the strike location and 18 m above the crest of the hill at 1005 m.

Figure 30 Profile along the line from firing point (red arrow at the right) to strike location (red dot at the left). It can be seen that there is a line of sight between the firing point and the incident location⁹. This is also confirmed by Figure 3 and Figure 4. Figure 31 presents another still from [AFP C6338 Footage to the East 1.MP4] facing the firing point, slightly to the right of the line of sight to the radio tower.

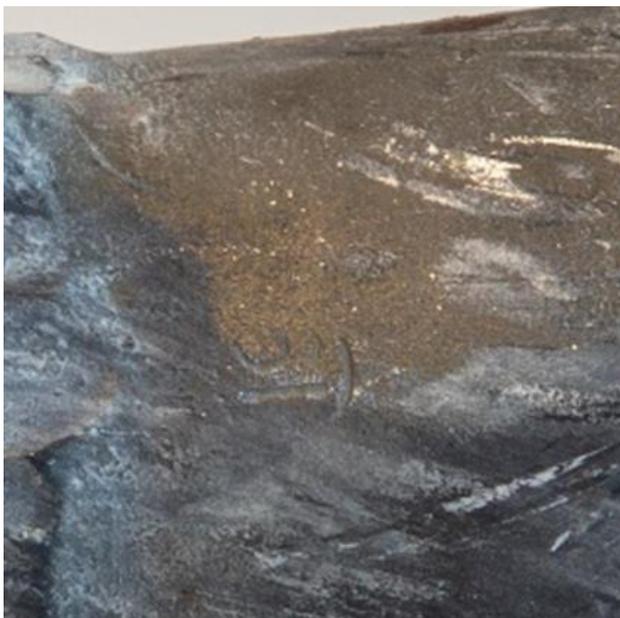
Further identification was attempted based on a small marking on the tail fin retrieved from the scene. This marking was discovered near the top of the shaft close to where it originally was attached to the warhead. As shown in Figure 36, the marking appears to represent an encircled “19”. This marker may refer to the tail fin manufacturer, but this could not be confirmed.

Figure 36 Marking on the tail fin shaft, possibly representing an encircled “19”.

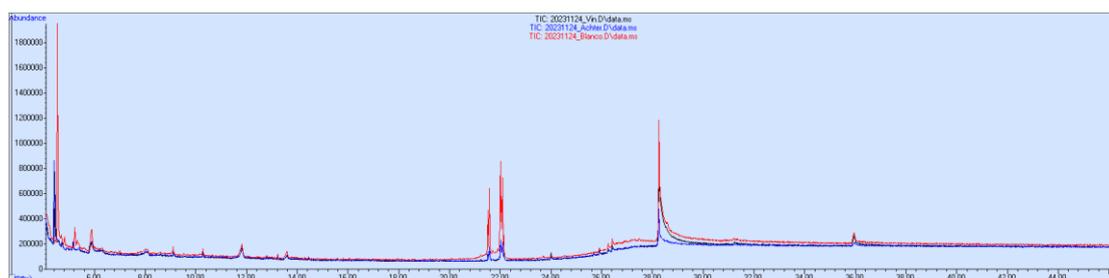
For chemical (explosive) trace analysis, the tail fin was sampled by swabbing its surface with a sterile cotton swab soaked in 50%/50% methanol/acetonitrile (MeOH/CAN). The same has been done in and around the tracer pocket. A blank is taken by repeating the process of soaking, without wiping over a surface. The cotton swabs were placed in a gas chromatograph (GC) vial containing 50%/50% MeOH/CAN. An extraction time of about 120 minutes was maintained. The liquids were filtered with a 0.45 µm polytetrafluorethylene (PTFE) filter, with the first drops being rejected. The samples were analyzed with a gas chromatograph mass spectrometer (GCMS)¹¹. The results of the analysis are shown in Figure 37. No difference is observed between the swabs of the tail fin, tracer pocket and blank.

Figure 37 GCMS analysis results.

Traces of explosive were not found by sampling of the surface of the tail fin. Explosive traces, if any, may have burnt or evaporated completely.

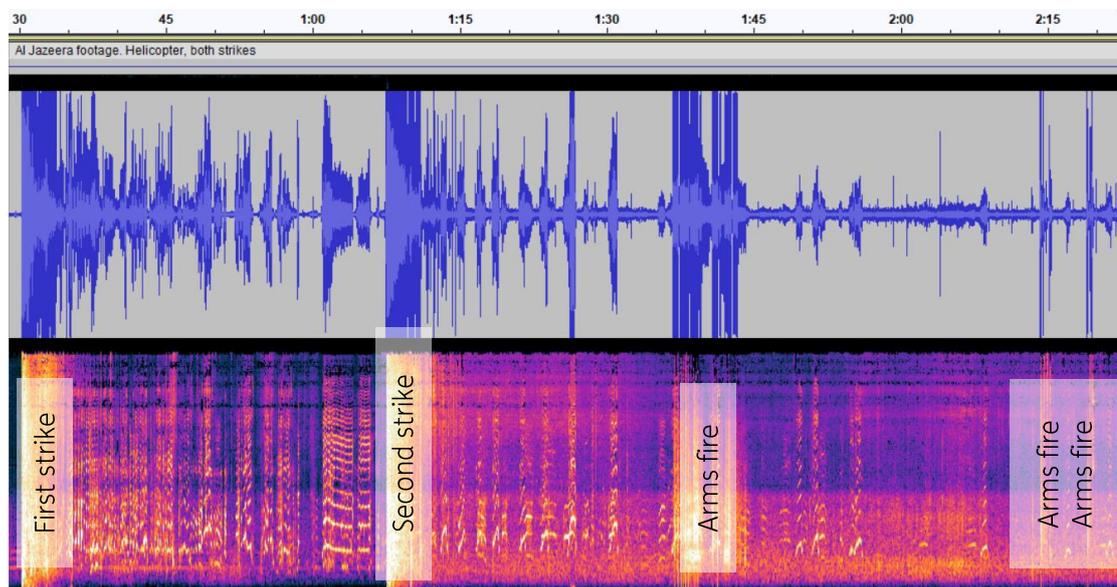
The Reuters and AFP cameras stop recording at the moment of the second strike. The Al Jazeera camera goes down but keeps recording. About thirty seconds and one minute after the second strike, arms fire can be heard [Al Jazeera footage. Helicopter, both strikes.mp4]. The moments of the strikes and arms fire are shown in Figure 53. The arms fire consists of one burst of about 25 shots, followed by two bursts of about nine and twelve shots (Figure 54), one burst of three shots (Figure 55) and a single shot (Figure 56).

Figure 53 Waveform and spectrogram with the moments of the first strike, second strike and arms fire.

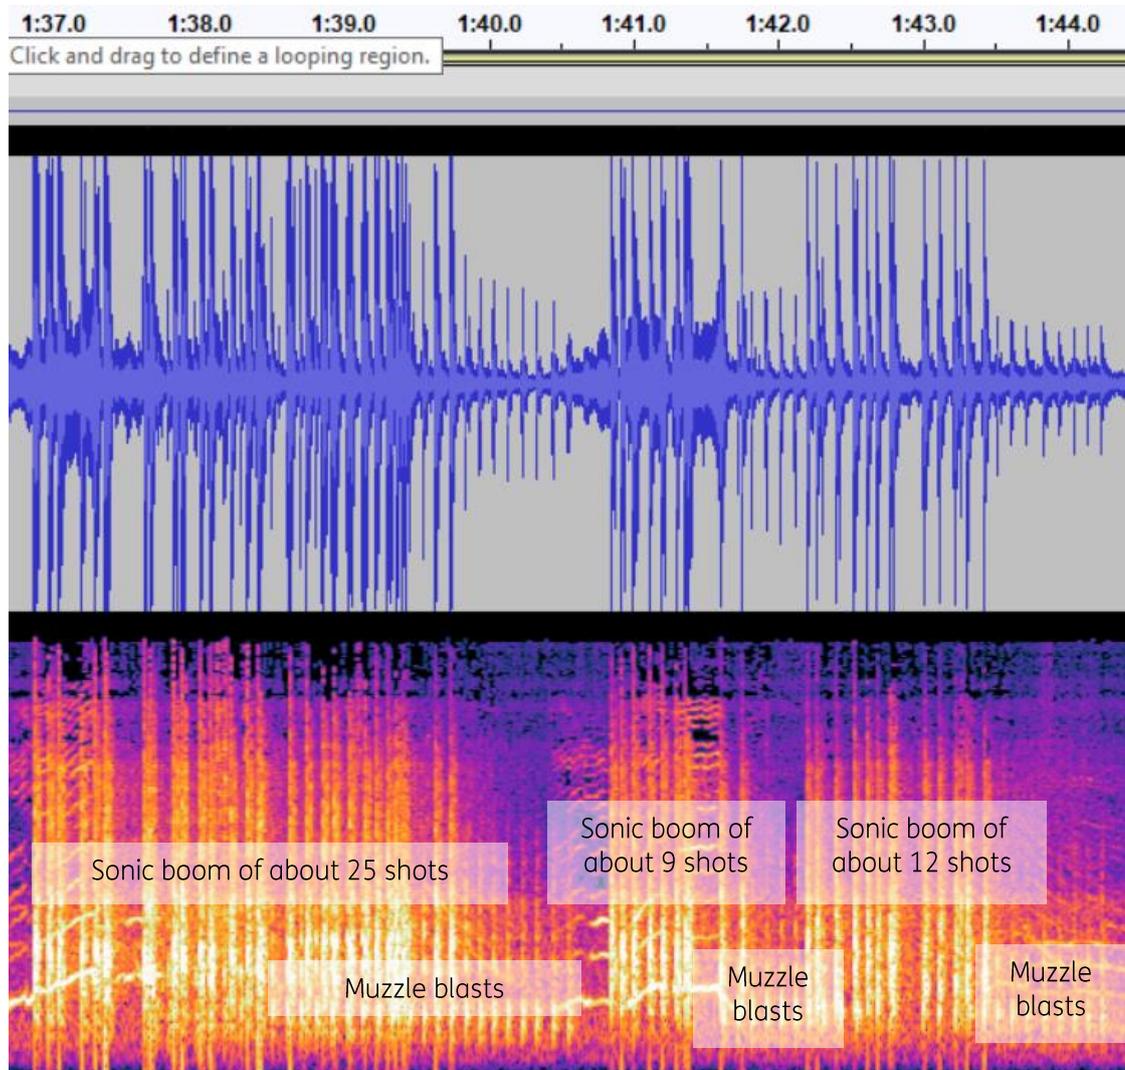
Figure 54 Three bursts of arms fire: sonic boom of about 25 shots, followed by the sonic boom of about nine shots and of about twelve shots.

The bursts in Figure 54 are compared against measurements made by TNO of .50 caliber (12.7 mm) rounds fired by a heavy machine gun on a firing range of the Netherlands Ministry of Defence (MoD). The frequency of the highest sound exposure levels of the sonic booms of around 1000 Hz , and a lower spectrum for the muzzle blasts, are found to be consistent with the TNO measurements.

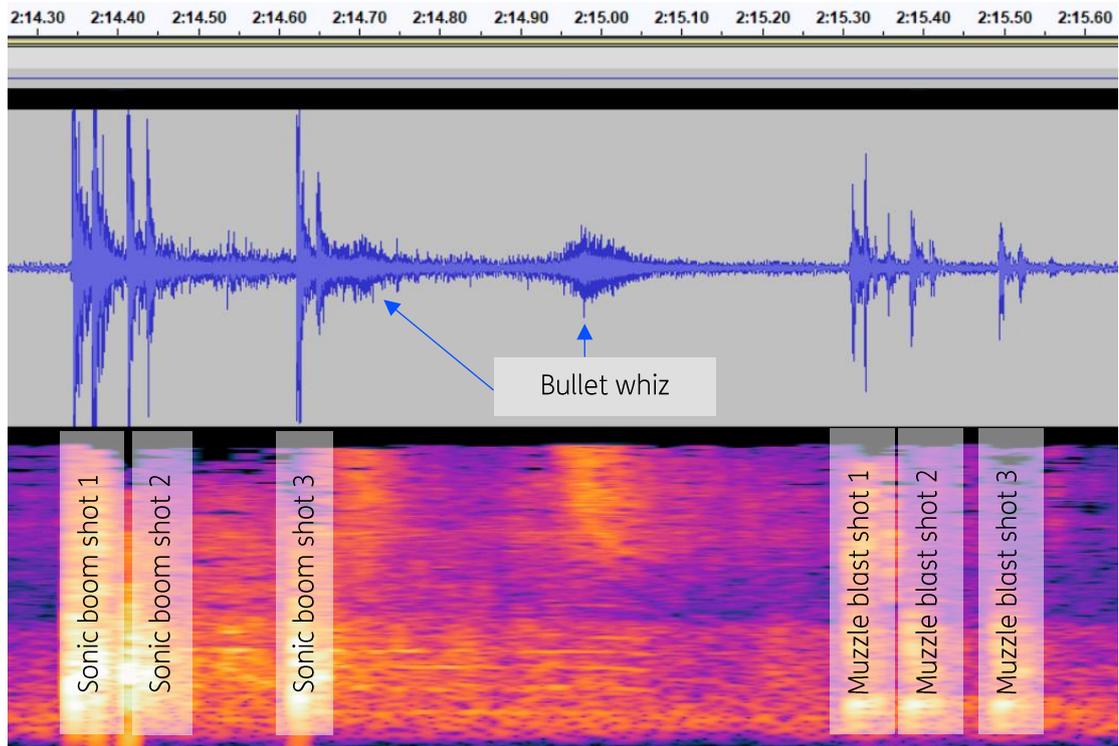
The audio for the burst of three shots in Figure 55 allows for determination of the interval between the sonic boom and muzzle blast per shot. These intervals are 0.97 s, 0.97 s and 0.90 s for shot number one, two and three respectively¹⁵. In between the sonic booms and muzzle blasts, two whiz-type of sounds are heard that are thought to represent bullets that are travelling at subsonic speed at close range to the microphone. The interval between the sonic boom and bullet whiz of the third shot can be distinguished. This interval starts at about 0.313 s and ends at about 0.428 s, and measures roughly 0.35 s where the whiz has the highest amplitude.

Figure 55 Arms fire consisting of three sonic booms, two bullet whizzes and three muzzle blasts.

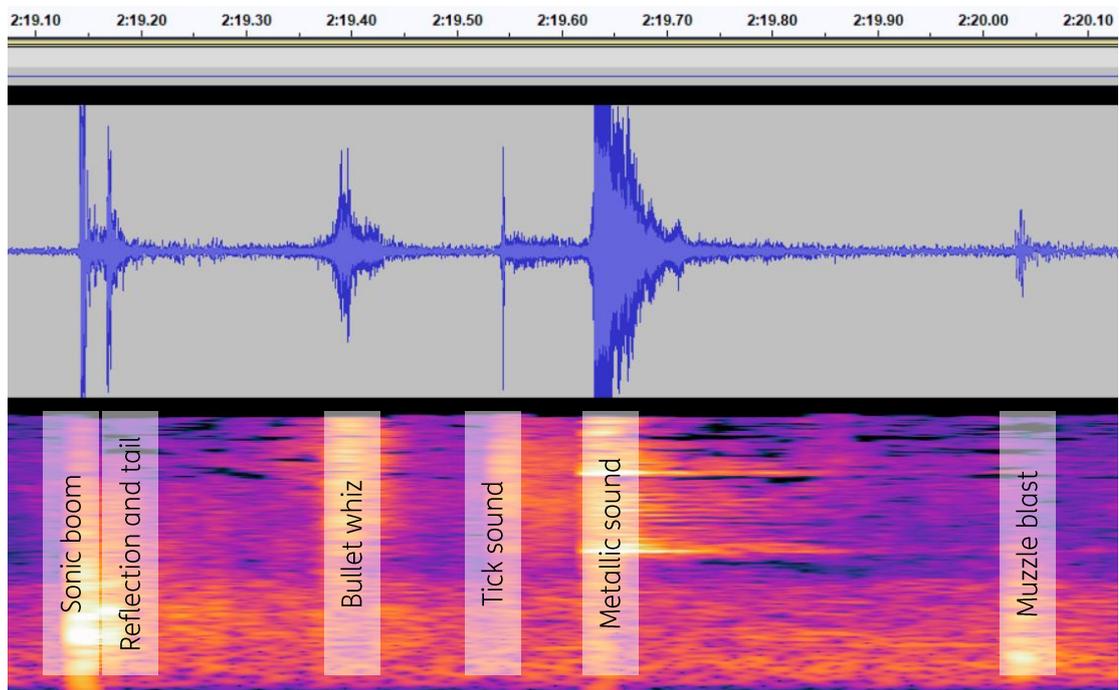
The audio for the single shot in Figure 56 includes a tick and metallic sound that is thought to relate to an impact. When the sonic boom is set at $t = 0$ s, the reflection occurs at 0.026 s^{16} , the bullet whiz at 0.25 s (at the highest amplitude), the metallic impact sound at 0.49 s and the muzzle blast at 0.89 s .

Figure 56 Arms fire consisting of a sonic boom with reflection and tail, a bullet whiz, a tick and metallic sound and a muzzle blast, all related to a single shot.

Based on the sequence of sounds in Figure 56 it is anticipated that the bullets have slowed down in flight from supersonic to subsonic speed allowing their air disturbance to be heard when passing (whizzing) by the microphone of the Al Jazeera camera at a close range.

¹⁸ The bullet impacting the wall observed in the back of Figure 15 may have caused the metallic sound in Figure 56.
