Investigation of the Aalma el-Chaab incident

TNO 2023 R12286 – 26 January 2024

Author(s)	Not disclosed
Classification report	TNO Public
Report text	TNO Public
Number of pages	70 (excl. front and back cover)
Sponsor	Reuters News & Media Limited
Project name	Reuters investigation

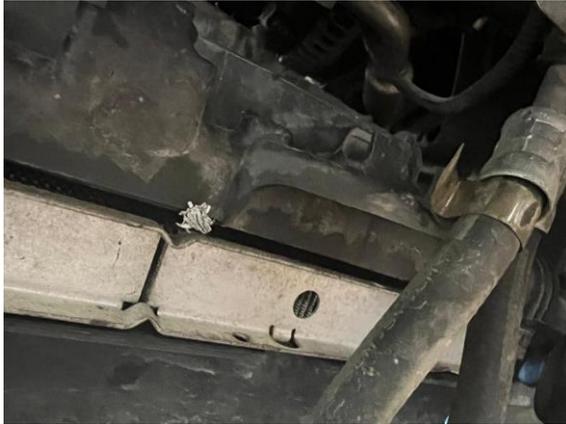
Three fragments were removed from the Reuters car that was parked up the hill roughly ten meters away from the car that was hit. One of these fragments is shown in Figure 61. The fragments were sent by Reuters to TNO for analysis by means of SEM-EDX.

Figure 61 Fragment lodged in Reuters car.

The analysis showed that two of the fragments are made of aluminum and are covered with gravel and other metal and organic material. One fragment is made of iron and covered with silicon and calcium, presumably stemming from gravel. The fragments appeared to have a random shape.

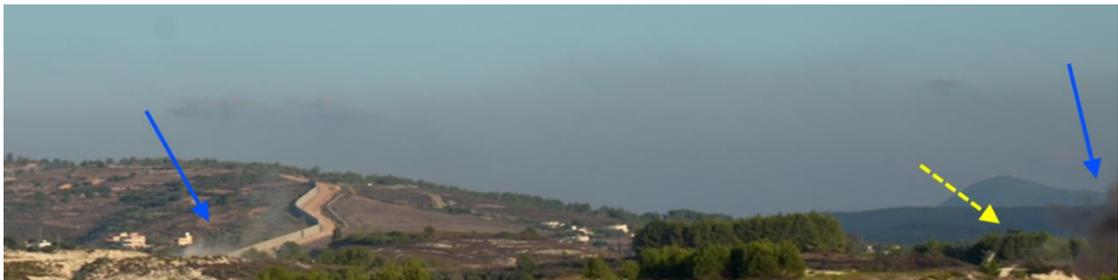
Approximately 45 minutes prior to the two strikes at the journalists' location, AFP cameras captured mortar fire towards the east. Figure 65 shows a screen capture from this footage [AFP Footage to the East 1.MP4]. Visible in the figure are a white and black smoke plume, indicated by blue arrows. Based on the analysis of similar footage, these plumes are assumed to be from the firing of an ammunition round from behind the UN 2000 Blue Line and its subsequent detonation on Lebanese soil. Also visible in the figure is a structure resembling an observation tower (yellow arrow). Given the direction in which the plumes are moving, and the fact that the impact happened about 10 seconds earlier, it seems likely that the this structure was the target of the strike.

Figure 65 Still from [AFP Footage to the East 1.MP4] that shows a white and black smoke plume (blue arrows), assumed to be from the firing and detonation of an ammunition round respectively. The yellow arrow indicates a tower like structure (with Mount Adir in the background).

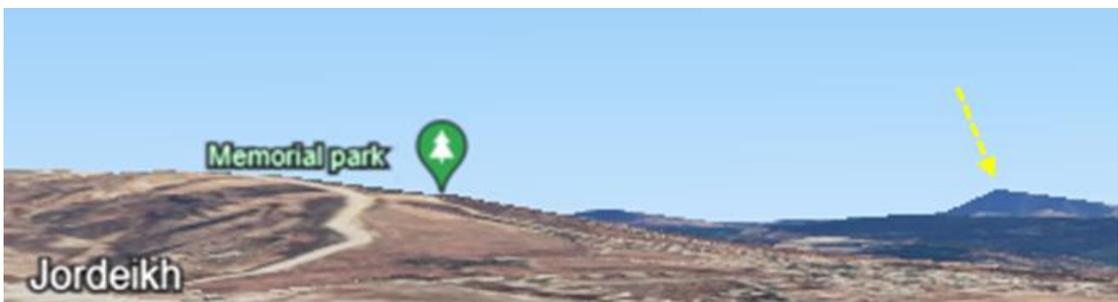
Figure 66 shows the view of Figure 65 captured in Google Earth. The mountain top visible in the background in Figure 65 (directly behind the observation tower) can be identified as Mount Adir. Drawing a line from the filming location to Mount Adir provides the direction of the impact location. This is shown in Figure 67 and Figure 68.

Figure 66 The view of Figure 1 captured in Google Earth. The yellow arrow indicates the top of Mount Adir.

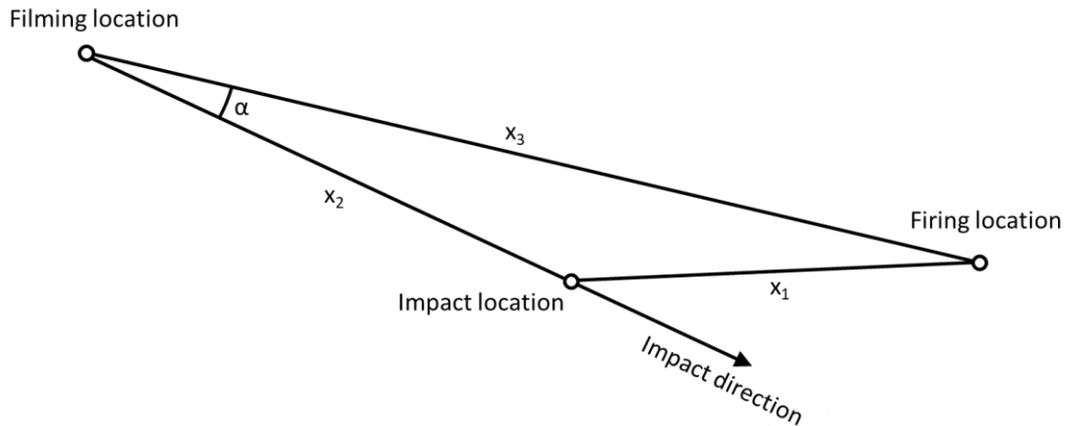
Figure 69 Schematic view of the filming location, firing location, impact location and impact direction.

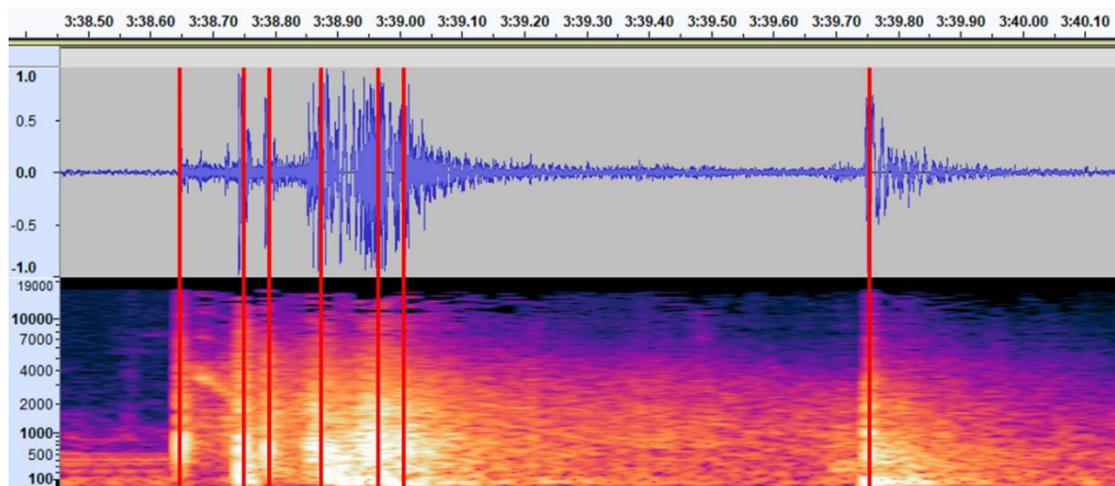
Figure 65 shows the audio waveform and spectrogram extracted from the footage. In the left of the figure, a cluster of six distinct pulses can be identified. This is consistent with an M329 APAM-MP-T round in airburst (AB) mode (see Table 2). In this mode, the projectile releases six submunitions detonating in quick succession (see Figure 43). Approximately one second after the detonations, the sound of the muzzle blast can be heard. Looking at the spectrogram in Figure 70, the muzzle blast can be distinguished by a low frequency pulse similar to that seen in Figure 19 and Figure 21.

Figure 70 Audio waveform and spectrogram extracted from the AFP footage. A cluster of six pulses is heard, followed by the sound of the muzzle blast approximately one second later.

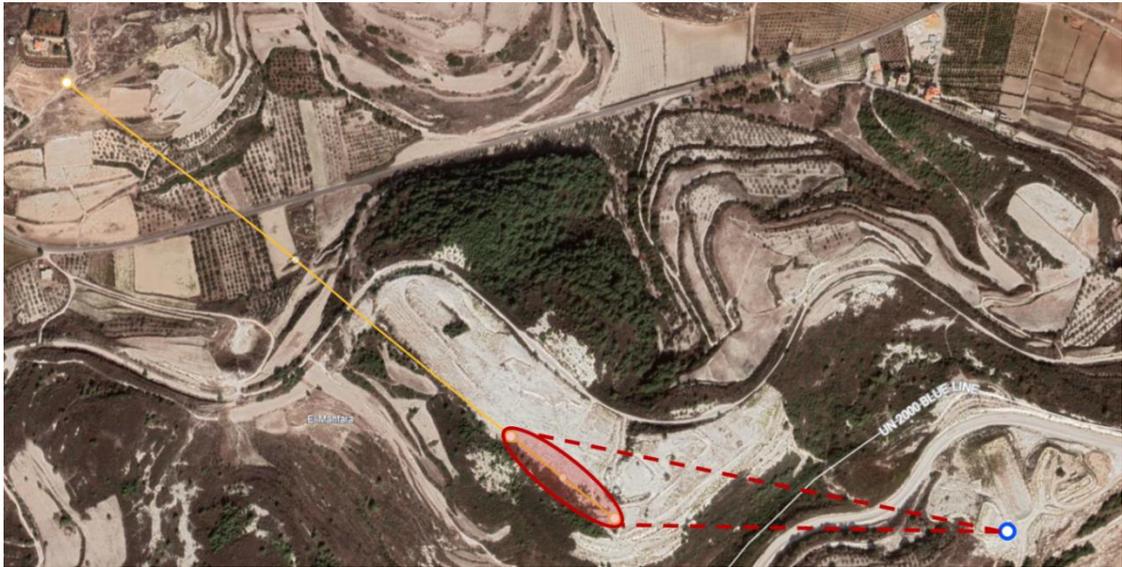
Using these values, the area in which the impact likely took place is shown in Figure 71. Figure 72 shows a more detailed view of the impact zone, which stretches across a hilltop.

Figure 71 The calculated impact location is within the red ellipse. The filming location (yellow) and firing location (blue) are also shown.

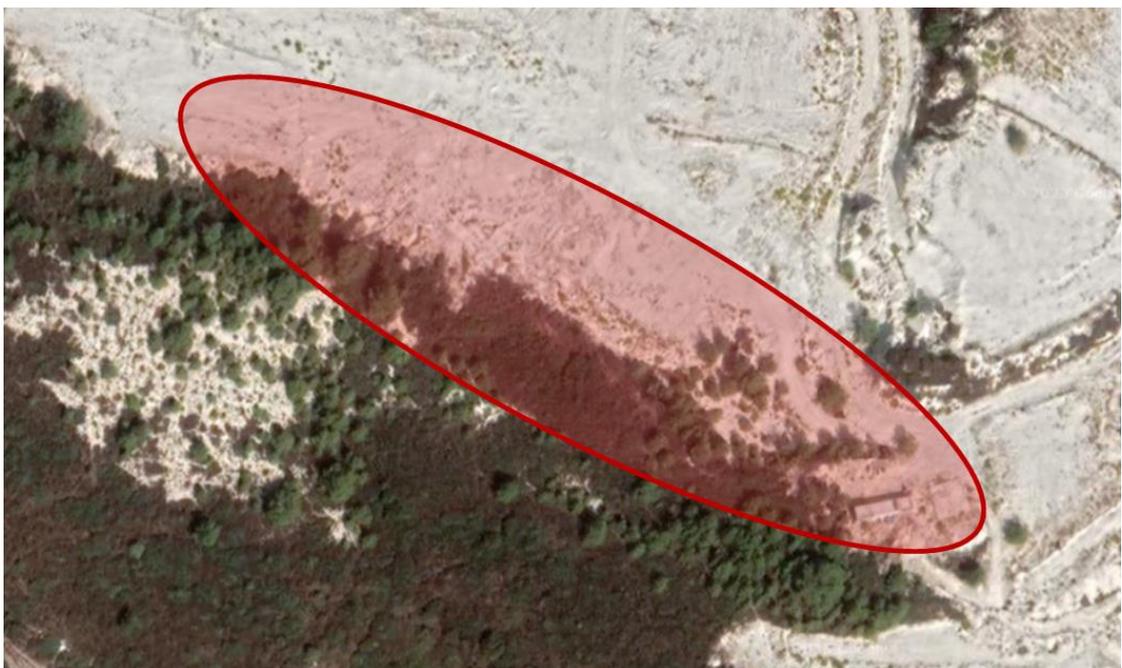
Figure 72 Zoomed in view of the calculated impact location (red ellipse).

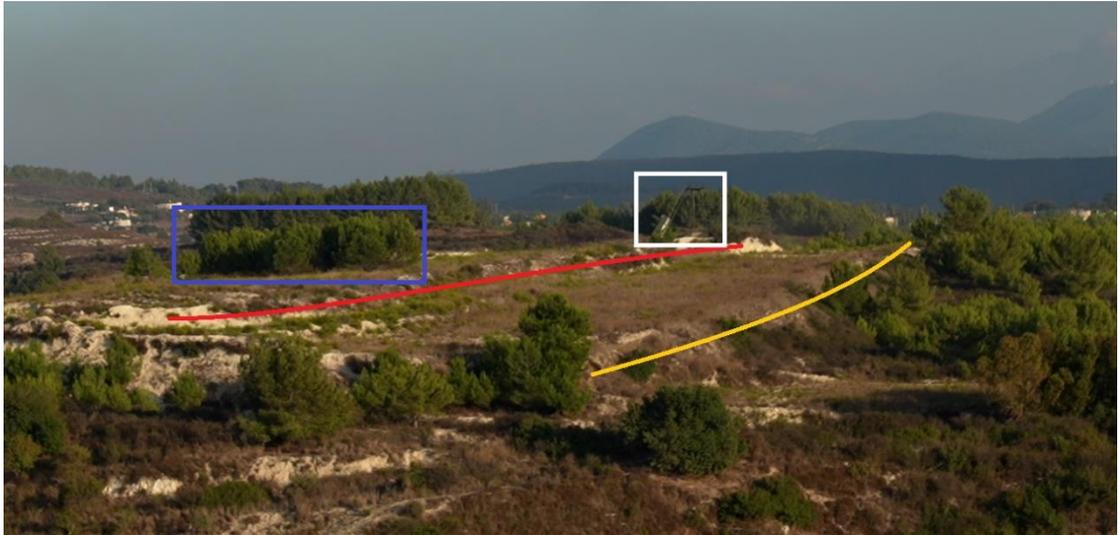
In [AFP Footage to the East 2.MP4], the observation tower and its surroundings are visible in more detail. Figure 73 shows a screen capture from this footage, showing the observation tower (white frame), as well as three distinctive features of the surroundings. Figure 74 shows the same view in Google Earth, with the distinctive features from Figure 73 labelled using the same colours. The observation tower is not visible in Figure 74, but its approximate position is indicated by a white box. The blue circle in Figure 75 shows the approximate location of the observation tower, which is within the impact zone calculated based on the audio analysis (red ellipse), at approximately 880 meters from the filming location.

Figure 73 Screen capture from [AFP Footage to the East 2.MP4], showing the observation tower (white box), as well as other distinctive features of the surroundings.

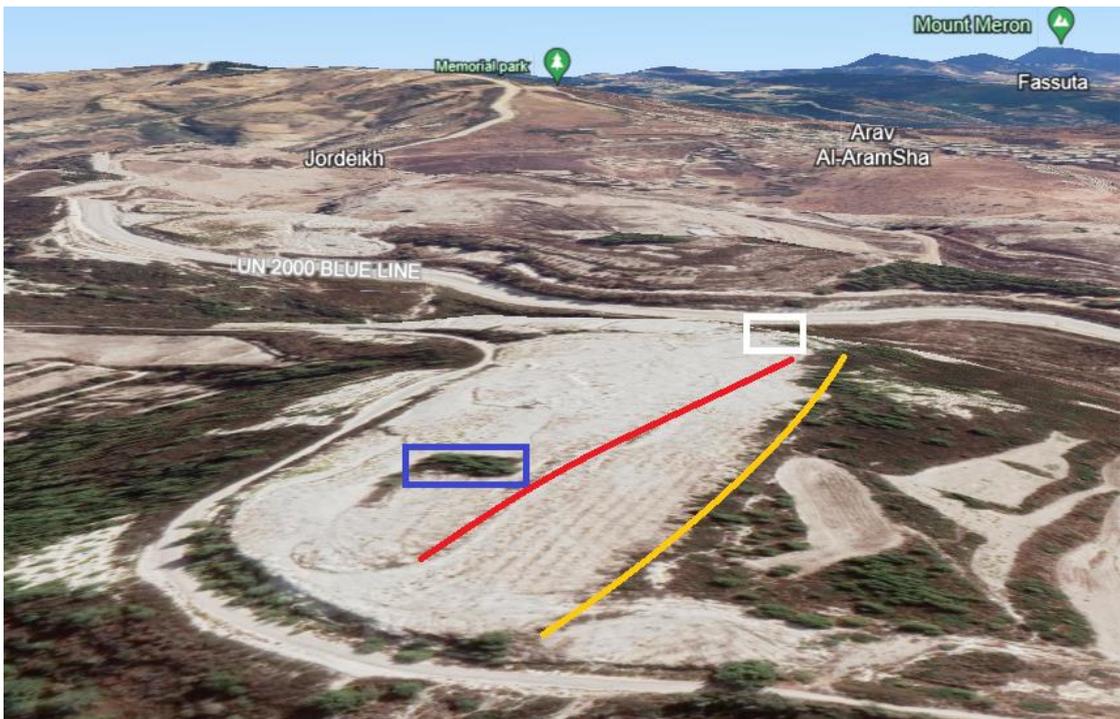
Figure 74 The view of Figure 73 captured in Google Earth. The distinctive features from Figure 73 are labelled using the same colours. The observation tower is not visible in this figure, but its approximate position is indicated by a white box.

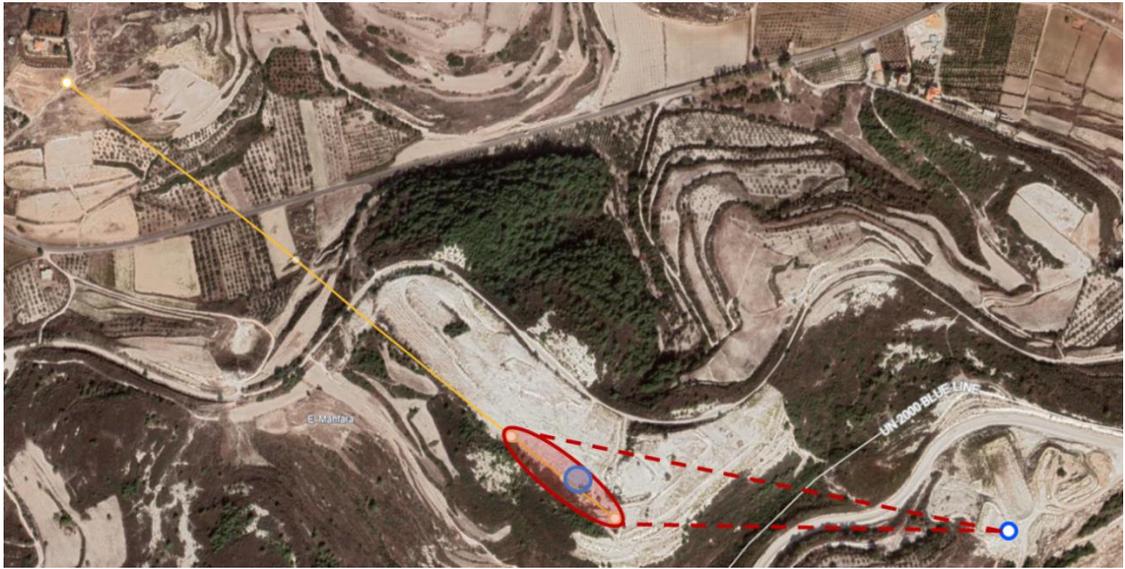
Figure 75 The impact location calculated from the audio analysis (red ellipse), with the approximate location of the observation tower determined from the video analysis (blue circle).
