Proceeding Paper

Post-Corrosion Repair Thickness Measurements Using Lamb-Wave Technology: An Aviation MRO Case Study [†]

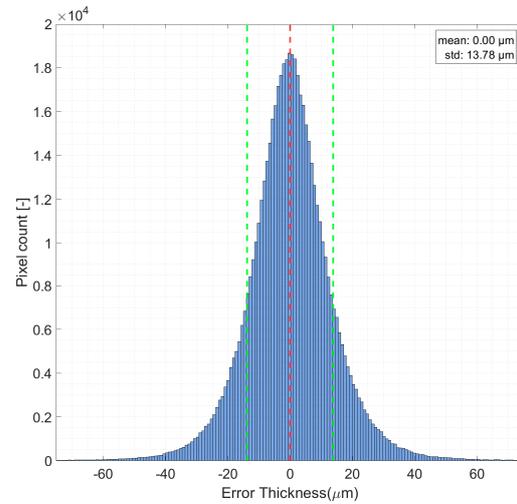
The histogram presented in Figure 3 depicts the variation in thickness between measurements. It is effectively a measure of the system's ability to repeat multiple measurements without significant deviations from each other. The figure indicates a normal distribution with a standard deviation of 13.78 μm , while the majority of the values are within 50 μm —a requirement set during the conceptual and design phases of the system to ensure reliable thickness readings. This is a promising first result, suggesting that the current configuration is able to reproduce repeatable thickness measurements in thin aircraft panels (0.5–2 mm [8]) and that a 10% thickness reduction should be detectable.

Figure 3. Repeatability test results. Variation in thickness between measurements calculated using the recorded acoustical data from 14 sets of measurements. The red dashed line indicates the position of the mean, and the green dashed lines are the \pm one standard deviation locations.

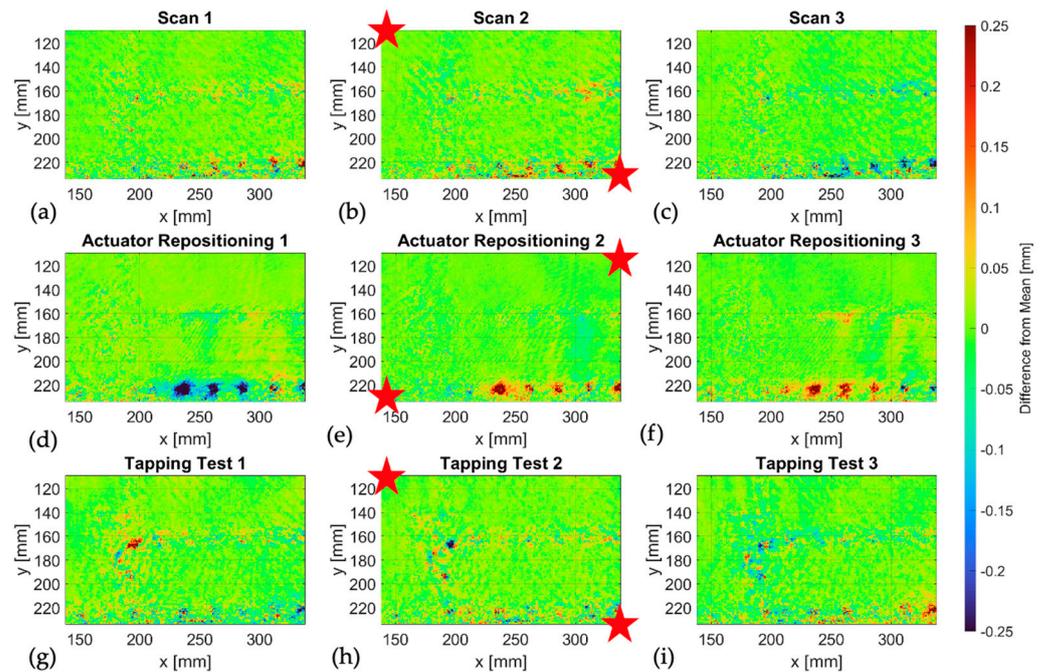
Figure 5. Repeatability (a–c), actuator repositioning (d–f) and tapping (g–i) test results. The difference between the actual thickness and the mean calculated for each thickness map. The red stars indicate the position of the actuators during each test and are the same across tests of the same row.

All tests indicate a larger spread in the rivet areas compared to the nominal thickness regions, where the difference from the mean is within a $\pm 2 \mu\text{m}$ range. In the rivet areas, that range is within $\pm 5 \mu\text{m}$, indicating that even small subsurface effects can influence measurements. In order to attempt a first indication of any potential vibration and actuator placement effects, the mean, standard deviation and the maximum error in nominal and rivet areas were calculated for each experiment. The mean is then the average of the three test cases within each experiment, which for all experiments is around $1 \times 10^{-18} \mu\text{m}$. This value is not significant within numerical precision and can therefore be considered effectively zero. The results are summarized in Table 1 below.

The data presented in Table 1 show that both the actuator repositioning and vibration (tapping) tests yield results consistent with the repeatability baseline. The mean deviations are effectively zero across all experiments, confirming that no systematic bias was introduced by actuator movement or external disturbances. Standard deviations in the nominal regions remain within 50–65 μm , while slightly higher variability is observed in rivet areas due to localized structural discontinuities and acoustic coupling. Maximum errors are below 0.9 mm in all cases, indicating that the system maintains stable performance under moderate external excitation and actuator repositioning, with measurement variation comparable to normal repeatability.
