EMERGENCY EVACUATION: HOW BETTER INTERIOR DESIGN CAN IMPROVE PASSENGER FLOW

Louis C. Boer
Boer@tm.tno.nl
TNO Human Factor Research Institute
P.O. Box 23, NL 3769 ZG Soesterberg

Rolf Skjong
Rolf.Skjong@dnv.com
Det Norske Veritas,
NO-1322 Høvik

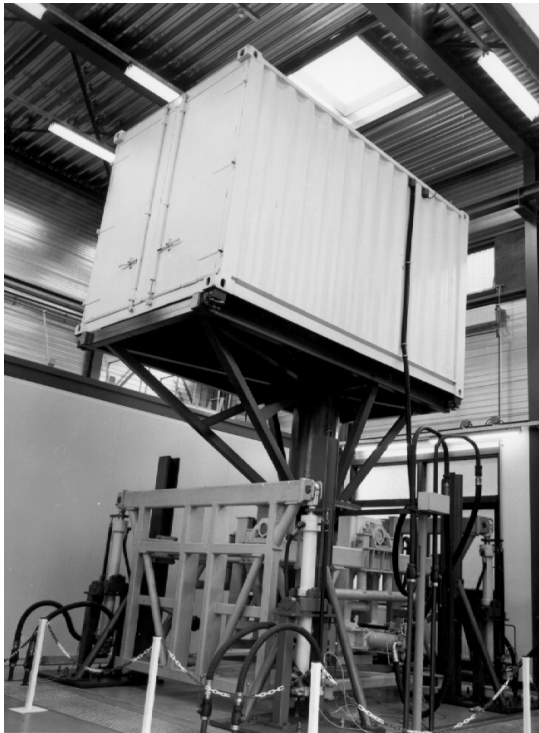
Figure 1: Ship Motion Simulator of TNO

When passengers are moving smoothly to their assembly stations, the time required can be estimated on the basis of normal walking, that is, human walking speed in buildings (e.g., see IMO, 2001). In other words, the effects of ship motion on walking speed are not considered. One of the aims of the MEPdesign project was to see what happens with walking behaviour if the platform moves or leans to one side in imitation of list/heel and roll/pitch. TNO did studies in the ship motion simulator shown in Figure 1. Data included:

The data are described in detail in Bles et al.(2001). In general, ship motion reduced walking speed. Evacuating a 15-20 degree listed platform would require 33% extra time. The same increase holds for vehement ship motion. This clearly shows that the estimates of the simplified analysis of the IMO guidelines are too optimistic because they ignore ship motion.

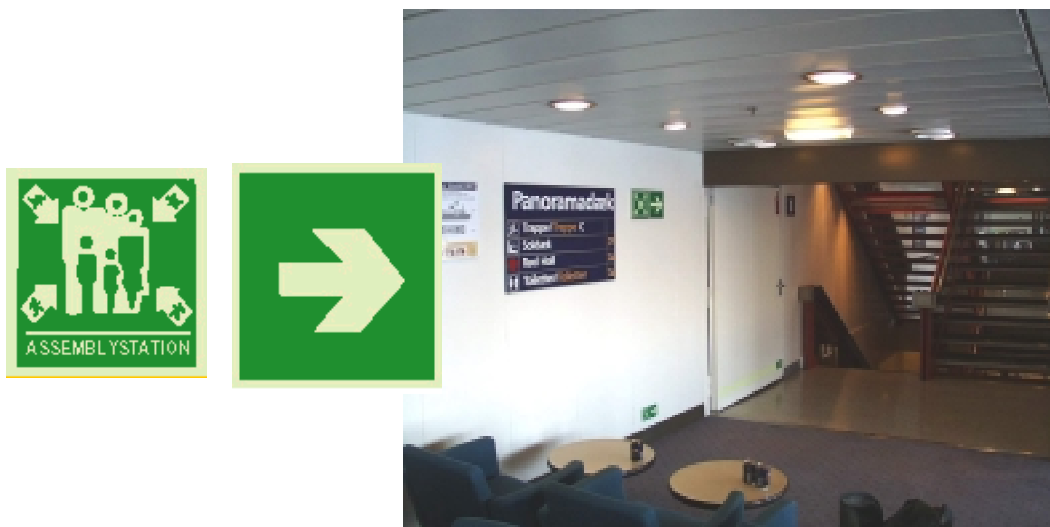
Figure 2: Assembly signs (photograph courtesy of Danish Maritime Institute).

Wayfinding problems are one of the reasons for slow evacuation. When there is no crew around for assistance, the passengers should find their assembly stations on the basis of signs alone. Despite care of the IMO, not all signs have been standardised, and these signs can be improved for human visual perception. Figure 3 presents an example for arrows. The arrow in the middle of the figure is the IMO standard. It is a rather "fat" symbol. Arrows less fat (left side of the figure) will retain their visibility longer during conditions such as smoke and are, hence, better. The figure also illustrates lack of standardisation.

- Signs can be placed poorly, thus confusing the passengers. The photograph of Figure 2 provides an example; the arrow points to the stairwell but does not indicate up or down. Guidelines are required for the placement of the assembly signs.
