Zwarte Wiek Expansie van Monitoring door Technologie

TNO 2026 R10561 – 10 March 2026
ZWEMT

Author(s)	J.C.M. Breuer, E.K. Fritz
Classification report	TNO Public
Number of pages	38 (excl. front and back cover)
Number of appendices	0
Project name	ZWEMT
Project number	060.55383

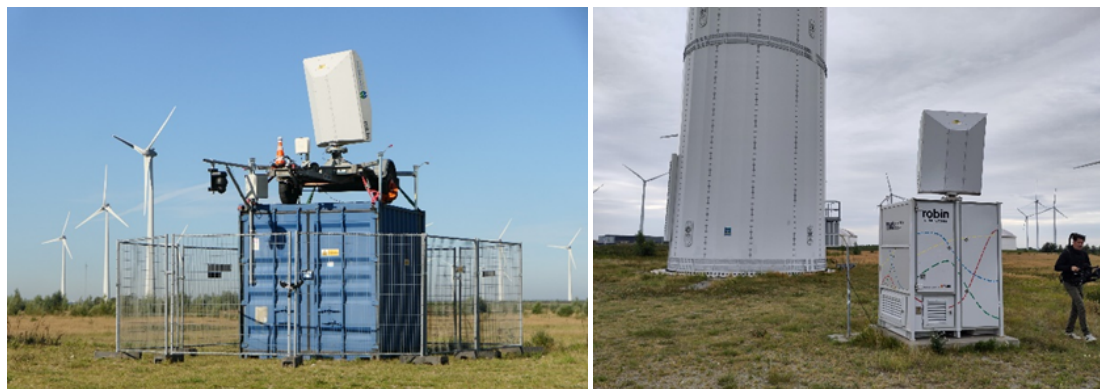
Figure 2.2: Setup with Waardenburg Ecology (left) and TNO (right) 3D MAX® radar, left picture provided by Waardenburg Ecology

A Robin Radar 3D MAX® was installed at the location shown in Figure 2.1 with a power supply from the nearby Lagerweg L136. For the first month, the Robin Radar 3D MAX® of Waardenburg Ecology was installed, which was replaced by the TNO 3D MAX® at a later stage. Photos of the two radar systems are given in Figure 2.2. The location of the TNO radar was similar, with a small distance of less than 10 m.

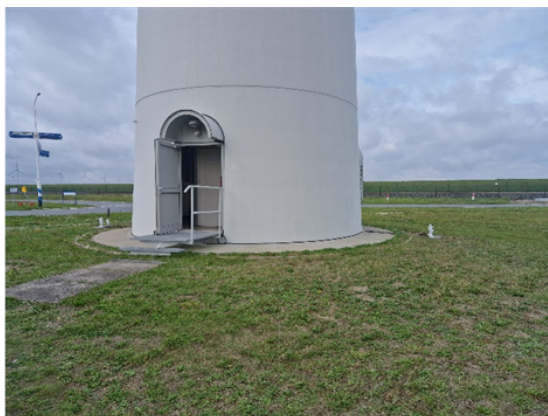
Figure 2.3: Picture of turbine 21 with two pairs of cameras mounted on either side

Figure 2.3 shows turbine T21 with two pairs of cameras installed on the ground.

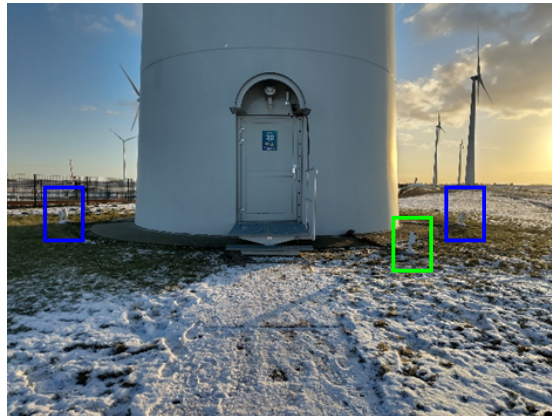
Figure 2.4: Picture of turbine 20 with two pairs of cameras on either side (in blue) plus an additional thermal camera for stereography tests (in green)

Figure 2.4 shows turbine T20 with two pairs of cameras installed on the ground.

At turbine 20, a third thermal camera was placed on one side of the turbine to make a stereo pair with the already present thermal camera next to the visual camera (see Figure 3.6). Thus, there is a left and a right “eye”. With the stereo setup, the height of the birds can be estimated. This could give additional information on whether the birds fly in the danger zone near the rotor disk. With further analysis, it could also give an estimate of the size to give information on the species group.

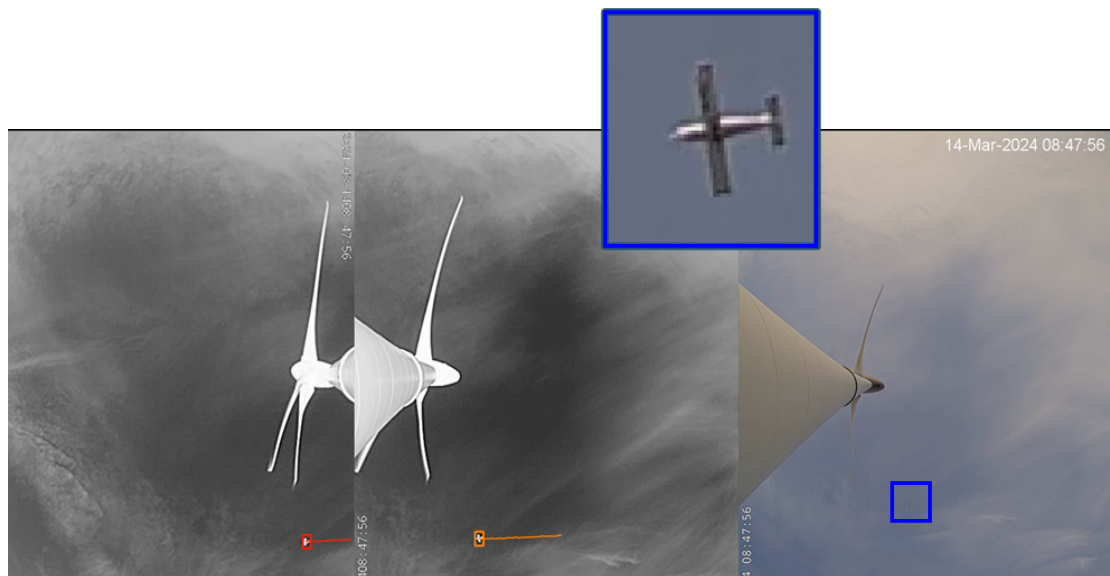
Figure 2.5: Compound image of airplane passing WT21 on the 14th of March

During the project, the visual cameras seemed less suitable for 24/7 observations even though the resolution is much higher compared to the thermal cameras. Compound images (see Figure 2.5) using both thermal cameras on either side of the towers were quite insightful and are also available for both turbines. The stereography setup gave additional information on the flight height of the objects. However, this was only tested on turbine 20 (black blade).

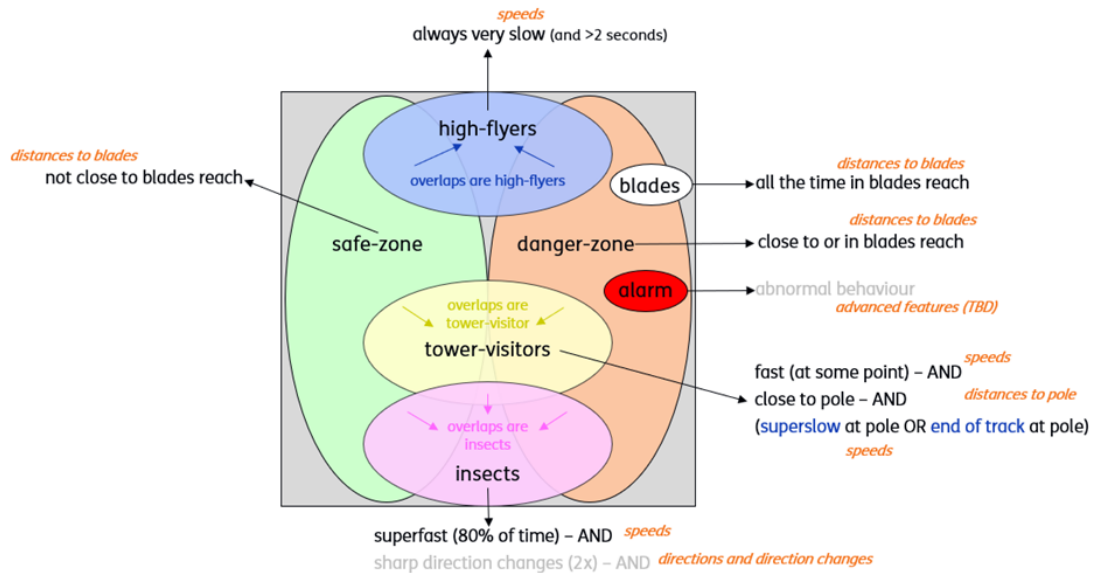
Figure 2.6: Bird track classification

The second step is to filter out the false tracks from the rotor blades. As they are big objects,

this is based on the amount of nearby detections. After this, the detections are classified based on several parameters, mainly location with respect to the rotor blades and speed of the object. An overview of the classification strategy is given in Figure 2.6.

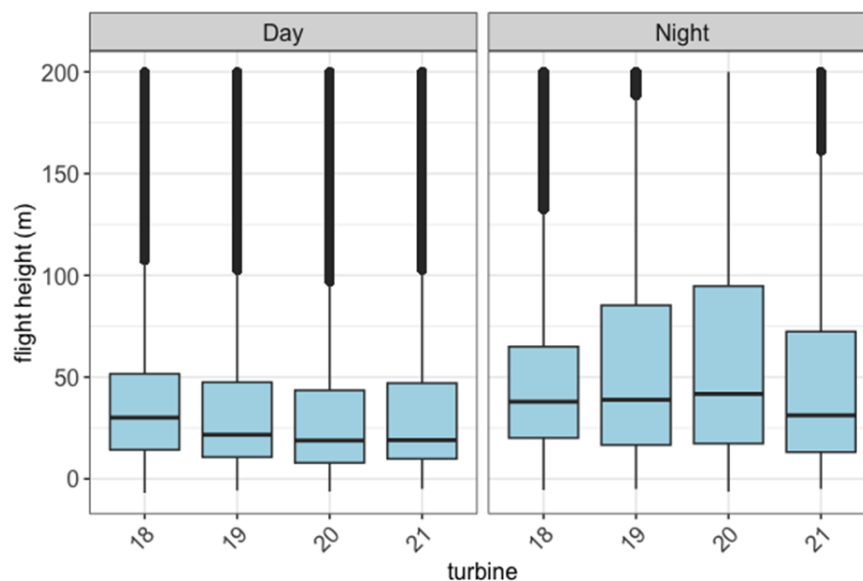
Figure 3.1: Average flight height around the different turbines split by day and night, reproduced from [5]

The outcomes are presented as part of the final reporting of the overall Zwarte Wiek project. The short conclusion is: the presence of the black blade, to the extent measurable with the 3D MAX® bird radar, has no effect on the flight height, flight speed and the straightness of flight of birds within a radius of 200 m of the wind turbines. Figure 3.1 exemplarily shows the flight height measured around the four turbines at day and night. More results can be found in [5].

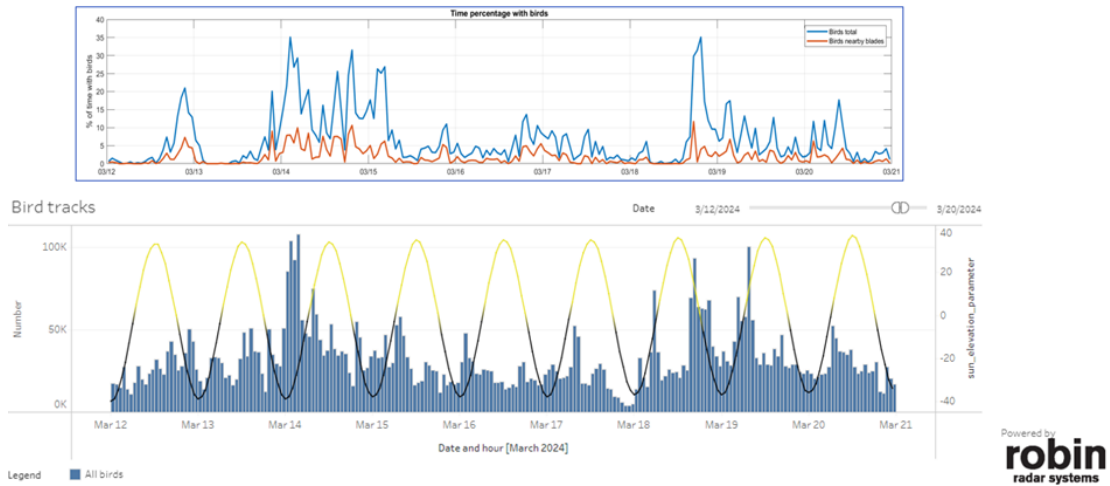
Figure 3.2: Comparison between bird activity based on camera (top) and radar (bottom), sine wave shows the elevation of the sun (day/night), screenshot from Robin Radar’s insight software

around the turbines. However, a rough comparison between the camera detection and radar detection shows similar trends, see Figure 3.2.

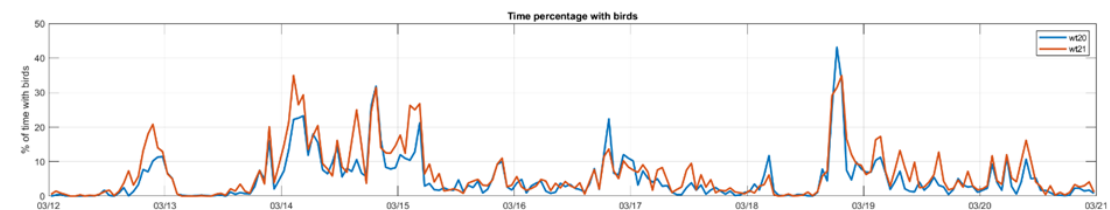
Figure 3.3: Comparison between bird activity around turbine 20 and 21 for the 12-20th of March

If the bird activity between the two different turbines is compared, there is no clear difference between the turbine with a black blade and the one without a black blade, see Figure 3.3. A more detailed analysis would need to be done to draw any final conclusions on this.

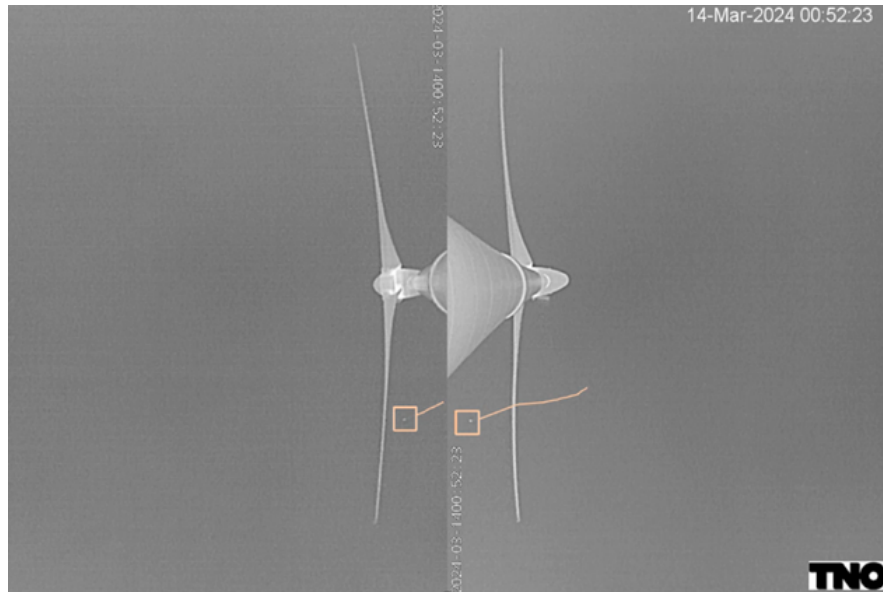
Figure 3.4: Still of a compound image from the thermal cameras showing the full rotor disk

Using compound video images of the thermal cameras, the behaviour of birds near the turbine can be studied. An example of such compound images with a detected track is shown in Figure 3.4.

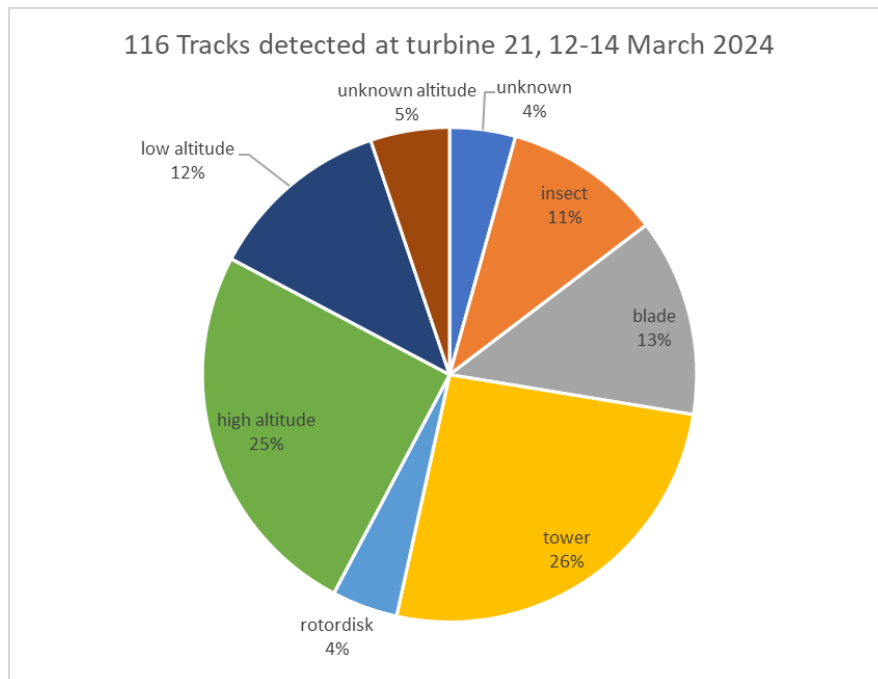
Figure 3.5: Categorisation of 116 tracks from 12-14 March 2024, Turbine 21

The detected tracks within videos of a short amount of time (12th to 14th of March 2024) were evaluated by ecologists (Waardenburg Ecology and Altenburg & Wymenga) and categorised by TNO. This categorisation is shown in Figure 3.5 and an explanation of the categorisation is given in Table 3.1.

Based on this small dataset, the current version of the algorithm still has about 25% false positives shared between insects and blades. Also, around a quarter of the tracks are birds interacting with the tower of the turbine, either landing on the ring or “visiting” the tower at low altitude. The remaining 50% are birds passing on the turbine, most of them at much higher

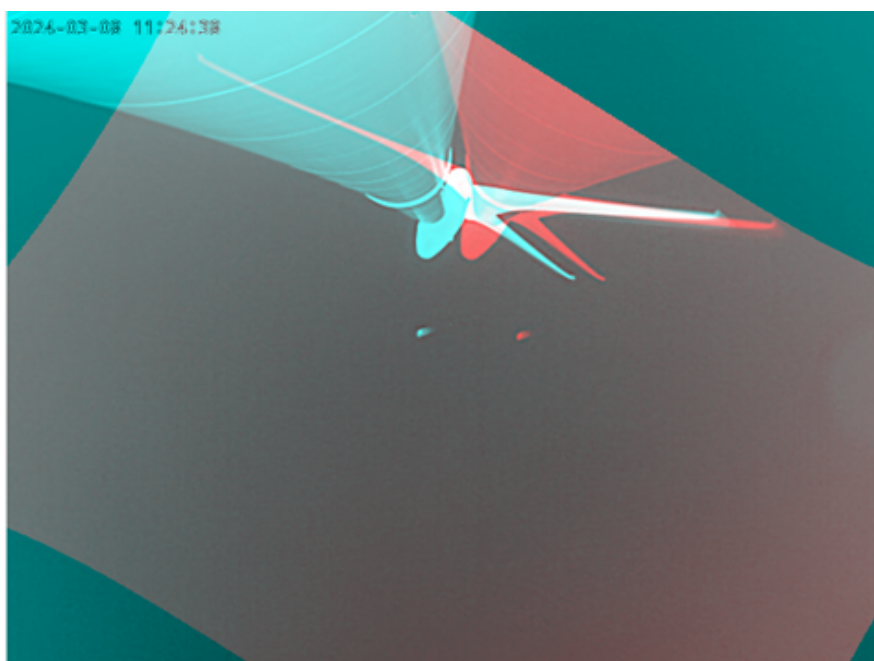
Figure 3.6: Still of initial stereo image of a single bird. Distance between red and blue gives an indication of the height

In Figure 3.6, the bird has a bigger distance between the left and right camera than the back of the nacelle of the wind turbine. This means that the bird is flying lower than the nacelle. The analysis of the flight height of the birds was done for a limited dataset from the 12th of

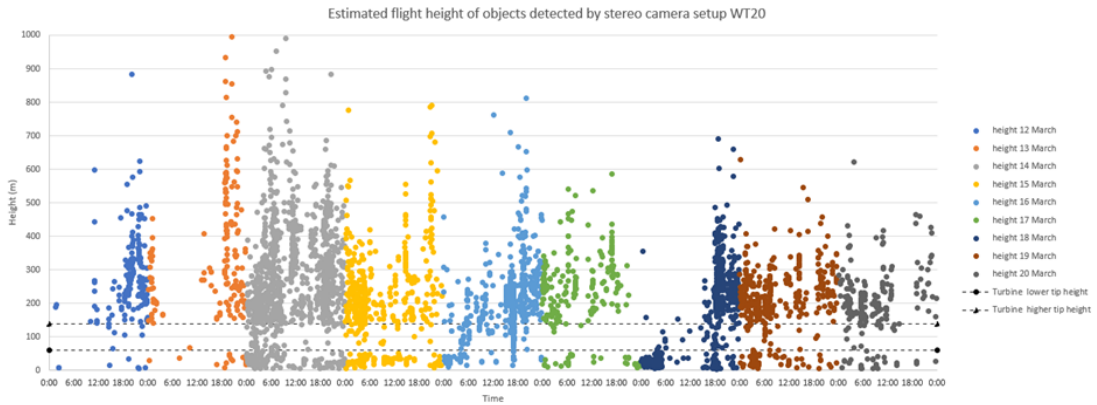
Figure 3.7: Estimated flight height of objects detected with the stereo setup of WT20

March to the 20th of March and is shown in Figure 3.7. Figure 3.8 shows a zoomed in version focussing on flight heights between 0 m and 200 m.

This preliminary evaluation of the flight height of objects detected with the stereo setup is interesting because only a limited number of objects are detected at the rotor height of the turbine. It should be noted that the stereo setup is not yet working perfectly, as there are some clear miscalculations of the height. Some examples are circled in Figure 3.8. In light blue, on the 16th of March, there is a flock of birds flying over the turbine. Because the motion detection algorithm “jumps” between two birds which are flying close together, the height estimate, which is based on the distance between the “right” and “left” camera, is wrong. This leads to a detection of the flock at a lot of different altitudes. In the dark blue on the morning of the 18th of March, there is a big cluster at low height due to insects.

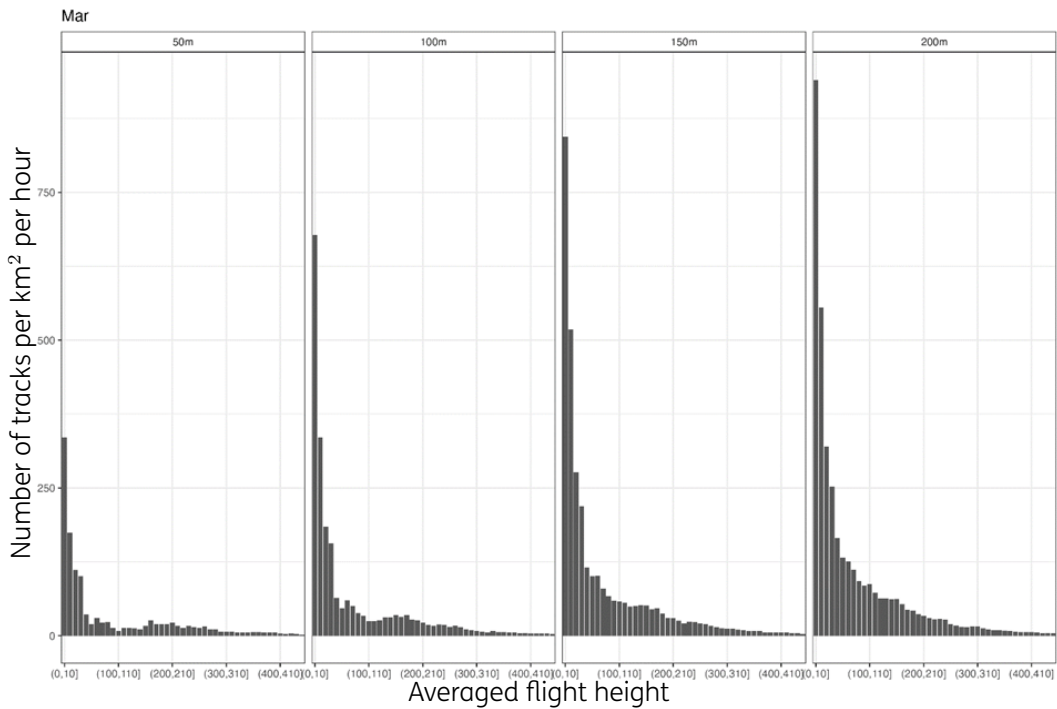
Figure 3.9: Tracks per km² per hour at different distances from the turbine based on radar data for the month of March, figure adapted from Waardenburg Ecology

Additionally, the comparison with flight heights from the radar data shows deviations, compare Figures 3.9 and 3.10. In Figure 3.9, the numbers at the top of the four columns indicate the distance from the radar. From this comparison, it can be observed that the trend in camera and radar data is similar. Both show a dip close to the rotor height, which would be interesting to investigate in more detail. As it was not part of the original ZWEMT project scope, there was limited time to look into this. However, TNO is currently working on a new project to extract additional information from this data.

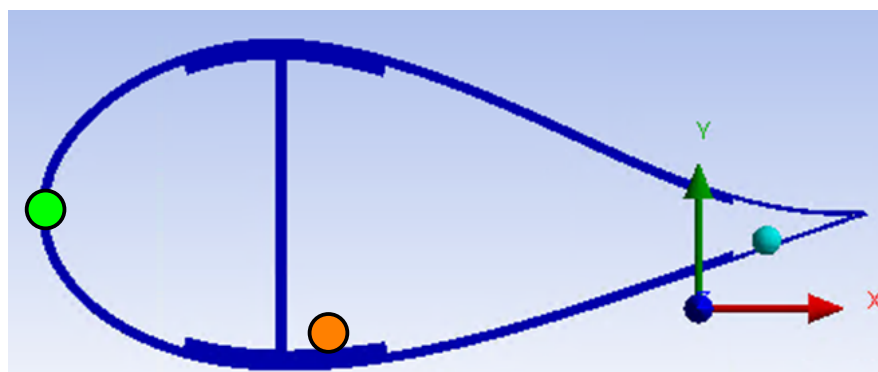
Figure 3.11: Location of sensors in a blade (preferred: green, current position: orange), edited screenshot from Ansys software

During installation, it became apparent that the preferred location of the sensors, namely on the inside of the blade directly behind the leading edge (LE), was not accessible. This location is indicated as green dot in Figure 3.11. A fan installed for the LE heating system for de-icing blocked entrance to the LE cavity. Instead, the sensor was placed directly behind the shear web as indicated by the orange dot in Figure 3.11. Note that Figure 3.11 is an approximation of the turbine blade structure and, thus, not an exact design replica. Figure 3.12 shows the installed sensor.

The current location of the sensors is not ideal and part of the signal is probably damped before it is registered.

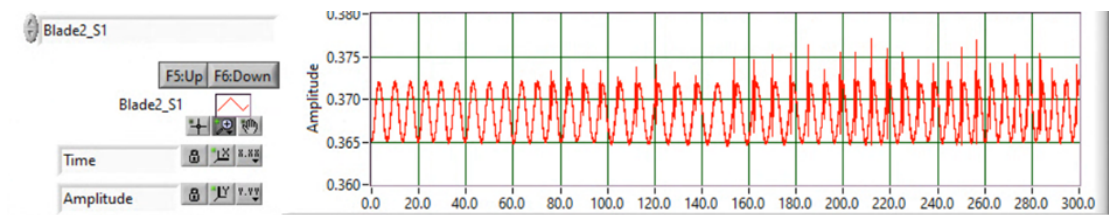
Figure 3.13: 5 min sample: First 1 min no noise, afterwards peak at each rotation

Under certain conditions, both turbines produce a cyclic noise signal as shown in Figure 3.13. These signals are very similar to a bird impact, compare Figures 3.14 and 3.15, and are classified

by the system as likely to be an impact. While the noise is assigned only an 80% likelihood of being a collision, it reduces the sensitivity of the WT-Bird® system as it can result in more than 2000 false positives per day.

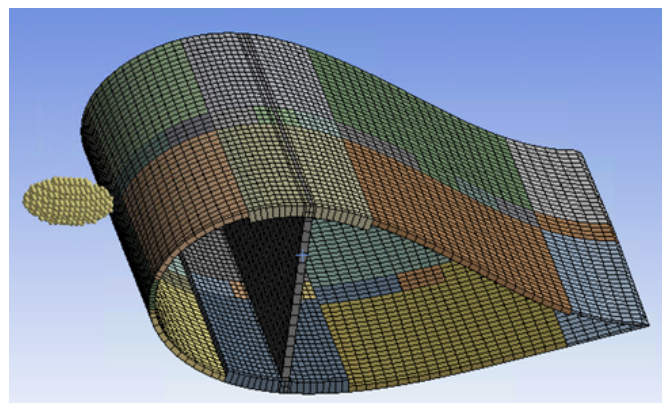
Figure 3.16: Section of FE model with 1.1kg bird modelled as water droplets just before impact, screenshot from Ansys software

- › Elements that allow out-of-plane movements in order to properly model the vibrations
- › Force burst input at impact location to represent the bird impact
- › Bird is modelled with water particle
- › Blade is modelled with shell element with layered section
- › No material damping added
- › Fixed support on trailing edges
- › Bonding is not modelled

As the precise geometry of the Enercon blade is not known, the shape and material properties of a generic TNO demo blade section with material definitions from the UPWIND project is used. To simplify the model, a continuous section of 6 m with a 2.4 m chord was modelled. The bird was assumed to be a duck with a flight speed of 18 m/s and a weight of 1.1 kg, impacting at 12 m (30 % of the blade span). Using a rotational speed of 18 rpm, the impact speed is 41 m/s. The rotational speed of 18 rpm was chosen as conservative number, slightly larger than the maximum rotor speed found in the SCADA data. Figure 3.16 shows the FE model consisting of the extruded blade cross-section and the approximation of the impacting bird.

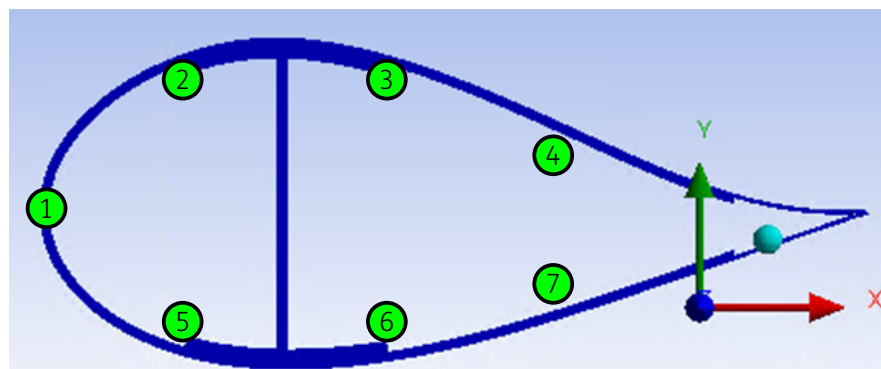
Figure 3.17: Locations of acceleration probes in the model, edited screenshot from Ansys software

Based on the model, the acceleration was determined at several chordwise locations in the cross-section (shown in Figure 3.17) and also at different spanwise locations of the blade.

For each probe location, the maximum acceleration as a ratio to the desired LE position 1 is listed in Table 3.3. If the bird were to hit exactly at the spanwise location of the sensor at

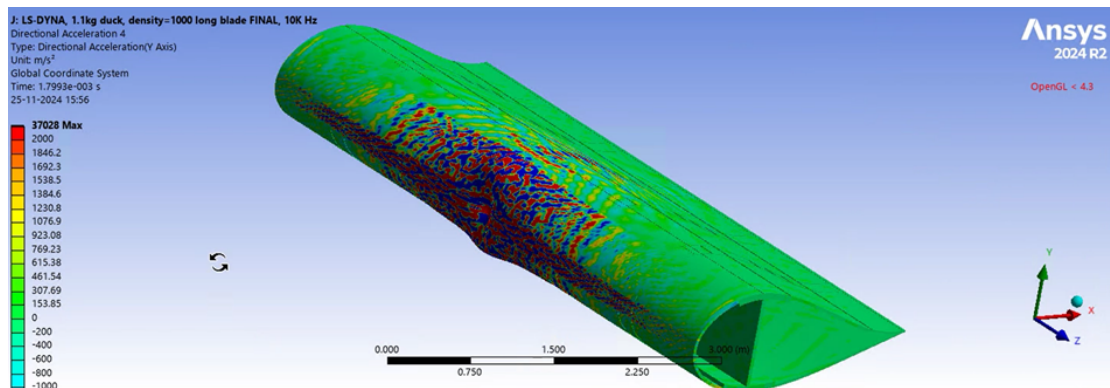
Figure 3.18: Snapshot of shockwaves travelling through the structure, screenshot from Ansys software

Interesting to see is that the shock waves are greatly impacted by the structure. The stiff laminate in the leading edge ensures that the wave travels relatively quickly in spanwise direction with a low amount of signal loss. This confirms that with only a couple of sensors along the span of the blade, impacts can reliably be detected. The much stiffer spar cap acts like a barrier, absorbing or reflecting much of the energy. This means that only a fraction of the energy reaches the probes in the other locations. A snapshot of the shockwaves travelling through the modelled body is given in Figure 3.18.

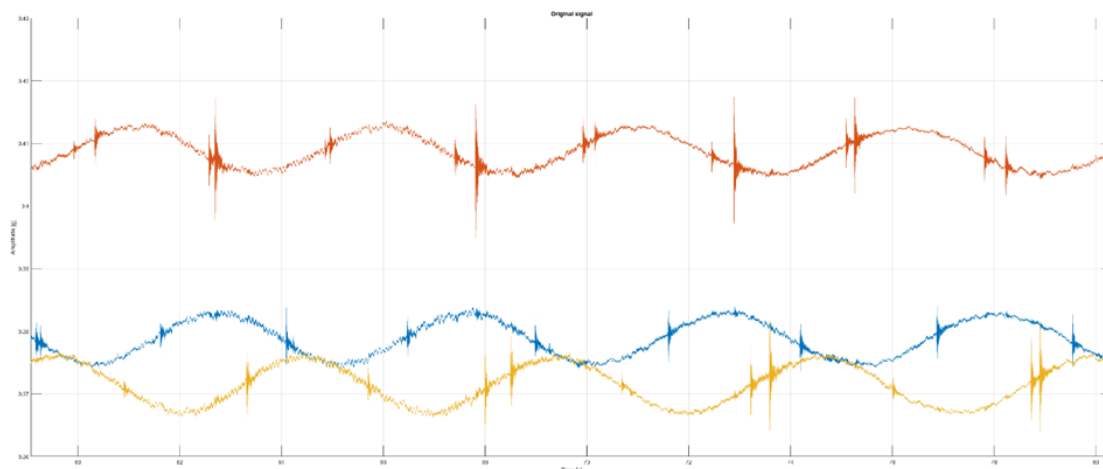
Figure 3.19: Sensor signals of the sensors closest to the blade roots with signal noise

On TNO’s request, RWE conducted two inspections of the turbines to check for any obvious sources of the noise. Among others, bolts of various components were fastened and while other parts were slightly moved. Especially the last inspection (around 11th of June 2024) was quite elaborate. Unfortunately, the problem was not solved by this. Ensuing, TNO and RWE checked the SCADA data to see whether there is any relation between the noise and the operational state of the turbine. The most likely cause is wear of the gears in the pitch system, which then slightly move every rotation under the force of gravity. This is clear from the data of the sensors closest to the blade root and the correlation with the pitch set point taken from RWE SCADA data, see Figures 3.19 and 3.20.

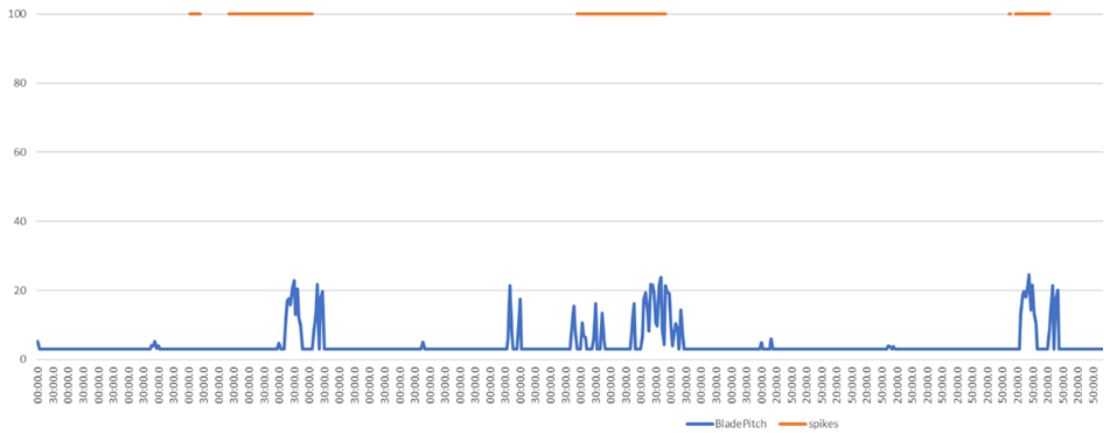
Figure 3.20: Correlation of blade pitch set point (SCADA) and noise (spikes)

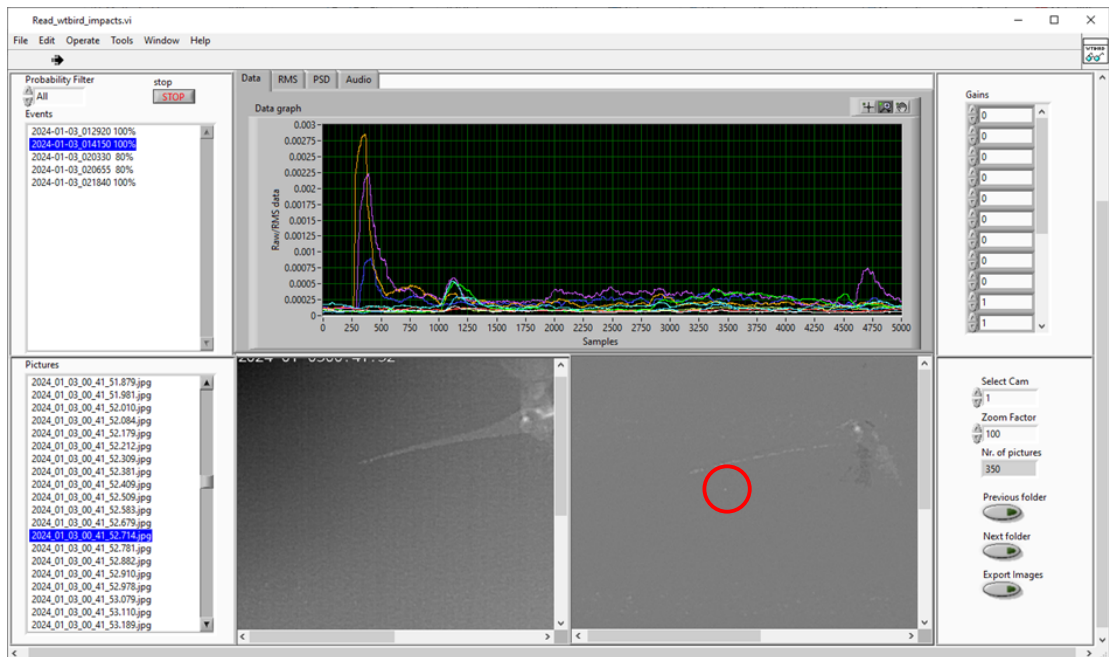
Figure 3.21: Screenshot of TNO WT-Bird® interface with victim circled in red

On the 3rd of January 2024, a collision was detected on turbine 21 and blade 3 at 00:41:52. Due to foggy conditions, the victim is difficult to see on video. Due to ice and snow, the first victim search after the detection was only conducted on the 24th of January, and no victim was found on the ground. Figures 3.21 and 3.22 show the measured data at the time of the impact.

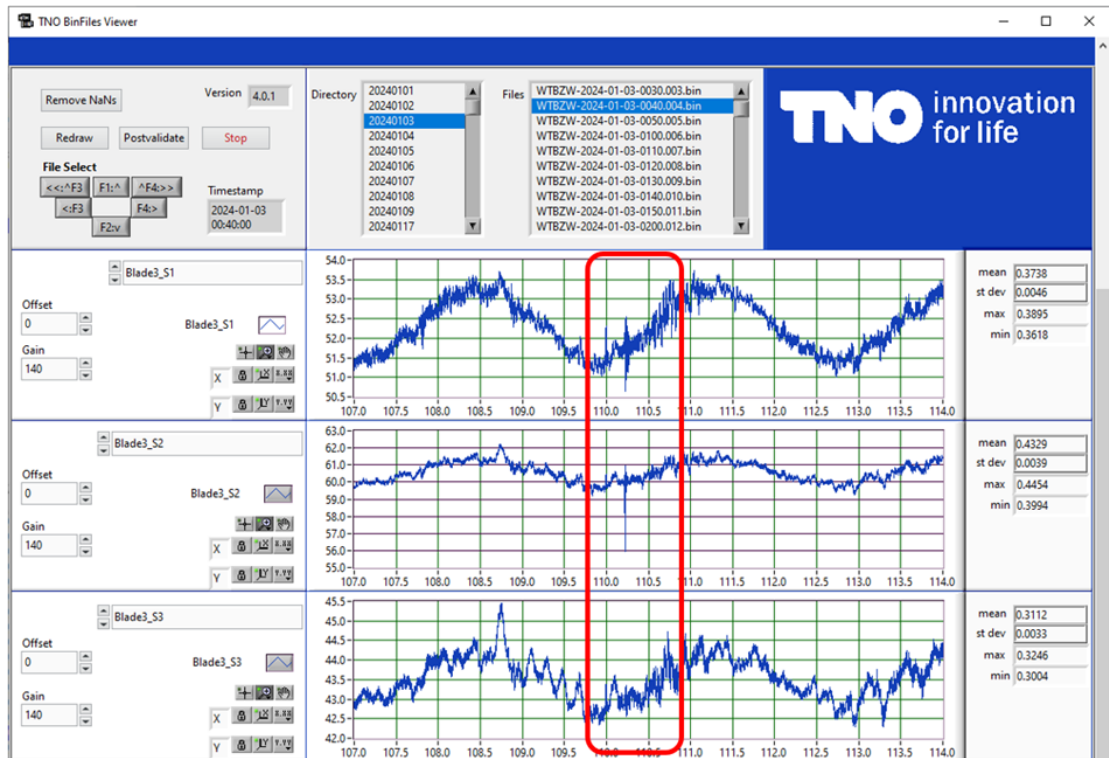
Figure 3.22: Signals of sensors in blade 3 of turbine 21 on the 3rd of January 2024 with signal peak of impact circled in red

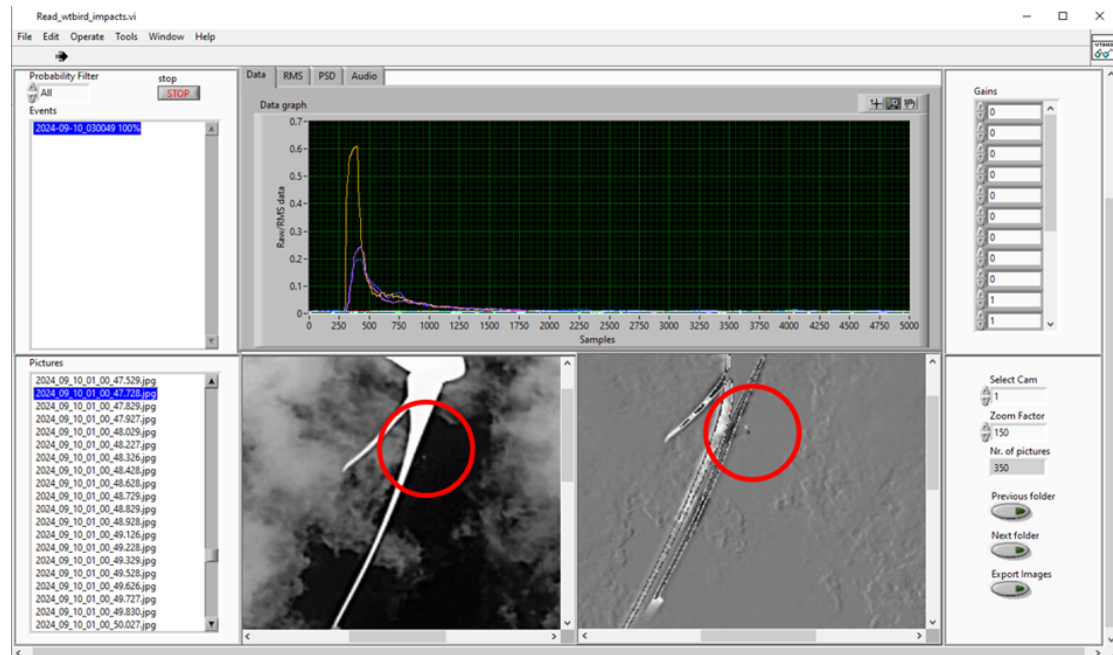
Figure 3.23: Screenshot of TNO WT-Bird® interface with victim circled in red

A second impact was detected by the WT-Bird® system on turbine 21 in the night of the 10th of September. As the conditions were clear, the victim can also be seen on the compound video footage, see Figure 3.23. The impact causes a clear peak in the sensor data, as can be observed in Figure 3.24.

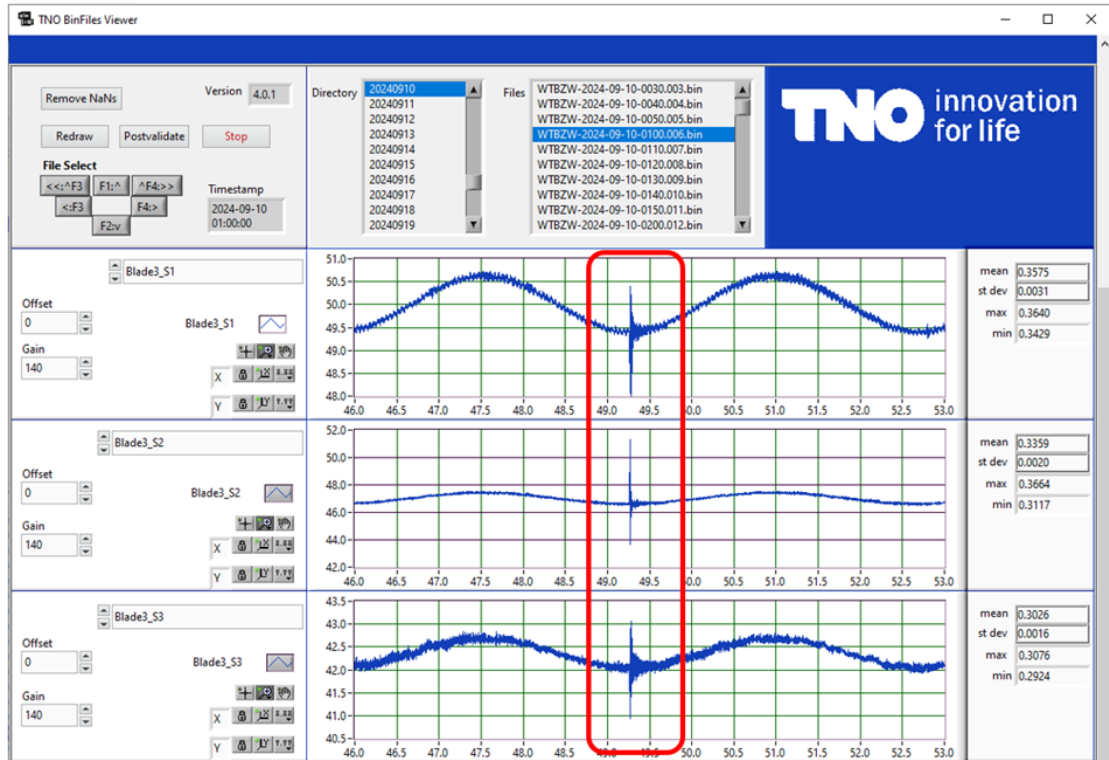
Figure 3.24: Signals of sensors in blade 3 of turbine 21 on the 10th of September with signal peak of impact circled in red

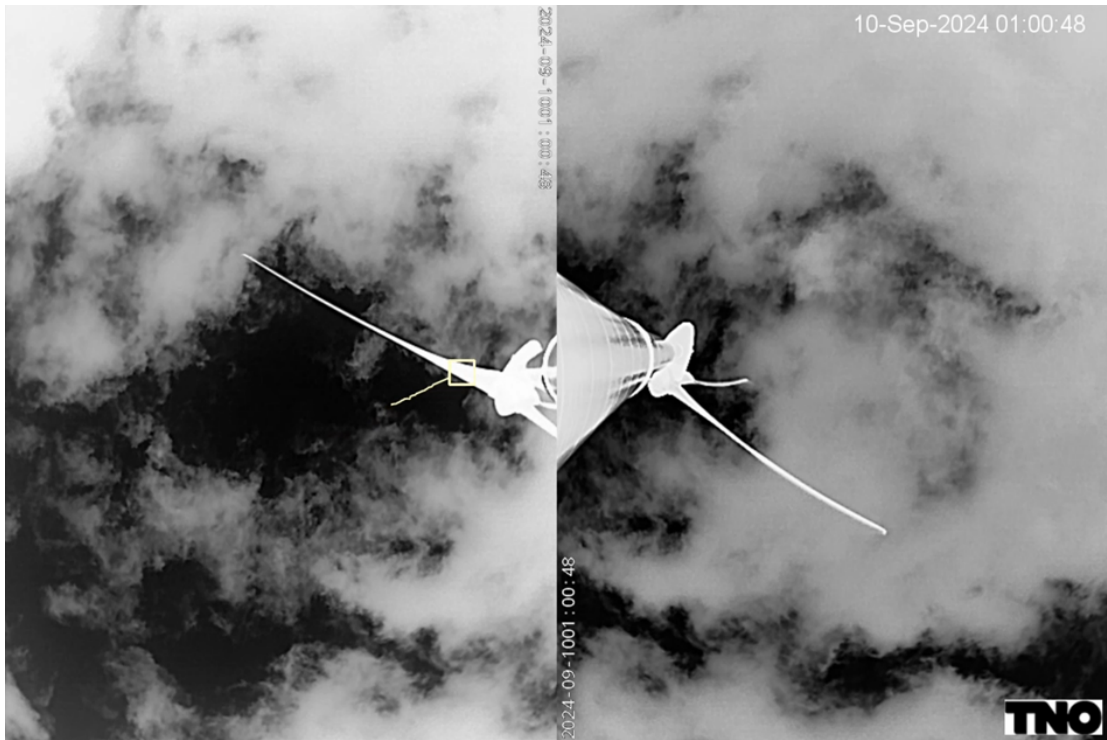
Figure 3.25: Still from the compound image with birds track just before impact on the 10th of September

Inspecting the thermal camera footage at the time of the detected collision confirmed the presence of a bird. Figure 3.25 shows a still including the detected bird track at the time of the collision.

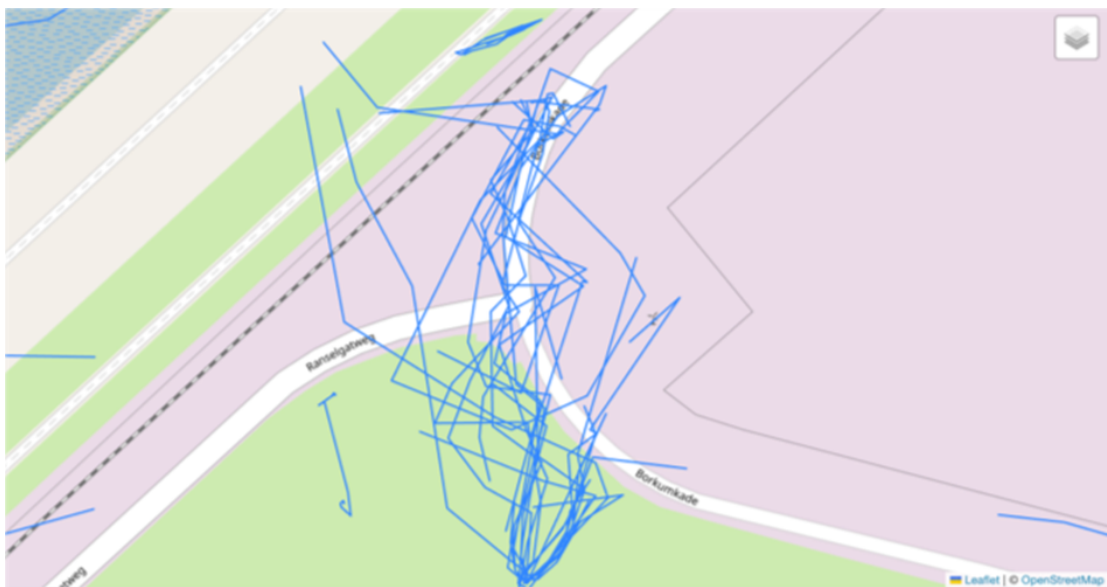
Figure 3.26: Radar tracks (mostly clutter) around the turbine 21 around the time of impact on the 10th of September 2024, map based on OpenStreetMap

Again, the radar tracks around the time where investigated. Near the turbine, a lot of clutter tracks due to the radar reflections of the turbine and especially the blade tips were observed, see Figure 3.26. There is one longer track which ends near the turbine (in the radar shadow) around seven seconds before impact. This track, shown in Figure 3.27, could potentially be linked to the victim.

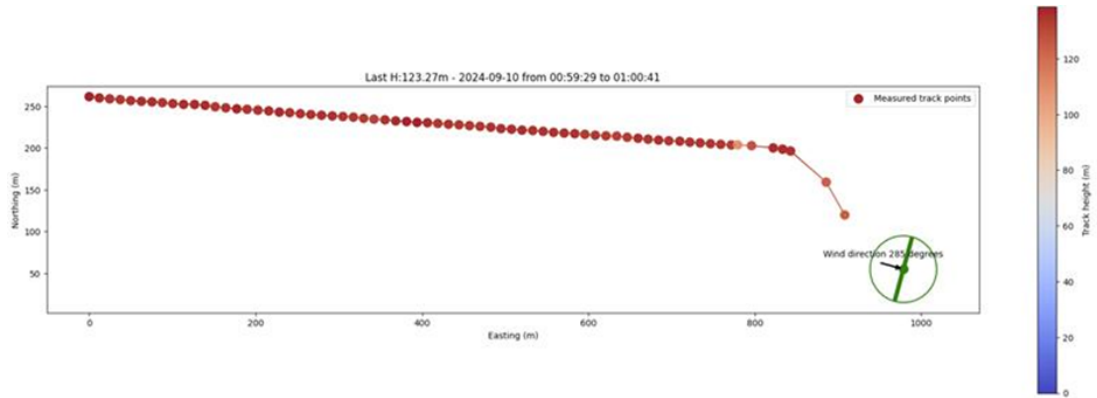
Figure 3.27: Potential track of bird victim the turbine 21 around the time of impact on the 10th of September 2024

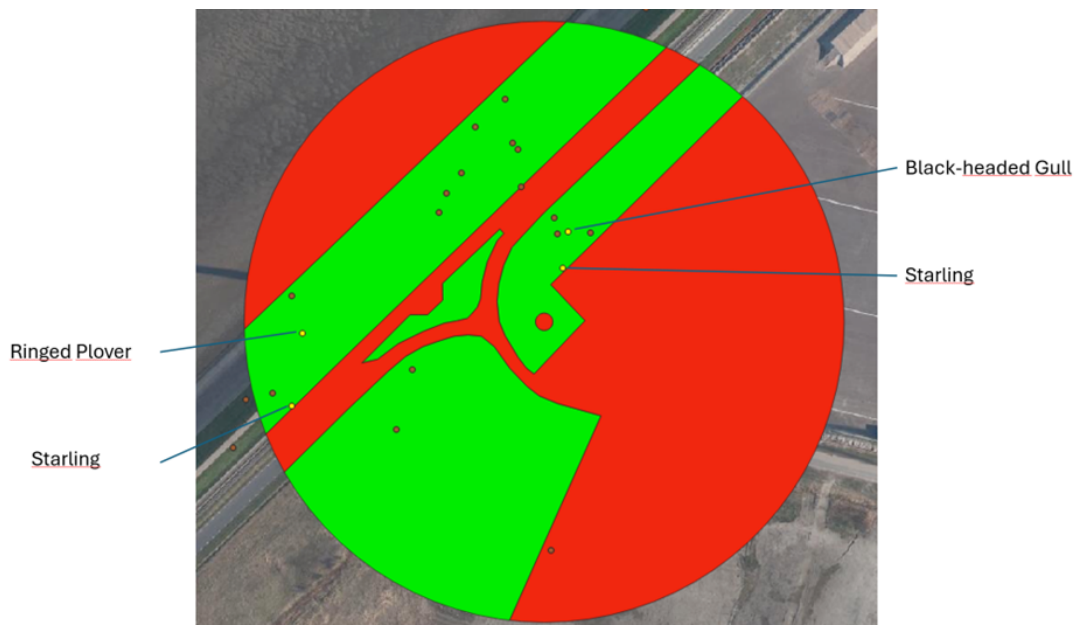
Figure 3.28: Locations of the victims found during the search on the 10th of September, reproduced from [5]

The impact occurred on the night of the 9th to 10th of September. During the day of the 10th of September, a victim search was conducted by ecologists of Waardenburg Ecology and Altenburg & Wymenga. Four potential victims were found. Their locations are given in Figure 3.28 and details are given in Table 3.6. Due to the state of the cadavers, the most likely victim detected seems to be the Ringed Plover.

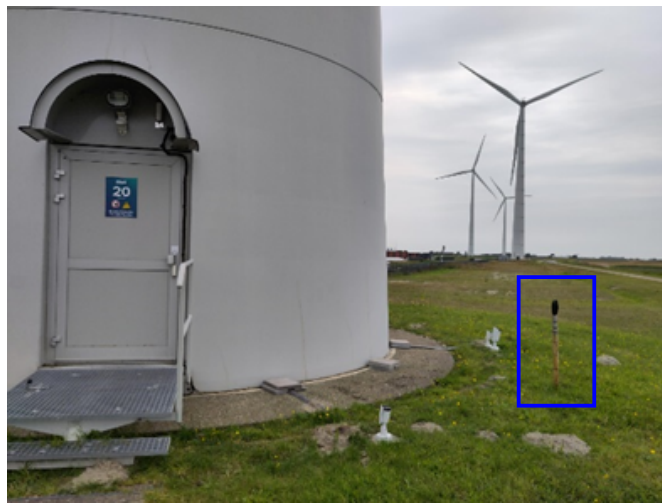
Figure 3.30: Microphone at the base of turbine 20

A microphone setup, borrowed from the TNO acoustic department, was placed at the bottom of turbine 20 as shown in Figure 3.30. This setup is normally used for, for example, monitoring traffic. It was operational since February 2024, but not all data was stored due to limits in data storage. A full dataset is available from the 18th of September 2024 till the 29th of September 2024.

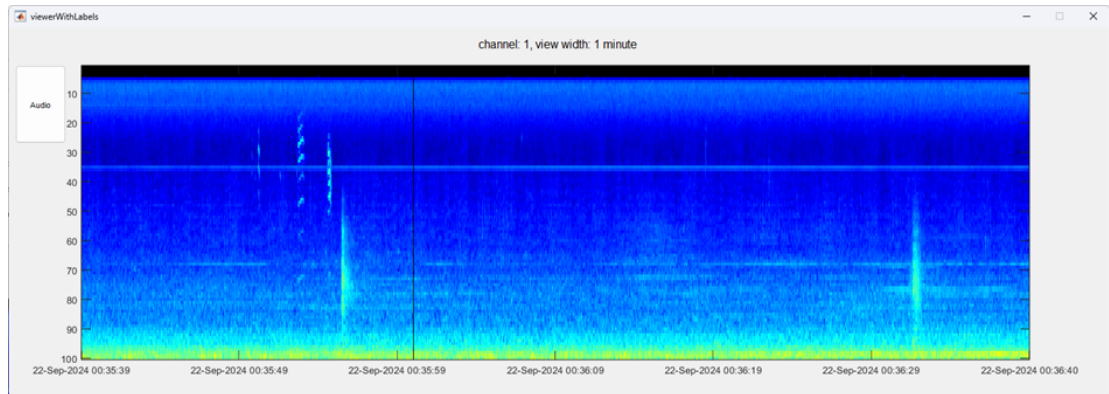
Figure 3.31: Example of audio output from acoustic setup

On the 23rd of September, feathers of a Lapwing were found underneath the turbines by the ecologists of Waardenburg Ecology and Altenburg & Wymenga. Unfortunately, at that time, the WT-Bird® sensors in the blades were no longer functional due to a defect on the 19th of September. However, the audio files from the microphone were available from the 18th of September. A visual search of the spectrograms, shown in Figure 3.31, indicates two anomalies on the 22nd of September, both around midnight (UTC). In the first instance, a bird can be heard, followed by a banging noise. The second is only a bang. The bird sound is most likely a Lapwing, which fits with the feathers found on the ground. The video images from the three

cameras do not confirm birds in the vicinity of the blades. So, it is questionable that the bang indicates a collision of a Lapwing with the blades, and it was concluded that it is more likely that the sound comes from the turbine itself.

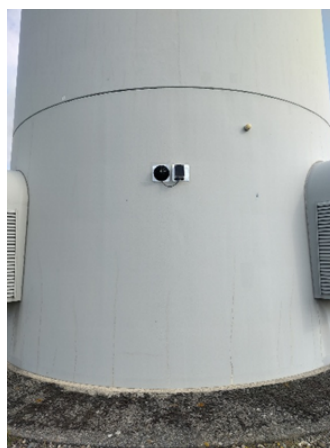
Figure 3.32: Picture of on tower microphone of Eologix-Ping in the Eemshaven

Next to the ground-based TNO setup, two commercial solutions were deployed, both from the company Eologix-Ping. The systems are usually used to monitor turbines for blade damage. One of the two solutions is an on-tower setup, depicted in Figure 3.32.

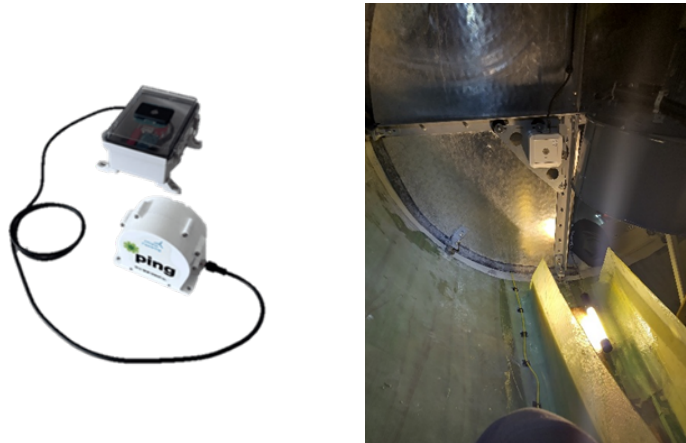
Figure 3.33: Picture of in blade microphone of Eologix-Ping and picture of the microphone installed in the blade of the turbine. Left picture by Eologix-Ping

In order to be closer to the source, two additional sets of three in-blade sensors are ordered. These are mounted in the root of the blade and pointed at the blade cavity, see Figure 3.33.
