Cathodic protection of steel in concrete – experience and overview of 30 years application

Abstract. This paper presents an overview of 30 years' experience with cathodic protection of steel in concrete in The Netherlands. Principles and practical aspects of CP and its design and installation are presented. Three phases have passed from the late 1980s until present: pioneering, development and maturity. In the first period CP was mainly applied to precast elements corroding due to mixed-in chlorides. The parties involved worked together to draw up a Technical Guideline. In the second period, application to bridges came up, including post-tensioned structures, which was then innovative. Furthermore, galvanic anode systems were introduced. In the third period, CP became a fully accepted method of securing durability and safety. Renewed collaboration led to a database that allowed analysis of various aspects of CP system working life, including shortcomings in early systems. Major successes and lessons learned will be presented. Technical and non-technical developments are highlighted and some recent innovative CP components and systems are discussed.

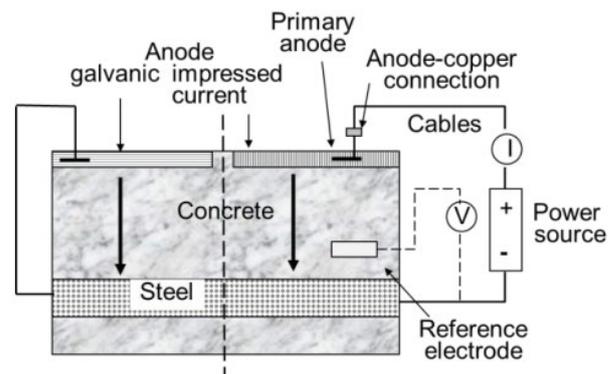
Fig. 1. Main components of galvanic (left) and impressed current (right) CP systems.

Two basic types of CP systems exist: impressed current CP (ICCP) and galvanic or sacrificial CP (GCP). The main components for both are illustrated in Figure 1. With ICCP a low voltage DC power source causes the current to flow. The anode consists of a material that is not or only slowly consumed, such as activated titanium (whose surface is covered with noble metal oxides, Mixed Metal Oxide or MMO) or a conductive coating. Activated titanium has the shape of a mesh embedded in a cementitious overlay installed on the concrete surface; or of strips in boreholes in the cross section or in slots cut in the concrete surface; holes and slots are filled with cementitious grout. Conductive coatings are carbon filled polymers applied to the concrete surface, usually covered with a top coat. Primary anodes are metal wires used to feed the current into the actual anode material; they should be separated closely enough to avoid large potential drops in the metallic circuit. Cementitious overlays and conductive coatings should be durably bonded to the concrete surface to ensure electrical contact. Obtaining good bond requires adequate surface preparation; proper application and curing are critical. Power source and anode are metallically connected by isolated copper cables and anode-cable connections. Cable cross sections should be large enough to limit potential drops. Cables need to be redundant in order to avoid system failure due to cable interruptions (e.g. by vandalism); at least two cables should feed both anodes and cathodes, with their connections as far apart as possible within a zone. Power sources are fed from the grid or by solar or wind energy, backed up by batteries.

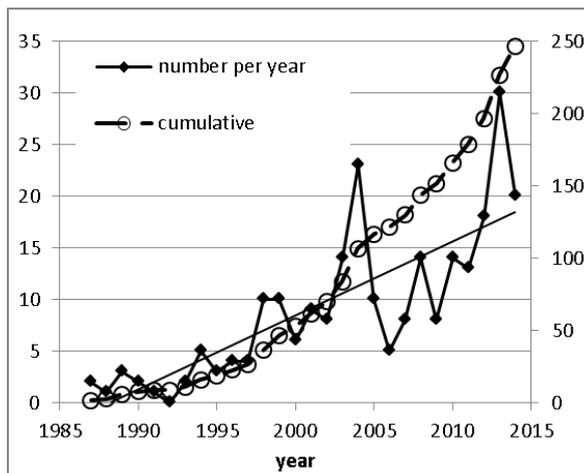
Fig.2. Number of CP systems installed in The Netherlands per year (left Y-axis), cumulative number (right Y-axis) and trend line for number per year.

total of 230 structures had CP with some multiple systems installed, counting a total of 250 CP systems. Figure 2 presents annual and cumulative numbers. They comprised 105 buildings, 97 bridges and 44 other structures. From the total, 103 had conductive coating anodes, 57 titanium and 58 galvanic anodes (29 had other anodes or two types). Owners were The Ministry of Infrastructure (65 systems), lower governments (41) housing companies (48), private collective building owners (24) and other owners (69). Increasing numbers of projects involved protecting corroding bridge abutments, preventive applications and systems with ground bed anodes; some are illustrated in more detail below.
