TNO report

TNO 2016 R10735v2

**Investigation into a Periodic Technical
Inspection test method to check for presence
and proper functioning of Diesel Particulate
Filters in light-duty diesel vehicles**

| Project name | In use compliance program for light-duty vehicles |

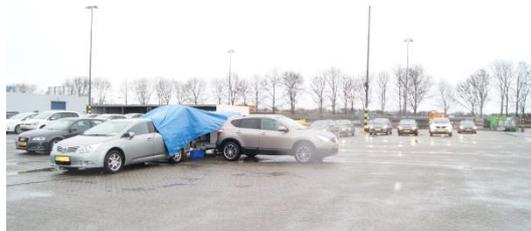
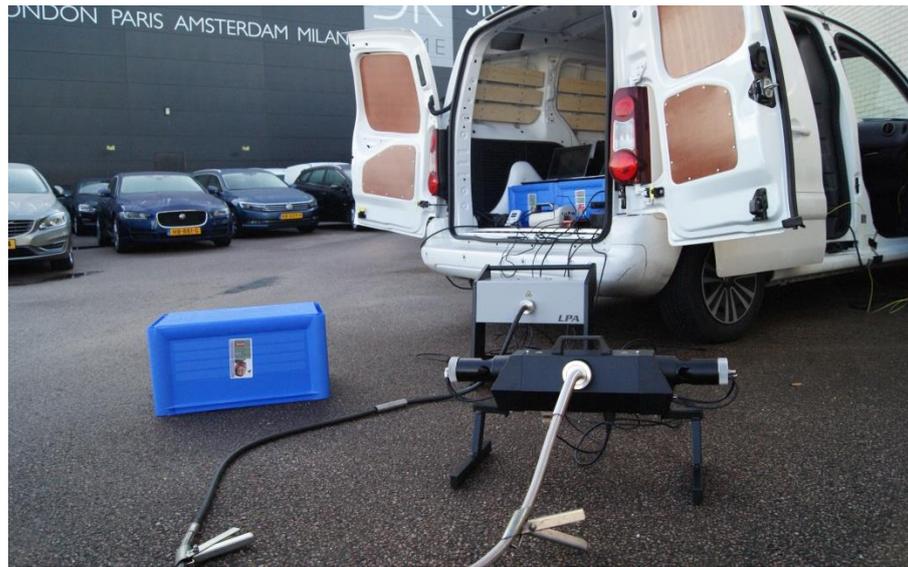
All measurement equipment and supporting materials were placed in a van, thus creating a mobile laboratory capable of performing measurements throughout the Netherlands.

Figure 3 The measurements were carried out on-site at various lease companies and car shops using a 'mobile laboratory'.

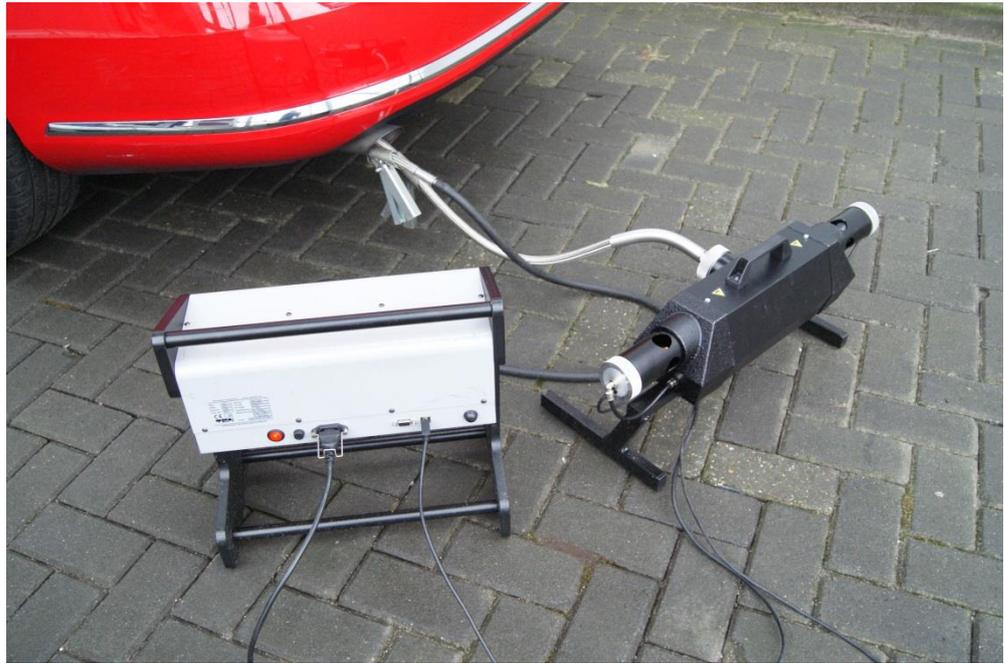
Figure 4 Opacity was measured using two types of opacity or smoke meters. The conventional EDA2 (right), and the modern, more accurate LPA (left). Both smoke meters are manufactured by TEN Automotive Equipment. As the picture shows, the in-line opacity meters were inserted into the exhaust pipe simultaneously.

TNO performed opacity measurements in free acceleration tests using two types of opacity meters or smoke meters, the TEN EDA2 and the TEN LPA (Figure 4). The particle number (PN) measurements were performed at idle engine speed using the TSI 3007, a handheld Condensation Particle Counter (CPC, Figure 5, Figure 6)

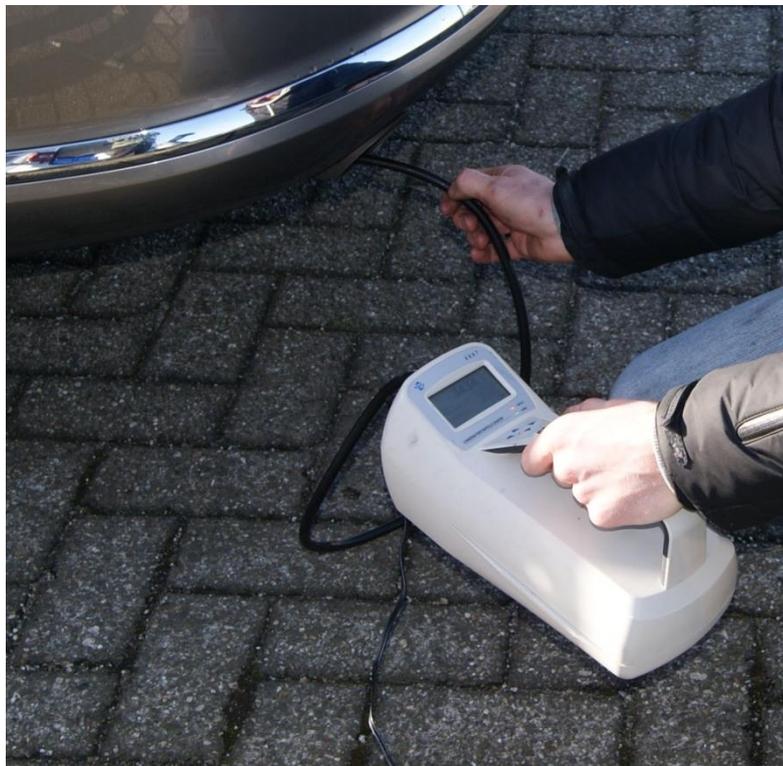
Figure 5 The particle number (PN) measurements were performed using the TSI 3007, a handheld Condensation Particle Counter (CPC). A sample hose, connected to the 3007, was kept in the exhaust flow with the engine running at idle engine speed.

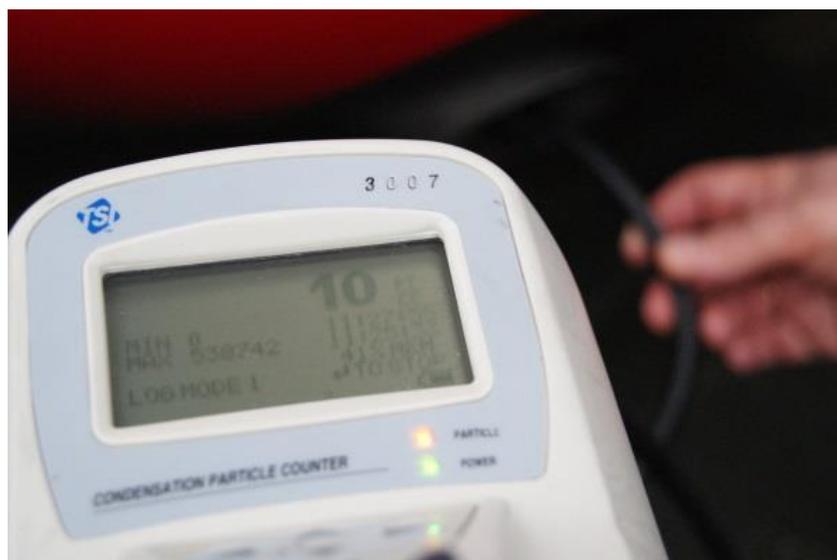
Figure 6 The sample hose was kept in the exhaust pipe until the read-out stabilized.

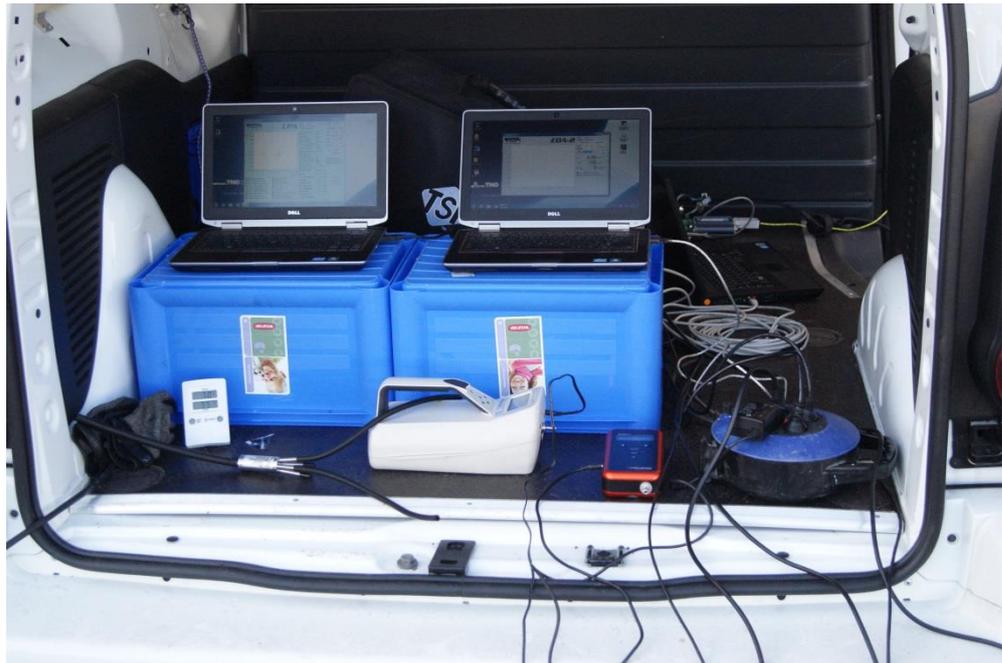
Figure 7 The smoke meters were connected to a laptop and data was logged using dedicated software. The TSI 3007 logs data internally, and test data was retrieved from the device by connecting it to a laptop at the end of a measurement day.

The smoke meters were connected to a laptop and data was logged using dedicated software. The TSI 3007 logs data internally, and test data was retrieved from the device by connecting it to a laptop at the end of a measurement day.

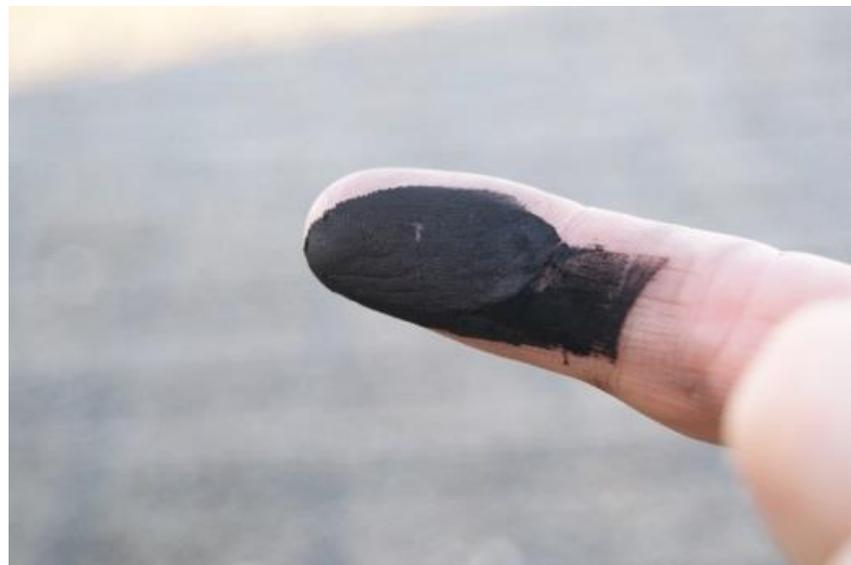
Figure 8 Example of two tailpipe swipe tests resulting in a deep black finger, scoring 3.

The results were categorized into four groups or scores: clean or no darkening (0), grey (1), black (2) and deep black (3). Clean tailpipes generally show no soot at all and leave fingers absolutely clean, indicating a well-functioning DPF. In case of heavily soiled tailpipes, a black, sticky and greasy layer of soot can be found. This black soot may indicate a malfunctioning or removed DPF.

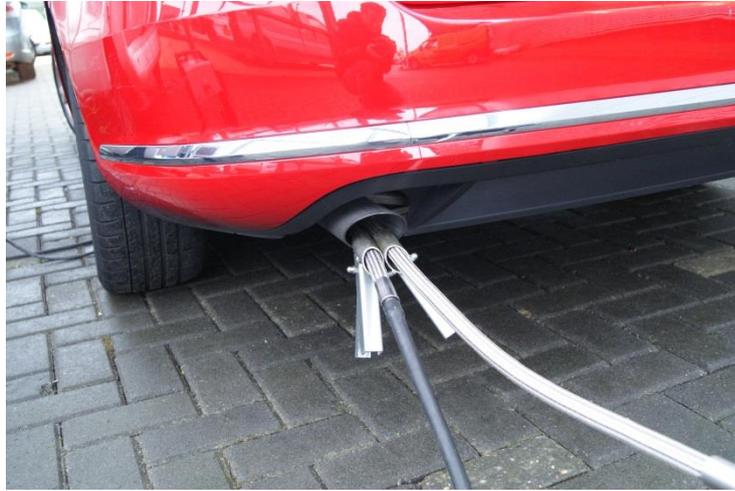
Figure 9 The probes of the LPA and EDA2 opacity meters were both inserted into the tailpipe during the free acceleration test and the high idle speed test. This way, both smoke meters measured simultaneously. Also see Figure 4.

In the free acceleration test, the probes of both smoke meters were inserted into the tailpipe, in line with the exhaust flow (Figure 9). It is assumed that both meters are charged with equal exhaust gas mixture.

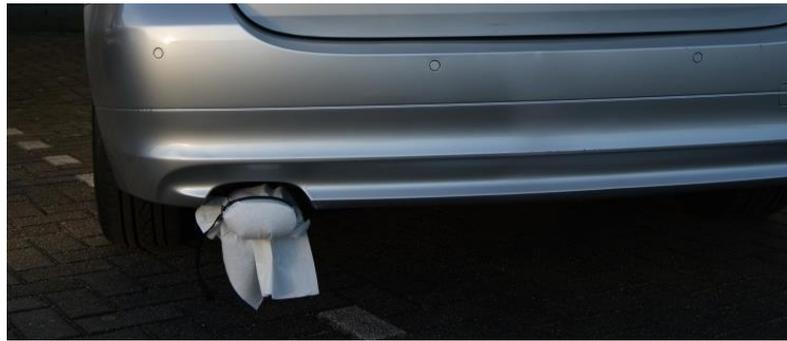
Figure 16 In the tissue filter test, a tissue was attached to the end of the exhaust pipe after which the engine was let running at idle speed for three minutes. Cars showing elevated emissions in previous tests were selected for the TFT.

Vehicles scoring 3 on the tailpipe swipe test and showing high opacity values and/or high PN emissions were selected for a tissue filter test. A tissue was attached to the end of the exhaust pipe, as can be seen in Figure 16, after which the engine was let running at idle speed for three minutes.
